U. S. FOREST SERVICE  
RESEARCH PAPER NC-16  
AUGUST 1967

# HARDWOOD SIDING PERFORMANCE

GLENN A. COOPER

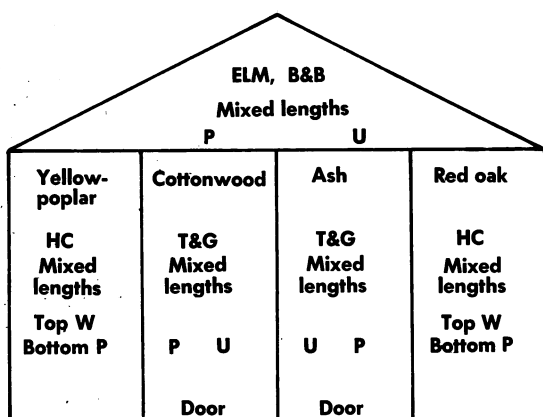
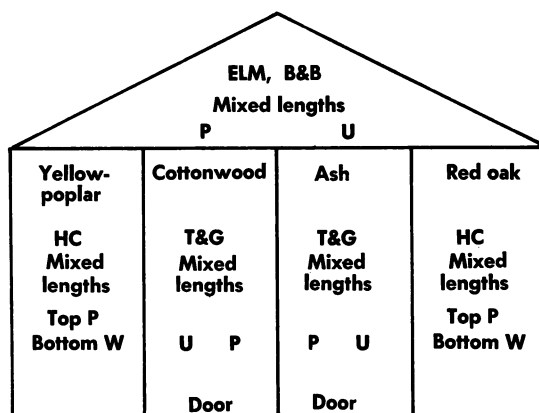
Figure 1.—Species, style, board length, treatment, and location of the test panels. Styles were T&G (tongue-and-groove), B&B (board-and-batten), and HC (horizontal clapboard). Treatments were P (pentachlorophenol), W (water-repellent penta), and U (untreated).
