## Quincy Mine Blacksmith Shop Condition Assessment of Timbers

By Robert J Ross and Xiping Wang

### Scanning Timbers for Deterioration

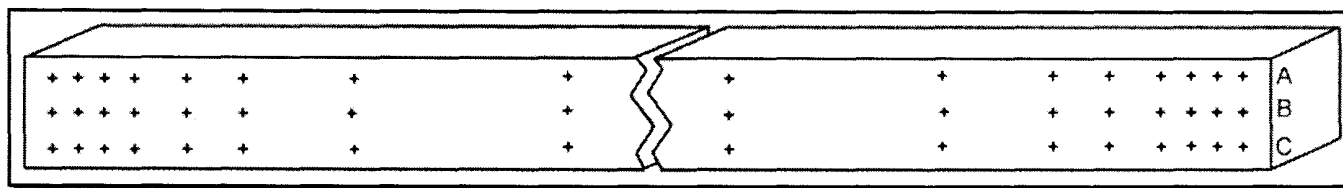
Figure 2 shows a typical scanning diagram used to conduct stress wave transmission tests. The timbers were supported on two beams. Each timber was stress wave scanned along three lines (A, B, and C) on the side surfaces, with A, the upper line, B, the middle line, and C, the lower line, through the height of each timber. Since the ends of the timber were usually considered to be the areas having a high risk of decay, stress wave transmission tests were more intensively performed at ends than other parts of the timber. The intervals between the two scanning

Figure 2. Scanning diagram for nondestructive evaluation of 12-by 12-inch white pine timbers

points in the longitudinal direction changed from 6 inches beginning at the end of the timber to 1-foot, 2-feet, and 4-feet, respectively, as the scanning position approached the middle part of the timber.
