Forest  
Products  
Laboratory

Research  
Paper  
FPL 344  
**1979**

# California Black Oak Drying Problems and The Bacterial Factor

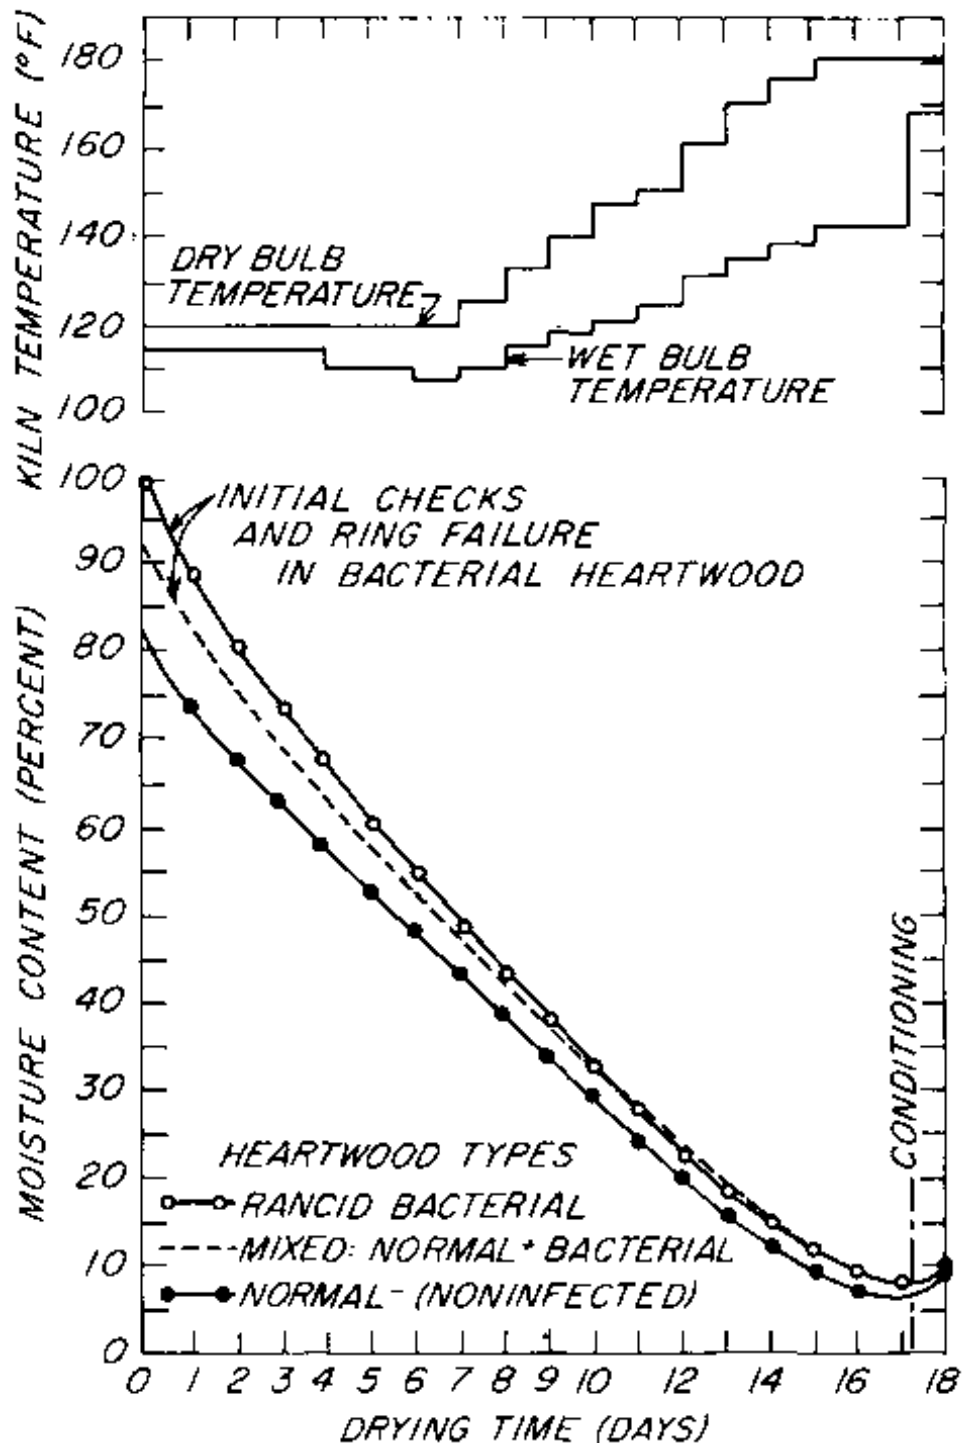
Figure 2.—Experimental kiln conditions and drying curves for 4/4 California black oak.  
(M 146 707)

Experimental drying conditions and moisture loss curves for the green boards shipped to FPL are shown in figure 2 for simulated kiln drying and in figure 3 for air drying. Under both drying conditions, surface checking started in about 24 hours in bacterially infected heartwood of the rancid sample and the mixed wood sample. The initial air drying conditions were quite mild but not enough to prevent surface checking in bacterial heartwood. Normal, noninfected heartwood did not develop surface checks under either air drying or kiln drying. Ellwood (1959b) observed that most surface checking occurred in green flatsawn California black oak on the first day of kiln drying.

These laboratory drying experiments demonstrate that the normal, noninfected heartwood of California black oak can be kiln dried green from the saw without defects even under an initial temperature of 120° F. This compares with the first test of the large-

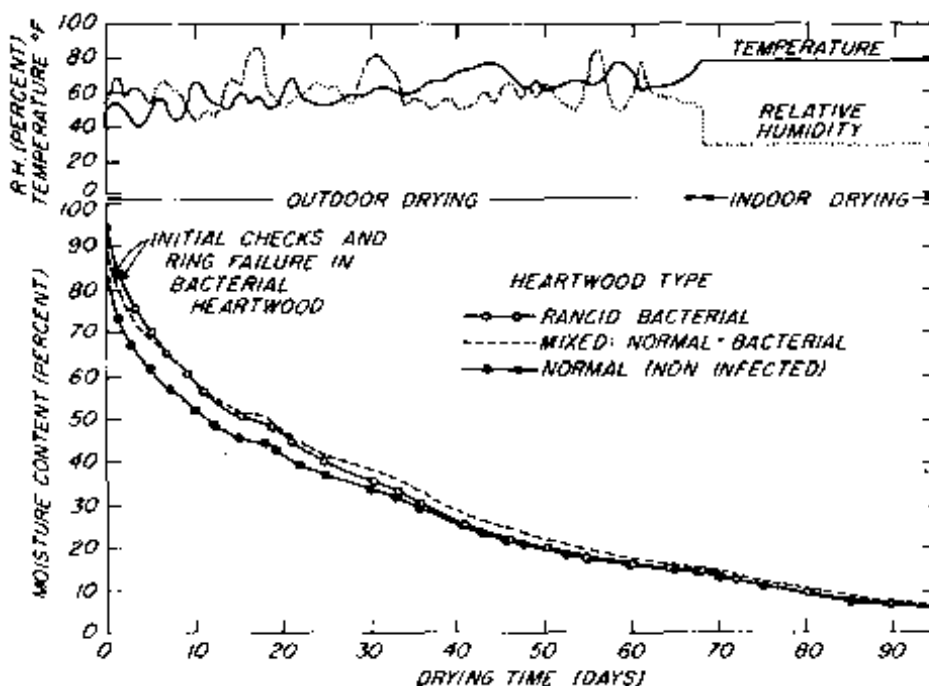
Figure 3.—Atmospheric conditions and air-drying curves for 4/4 California black oak. (M 146 705)

The absence of honeycomb in air-dried boards containing bacterial heartwood substantiates Smith's (1961) recommendations that California black oak in general should be predried under temperatures that do not exceed 100° F. However, our laboratory experiments also indicate that some bacterially infected heartwood, particularly the rancid-odor type, cannot be dried defect-free even under the mildest commercial conditions. This is substantiated by the third test of the mill study where over half of the kiln charge was degraded from checking and collapse, even though drying was done in the winter with initial temperatures that did not exceed 100° F.
