# Buckland's Crossing Firefighter Burnover— A Case Study of Fire Behaviour and Firefighter Safety Implications

**Abstract**—On March 24, 1998, a crew of eight rural firefighters were burned over while attempting to suppress a backburning sector of the Bucklands Crossing Fire in North Otago, New Zealand. The fire demonstrates how factors typical of the New Zealand fire environment – steep slopes, highly flammable shrub fuels, and a strong foehn wind effect – combined to produce extreme fire behaviour. Several firefighters sustained varying degrees of injury. They were hit by a blowup that was most likely caused by a rapid reburn through previously underburned shrub fuels. The exact trigger for upslope spread and transition to a crown fire was not definitively identified; however, it was most likely the result of strong winds and localised turbulence, combining with steep topography and highly flammable, preheated shrub fuels. The case study report prepared on this burnover describes the activities of personnel leading up to and during the incident in relation to the fire environment and fire behaviour. Possible causes of the blowup are reviewed, and observed fire behaviour compared

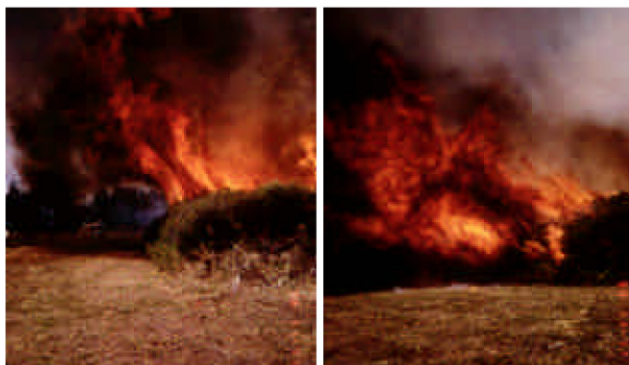
The firefighters involved in the Bucklands Crossing Fire burnover reported being hit by a “fireball” originating from the gully below them. This may have been the result of a collapsing fire whirl or convection column, flash-over, or even a carbon dust explosion. However, the most likely cause was a flame extension or “rollover” associated with an uphill run and reburn through the preheated shrub canopy. The collapse of the fire front as such a run reached the end of the shrub stand (see fig. 9) would push flames along the ground and, together with the pulsing of the flame front as volatile gases are burned, would create an effect similar to that of a fireball or flashover observed by the firefighters. It would also produce extreme flame lengths capable of reaching the 30 to 50 m (100 to 165 ft) to the ridge where the fire appliance was parked.

**Figure 9**—Example of flame front collapse in New Zealand manuka shrub fuels during experimental burning trials observed from consecutive photographs.
