# FIELD INVESTIGATION OF A 100-YEAR-OLD TIMBER CRIB FOUNDATION AT A HISTORIC COPPER MINE

James P. Wacker<sup>1</sup>, Xiping Wang<sup>2</sup>, Douglas R. Rammer<sup>3</sup>

**ABSTRACT:** In June 2009, the authors conducted a comprehensive on-site evaluation of the timber crib foundation at Alaska's Historic Kennecott Mine Concentration Mill Building. The primary goal of the 6-day inspection was to assess the physical conditions of the existing timber crib foundation and identify timber members and areas that have structural deficiencies. The inspection process included visual assessment, species identification/confirmation, moisture content determination, stress wave scanning test, resistance micro-drilling, and core-drilling. Extensive deterioration was noted in the timber crib foundation members at the lower floors of the mill building. The upper levels of the timber crib foundation exhibited less deterioration, especially in areas where the timber crib cells were not filled with soil. Current efforts are focusing on a comprehensive structural evaluation of the Concentration Mill building with the goal of stabilizing and preserving this historical mining building important to t

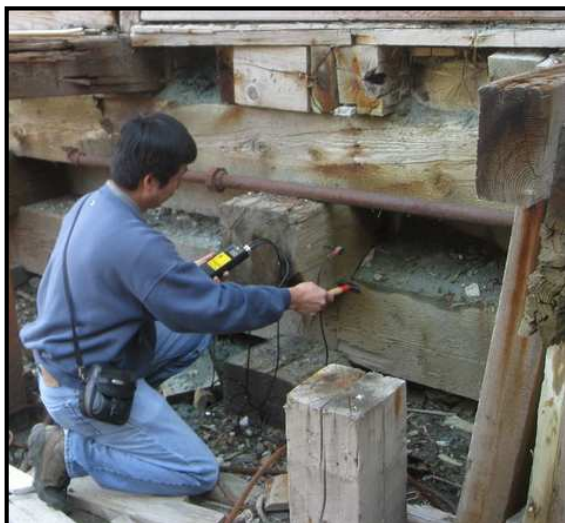
A stress wave timing device (Fakkop Enterprise) was utilized to measure the time it takes for sound waves to travel through the large timbers (Figure 4). For decay detection purposes, spiked-transducers are inserted into opposing faces (perpendicular-to-grain orientation) of the timber member. Then a hammer impact sends a sound wave through the member with the timing device precisely measuring time of flight through the member.

**Figure 4:** Testing a “header” timber crib member with a stress wave timer device.
