General  
Technical  
Report  
FPL-GTR-198

# Evaluation of Fleet Management Techniques for Timber Highway Bridges

Brent M. Phares  
Travis K. Hosteng  
Justin Dahlberg  
Michael A. Ritter

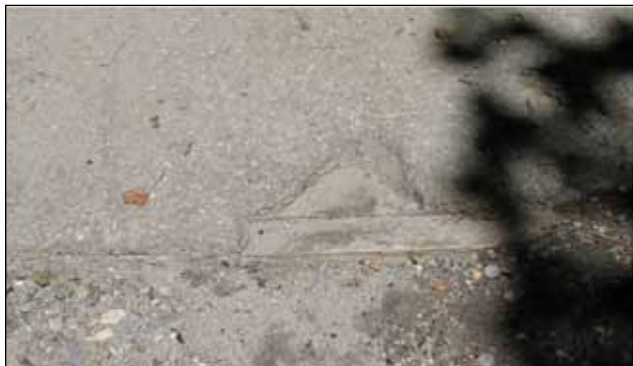
According to the NC–DOT 2005 report, scattered transverse cracks were present at the floor board seams. Though determined to be relatively minor, these cracks were verified by the ISU team during testing in 2006. The asphalt pavement generally looked to be in good condition; however, at the transition between the gravel approach and the bridge wearing surface at the west end of the bridge, the asphalt was chipping away and revealed the timber decking beneath (see Fig. C13). Besides this local case, the transition between the roadway and asphalt does not appear to be problematic for the bridge. An uneven transition could subject the bridge to unnecessary effects from dynamic loads even though slow

Figure C13. Pavement chipping at west end.

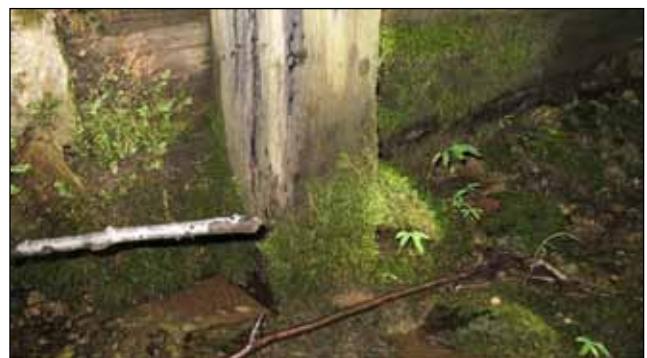
Figure C15. Moss growth at base of substructure posts.

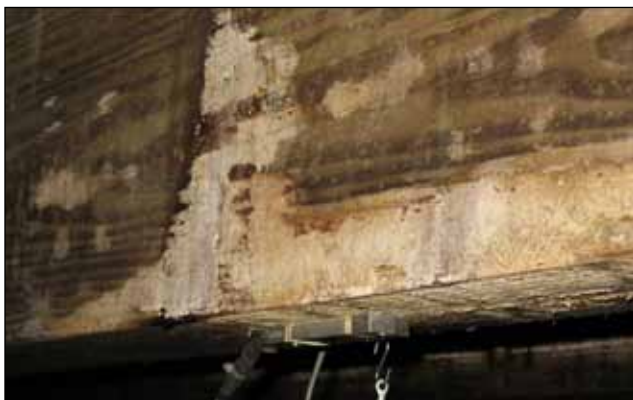
Figure C14. Biotic growth on girders.

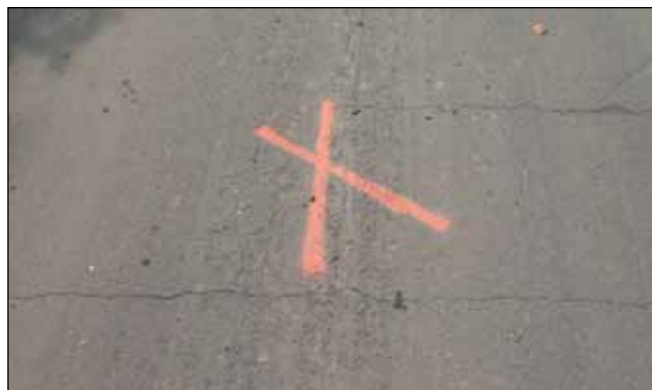
Figure D13. Pavement chipping at west end.

Several transverse cracks were observed throughout the bridge wearing surface. These cracks aligned with the transverse floor boards (see Fig. D13). Aside from the cracks, the wearing surface appeared to be in good condition. At the transitions between the roadway and the bridge, however, larger cracks have formed that mirror the abutment backwalls, which leaves the bridge vulnerable to filtering at the abutments (see Fig. D14). Imminent decay is not likely, though these cracks could be cause for concern in the future.

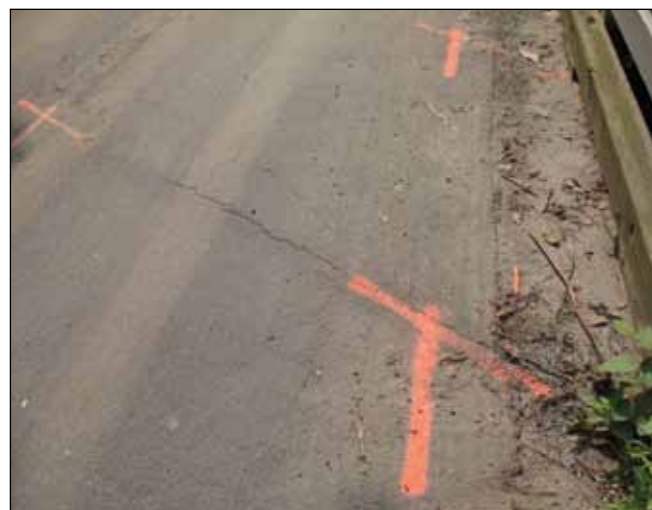
Figure D14. Transition between roadway and bridge.

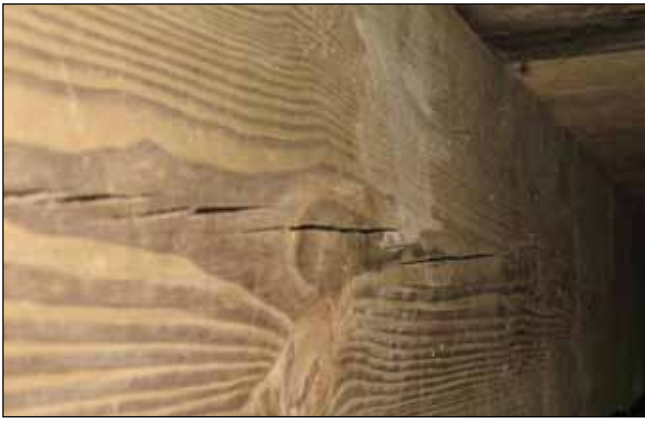
The superstructure appeared to be well protected from moisture, as only very minor water staining was observed. The most noteworthy observation was the checking found along the centerline of several girders (Figs. D15 and D16).

Figure D15. Checking at centerline of girder.

Though the checking appeared to be minor, the condition should be watched with future inspections. The girder bearing on the sill was sufficient, and there is no misalignment.

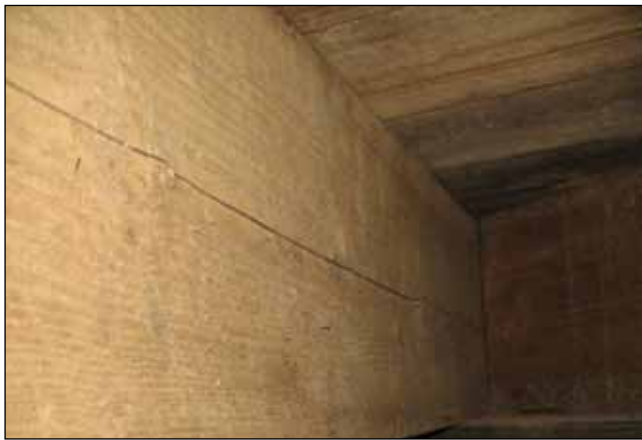
Figure D16. Checking at centerline near abutment.

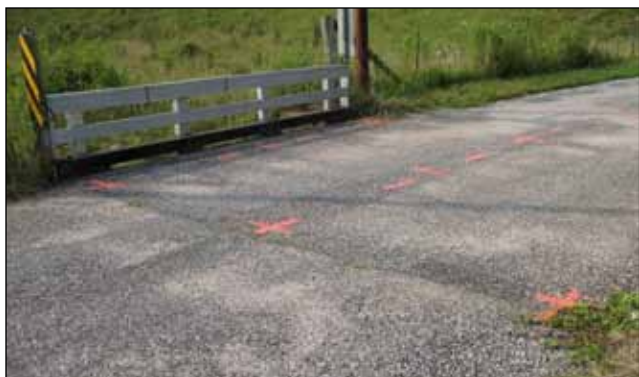
**Figure E13. Pavement condition.**

According to the NC–DOT 2004 report, the structure was still in good condition. No wearing surface problems were noted. The ISU inspection did note, however, that a number of transverse cracks had developed. Though determined to be relatively minor, it was decided that these cracks should be noted nonetheless. The asphalt pavement generally looked to be in good condition; however, at the transition between the roadway and the bridge wearing surface at the north end, a large crack has formed. The pavement condition and transition crack are shown in Figure E13. Large transition cracks leave the bridge susceptible to water seepage at the abutments and girder ends. Another notable, though minor, problem is the overgrowth along the east side of

Through visual inspection, transverse cracks in the wearing surface were found. Deflections exceeding the recommended live load limit state would suggest that the wearing surface may show transverse cracking. The wearing surface of this particular bridge is in satisfactory condition, though close attention should be paid to the existing transverse cracks and the effects thereof.

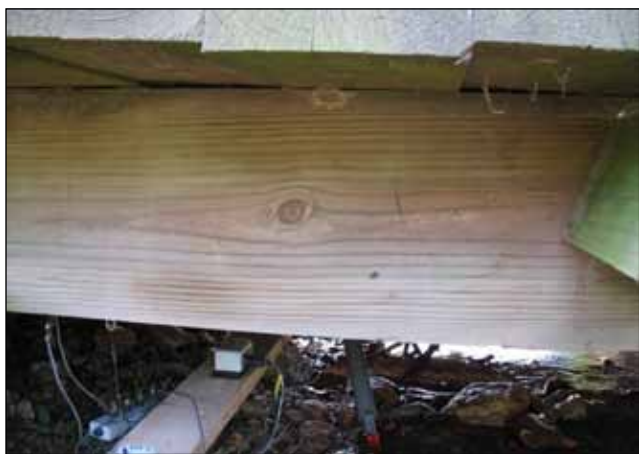
**Figure E14. Deck board detachment.**

Overall, the deck appeared to be in good condition. The deck boards were securely fastened to the girders except at the outermost girders, where some detachment has occurred (see Fig. E14). Minor water staining from seepage through

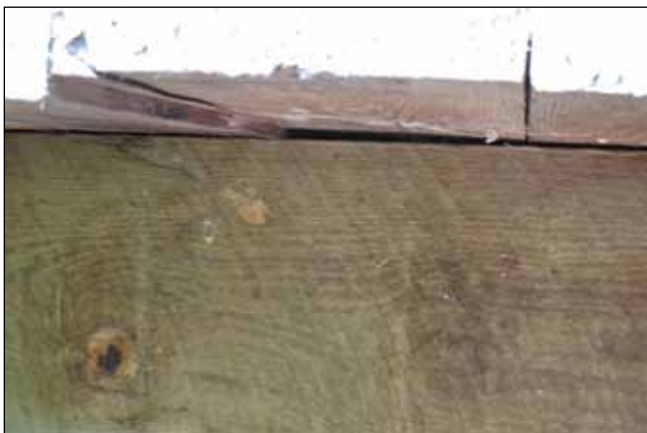
Figure F15. Deck board detachment.

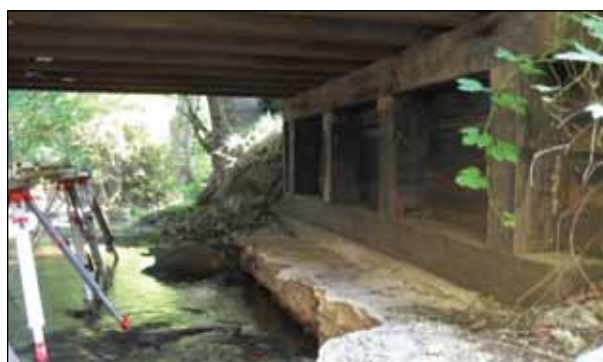
Figure G2. Dix Creek Bridge substructure.

The Dix Creek Bridge is a single-span, two-lane, timber girder bridge with a bituminous wearing surface. The bridge length measures 17 ft–9 in. from the west backwall to the east backwall. The bridge width measures 17 ft–1 in. from inside of curb to inside of curb and 18 ft–0 in. from outside to outside of deck. The substructure consists of solid timber posts and sills seated on concrete (see Fig. G2).

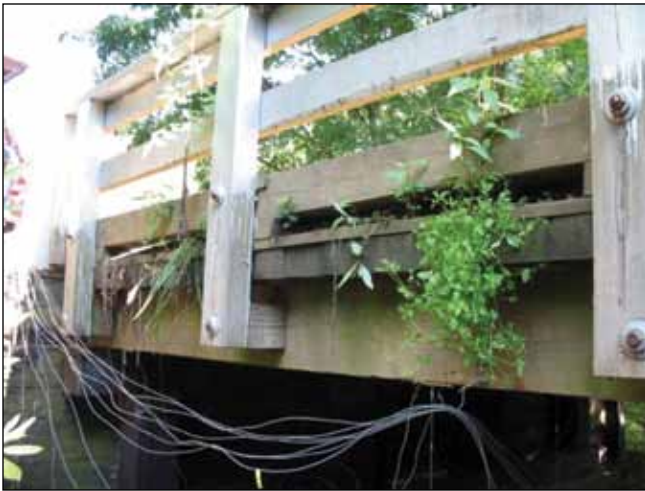
The parapet consists of solid timber posts and timber rails with a timber curb. Support for the parapet is provided by timber blocks and bolts into the exterior girders along with bolts into the curb, which is seated and bolted to the top of the deck, as shown in Figure G3.

**Figure G3. Dix Creek parapet.**

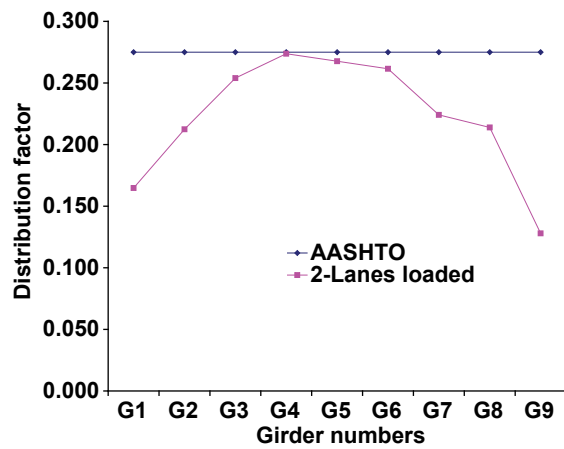
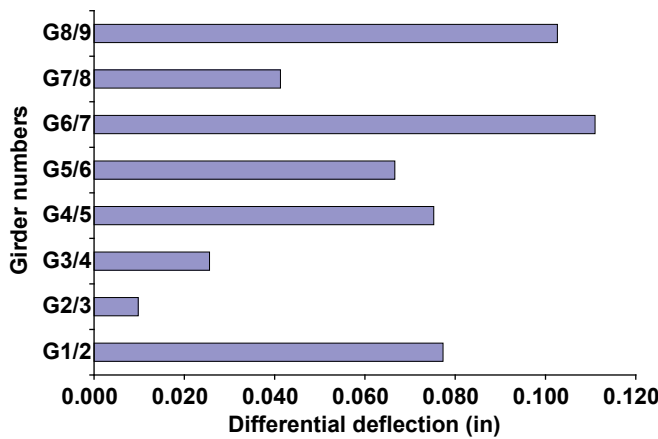
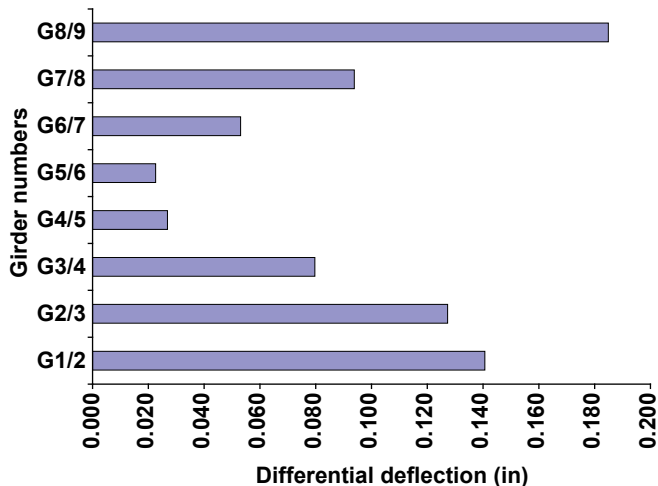
Appendix B discusses maximum recommended differential deflection between adjacent girders. Figures G25 to G27 show the differential deflections between adjacent girders for load paths 1, 2, and 3, respectively. The maximum differential deflections between adjacent girders are presented in Table G3.

The maximum differential deflection of 0.185 in. occurs in load path 2. This is nearly 46% of the maximum deflection resulting from that load path and 0.090 in. per ft of girder spacing. Among other potential reasons for large differential deflections, the possibility exists that the load is not well

distributed transversely between these two girders or the assumption that both girders are of equal stiffness is false. The same is true for load paths 1 and 3 as the maximum differential deflections are both greater than 0.1 in.

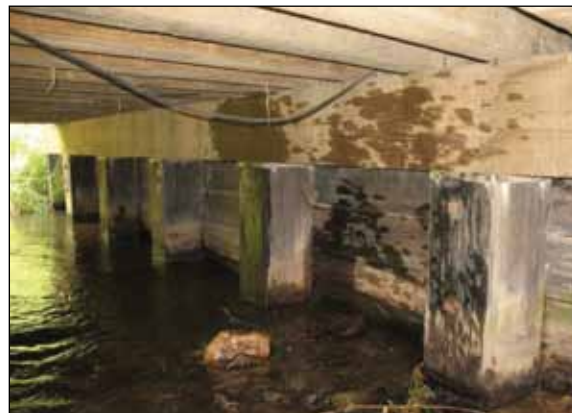
Figure H2. Bald Creek Bridge substructure.

The Bald Creek Bridge is a single-span, two-lane, timber girder bridge with a bituminous wearing surface set on a 20° skew. The bridge length measures 17 ft–9 in. from the west backwall to the east backwall. The bridge width measures 19 ft–2 in. from inside of curb to inside of curb and 20 ft–11 in. from outside of rail to outside of rail. The substructure consists of solid timber posts and sills (see Fig. H2).

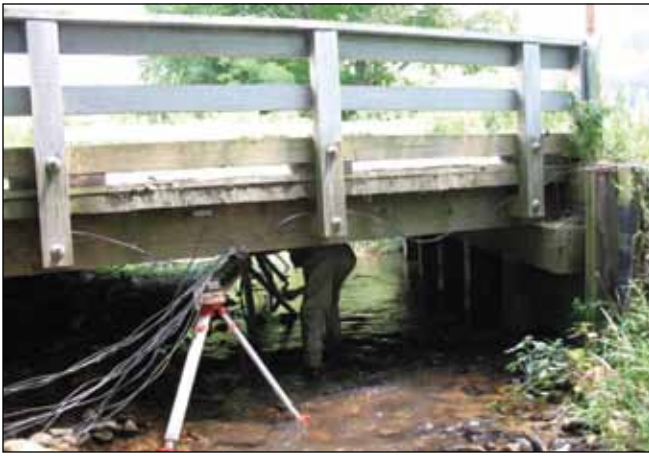
**Figure H3. Bald Creek Bridge parapet.**

The parapet consists of solid timber posts and timber rails with a timber curb. Support for the parapet is provided by timber blocks and bolts into the exterior girders along with bolts into the curb, which is seated and bolted to the top of the deck. The bridge parapet is shown in Figure H3.

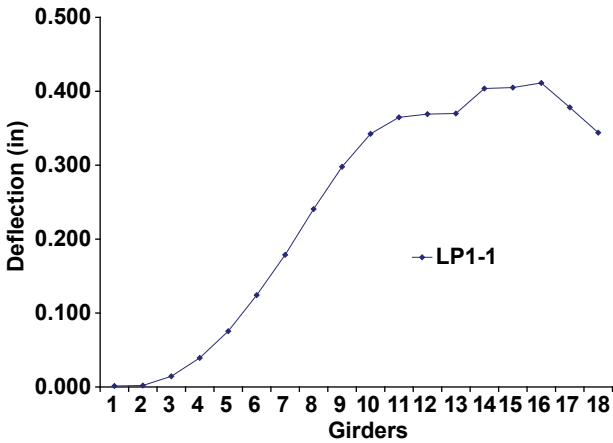
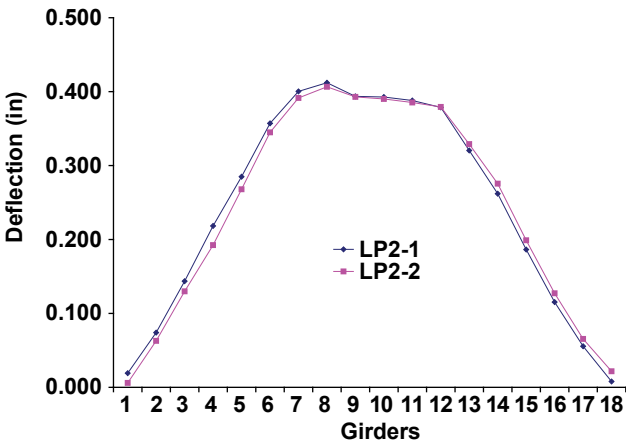
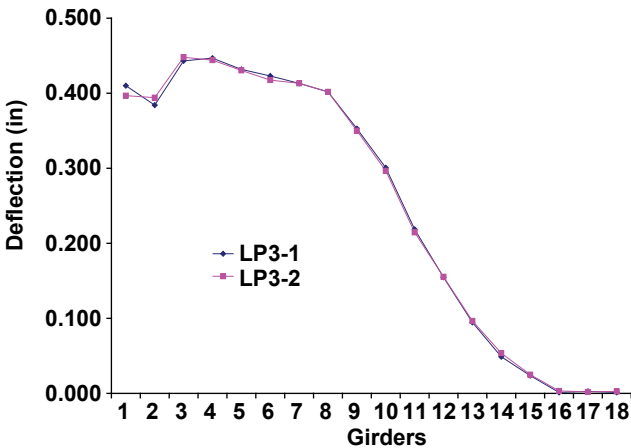
The minimum  $n$  value of the three load paths is 321. This value is less than the minimum recommended value for timber girders. In fact, all the  $n$  values are below the recommended  $n$  values stated in Table H2. The possible reasons for deflections greater than those recommended will be discussed later.

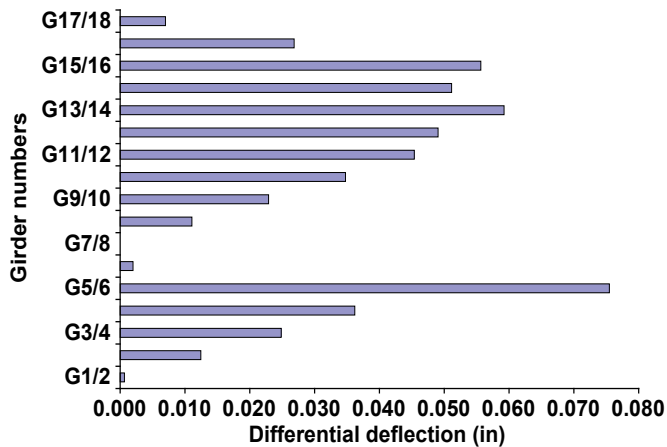
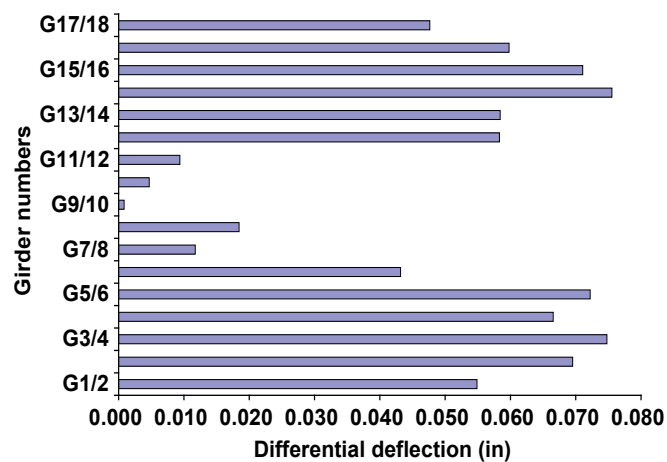
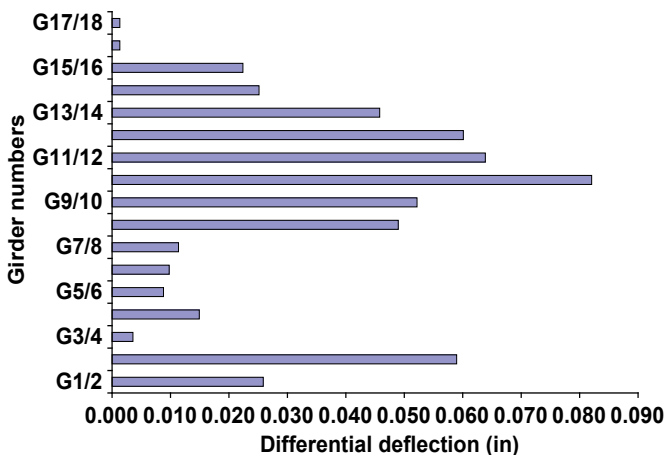
Appendix B discusses maximum recommended differential deflection between adjacent girders. Figures H24 to H26 show the differential deflections between adjacent girders for load paths 1, 2, and 3, respectively. The maximum

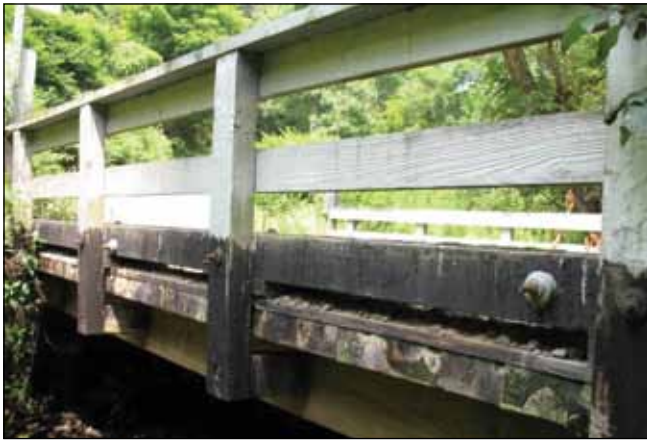
**Figure I3. Doebag Creek Bridge parapet.**

The parapet consists of solid timber posts and timber rails with a timber curb. Support for the parapet is provided by timber blocks and bolts into the exterior girders along with bolts into the curb, which is seated and bolted to the top of the deck, as shown in Figure I3.

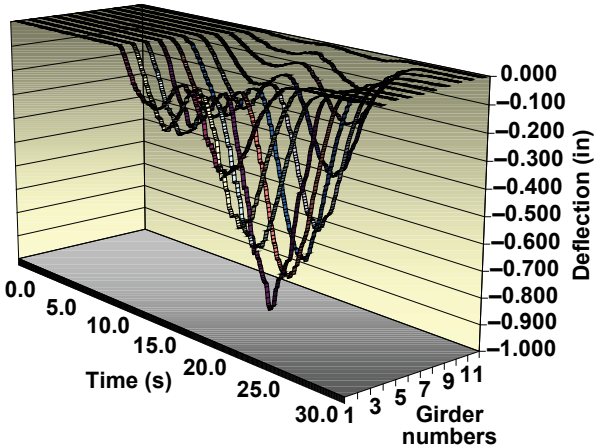
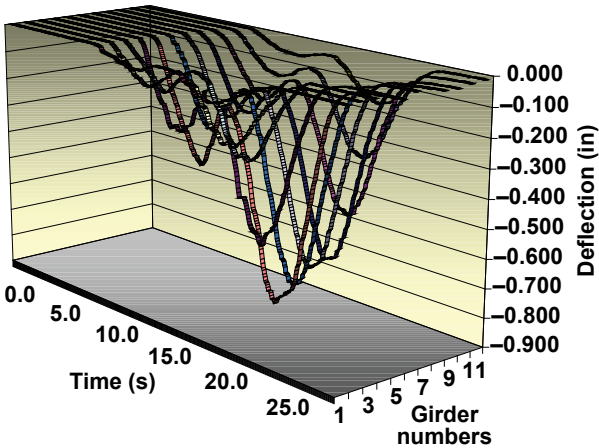
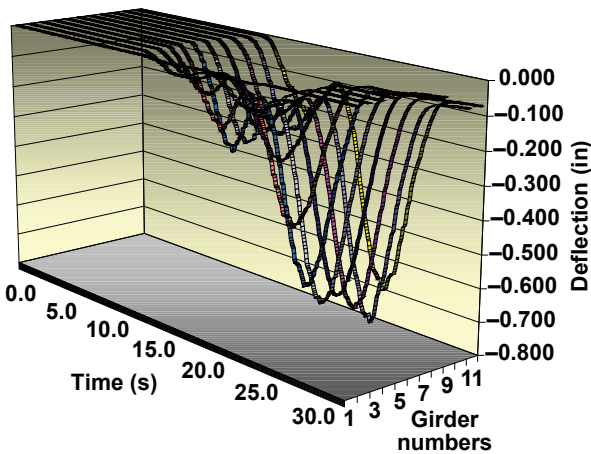
The minimum  $n$  value of the three load paths is 163. This value is less than the minimum recommended value for timber girders. In fact, all the  $n$  values are below the recommended  $n$  values stated in Table I2. The possible reasons for deflections greater than those recommended will be discussed later.

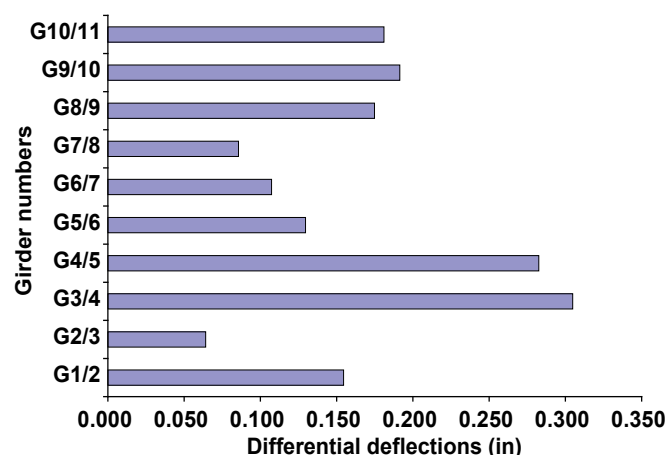
Figure I28. Differential deflections for load path 2.

The maximum differential deflection of 0.305 in. occurs in load path 2. This is nearly 38% of the maximum deflection resulting from that load path and 0.174 in. per ft of girders spacing. Among other potential reasons for large differential

deflections, the possibility exists that the load is not well distributed transversely between these two girders or the assumption that both girders are of equal stiffness is false. The same is true for load paths 1 and 3 as the maximum differential deflections are both around 0.2 in.

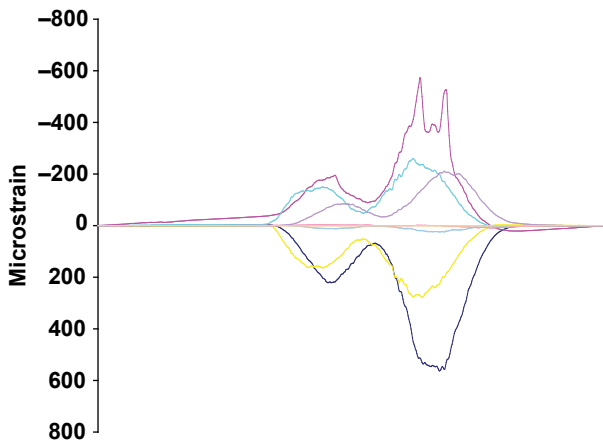
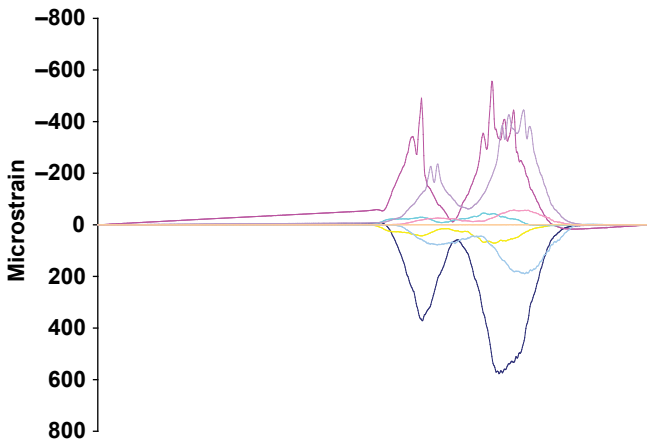
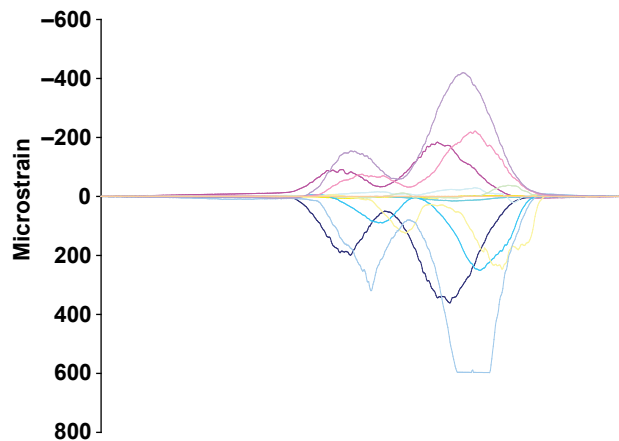
Strain data for timber bridges should be considered supplementary as the intrinsic properties of wood limit their use for primary analysis. Nevertheless, Figures I30 to I32 do show a reasonable relationship between the truck position and strain pattern. Assuming that the maximum values of compressive and tensile strain are in fact correct, the maximum compressive and tensile stresses can be obtained. The maximum overall compressive and tensile strains obtained from the three load paths are 572 and 597 microstrain, respectively. These strains equate to maximum stresses of 658 and 687 lb/in<sup>2</sup>, respectively. If the strains are

normalized to the AASHTO tandem load design, stresses of 851 and 888 lb/in<sup>2</sup> are obtained. Allowable stress design limits the total compressive and tensile stresses anywhere from 1,150 to 1,750 lb/in<sup>2</sup>, depending on the wood grade and moisture content. Therefore allowable stresses are not exceeded by standard trucks.

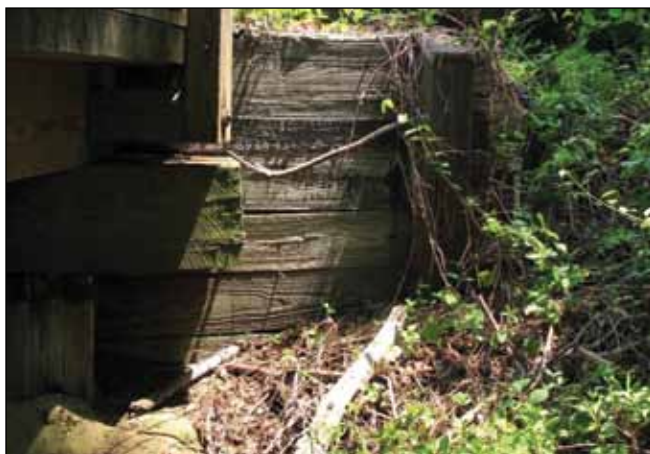
Figure J15. Wingwall weathering and decay.

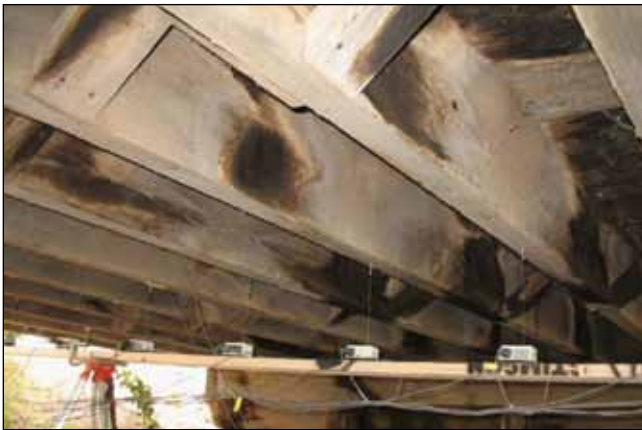
Figure K14. General superstructure condition.

The girders appear in good condition, yet some minor degradation was present throughout. The exterior girders were in poorer condition than the rest, presumably a result of more exposure to weathering conditions. Even so, the condition

is not cause for concern. These girders should be monitored closely with future inspections because if checking becomes severe, degradation effects can be accelerated further and the structural integrity of the girder could be compromised. Figure K14 shows the general superstructure condition, and Figure K15 shows the exterior girder condition.

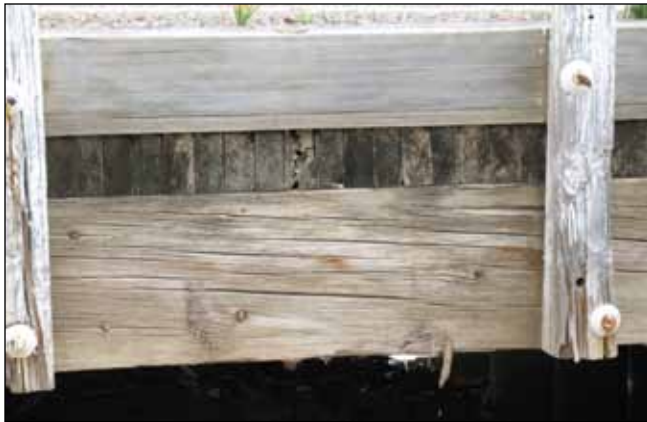
**Figure L14. Checking in exterior girders.**

Moderate checking was present in most girders, and the exterior girders were in worse condition than the rest, presumably a result of more exposure to weathering conditions. The checks in the exterior girders were deep in some locations and should be closely monitored with future inspections. If

checking becomes severe, degradation effects can be accelerated further and the structural integrity of the girder could be compromised. Figure L14 shows the typical checking in the exterior girders. The girder bearing on the sill was sufficient, and no misalignment was observed.

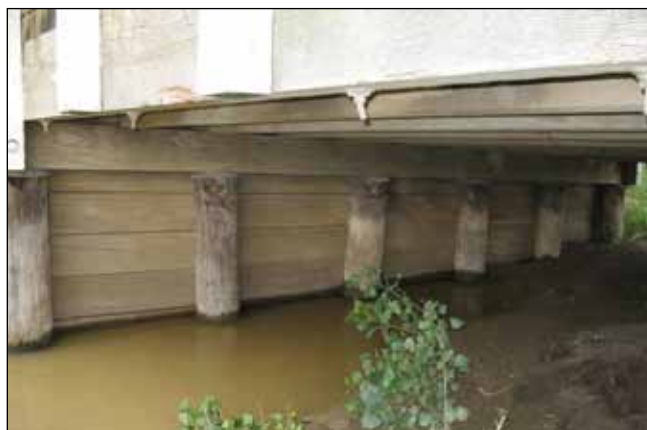
Figure M2. Bridge substructure.

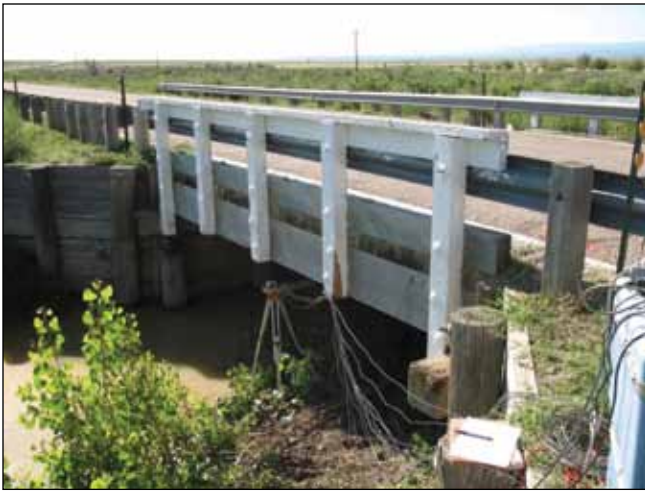
The parapet consists of solid timber posts and timber rails with a timber curb. Support for the parapet is provided by bolts into the exterior girders along with bolts into the curb, which is seated and bolted to the top of the deck, as shown in Figure M3.

**Figure M3. Colorado Bridge parapet support.**

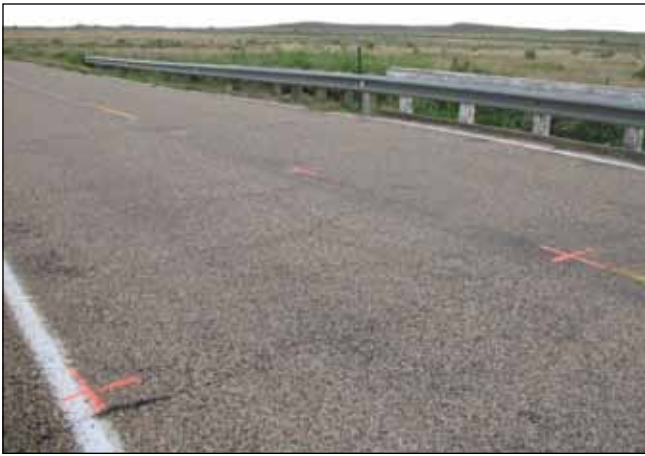
Some transverse cracking in the wearing surface reflecting the transverse deck boards beneath was observed by the ISU research team. Cracks have also formed at the transition between the roadway and the bridge, and these cracks could pose future problems if not monitored and repaired. Moisture could seep through these cracks and advance degradation in the backwalls, girder ends, and substructure. Also, if the wearing surface becomes uneven at the transition, the bridge could be subjected to unnecessary effects from dynamic loads which can be magnified by higher vehicle speeds on this roadway. Figure M13 shows some of the cracking observed. Aside from the transverse cracking, the wearing surface looked to be in good condition.

**Figure M13. Transverse wearing surface cracking.**

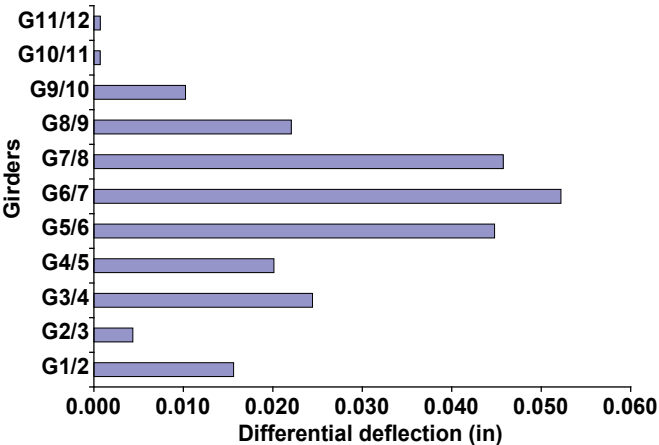
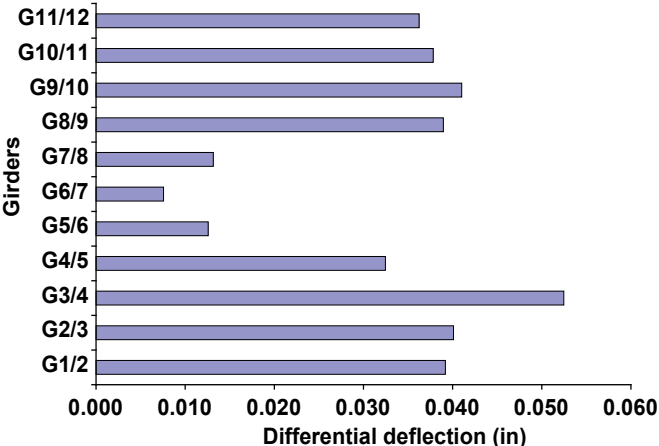
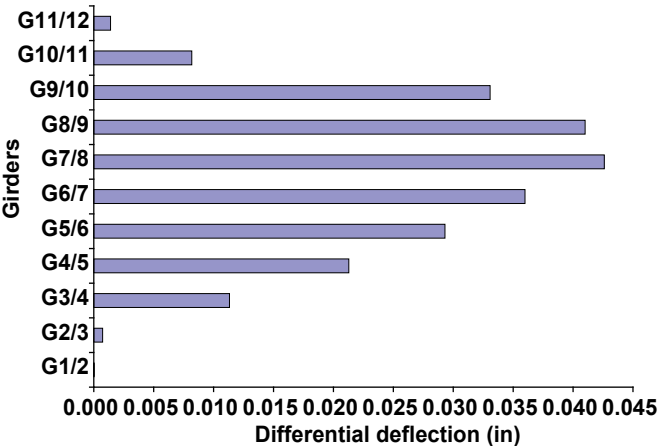
The maximum differential deflection of 0.052 in. occurs in load paths 1 and 2, equaling 0.023 in. per ft of girder spacing. It does not appear to be an issue as it is a relatively

small amount. The same is true for load paths 2 and 3 as the maximum differential deflections are both around 0.05 in. If the differential deflections were large, the possibility exists that the load was not well distributed transversely between these two girders or the assumption that both girders are of equal stiffness was false.

Figure M23. Differential deflections for load path 1.

Figure M24. Differential deflections for load path 2.

Figure M25. Differential deflections for load path 3.

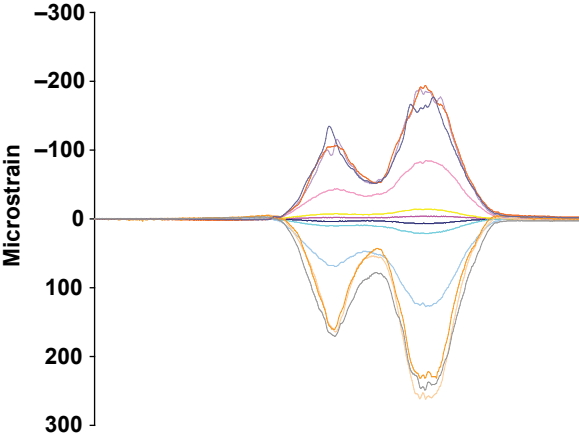
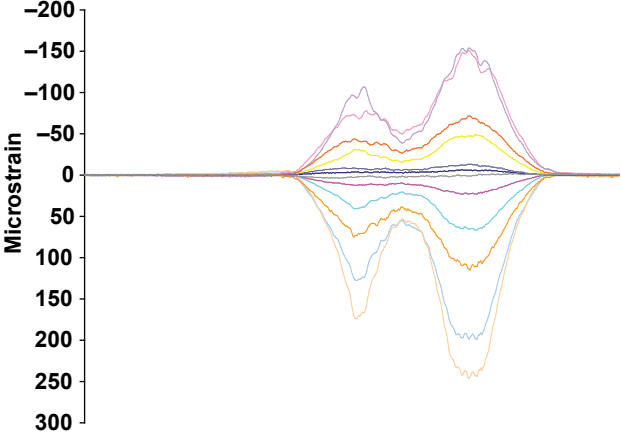
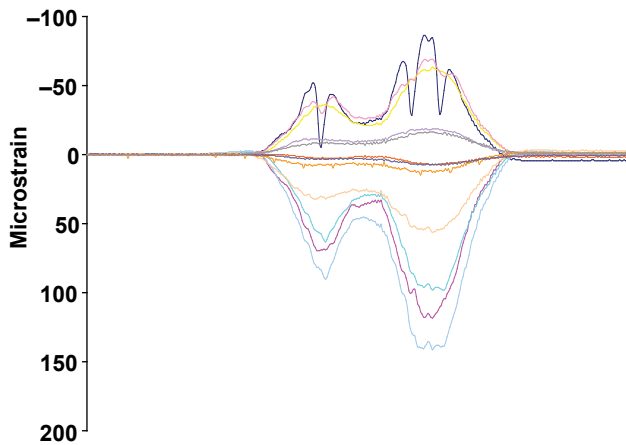
Figure M26. Strain at midspan for load path 1.

Figure M27. Strain at midspan for load path 2.

Figures M26 to M28 also illustrate the proportion about the neutral axis at midspan. The proportional pattern of the data signifies that there is very little if any composite action with the deck (that is, the girders act independently of the deck when subjected to bending).

Figure M28. Strain at midspan for load path 3.

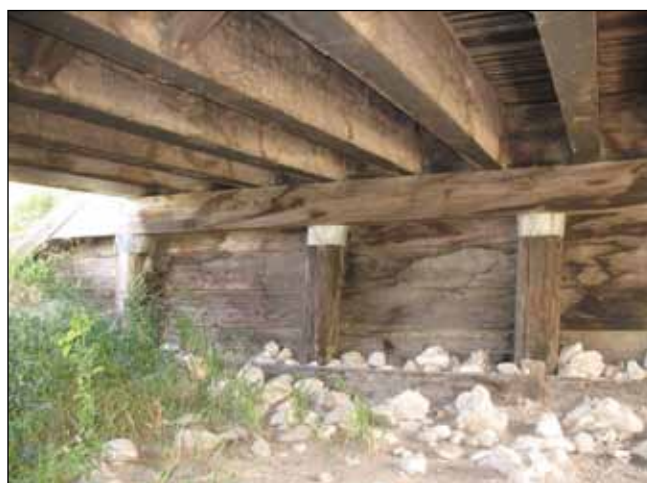
Figure N2. Bridge substructure.

The Montana Bridge is a single-span, two-lane, timber girder bridge with a bituminous wearing surface. The bridge length measures 20 ft–0 in. from the south backwall to the north backwall. The bridge width measures 21 ft–1 in. from inside of curb to inside of curb and 22 ft–0 in. from inside of rail to inside of rail. The substructure consists of solid timber posts and sills (see Fig. N2).

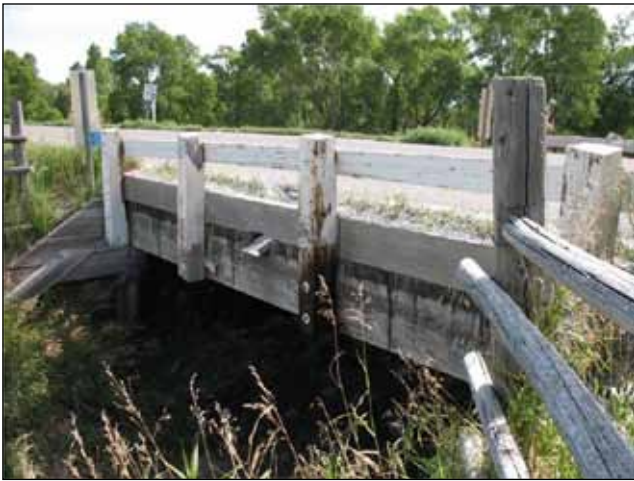
The parapet consists of solid timber posts and timber rails with a timber curb. Support for the parapet is provided by bolts into the exterior girders along with bolts into the curb, which is seated on top of the deck, as shown in Figure N3.

**Figure N3. Montana Bridge parapet support.**

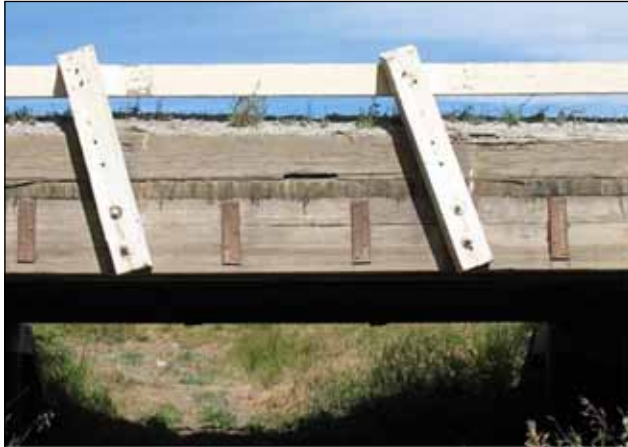
Overall, the wearing surface looked to be in good condition. No cracking was observed in the wearing surface as a new chip seal had just been laid upon the time of the ISU team visual inspection. The wearing surface did have a significant thickness of 15 in., which effectively reduced the parapet height and added a large amount of dead weight to the bridge structure. This is evident in Figure N13 as the wearing surface is shown above the curb.

Figure N13. Wearing surface thickness.

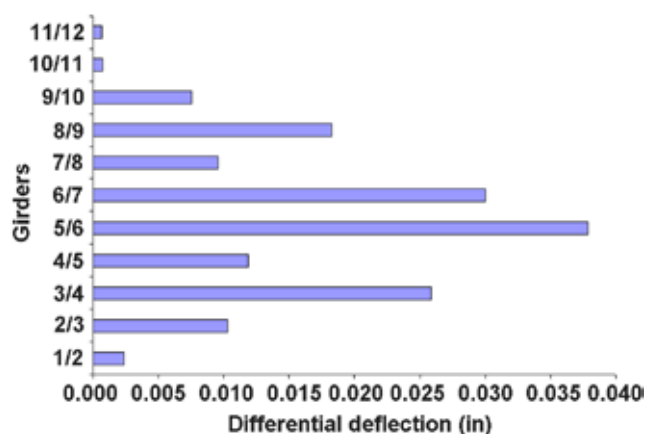
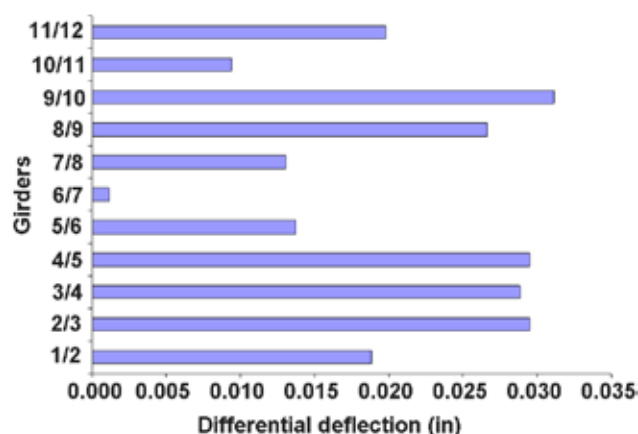
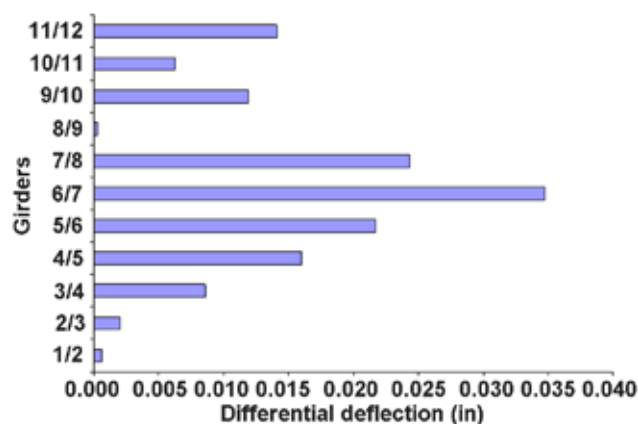
Figure N24. Differential deflections for load path 1.

Figure N25. Differential deflections for load path 2.

Figure N26. Differential deflections for load path 3.

The maximum differential deflection of 0.038 in. occurs in load path 1 and this equals 0.019 in. per ft of girder spacing. This does not appear to be an issue as it is a relatively small value. The same is true for load paths 1 and 3, as the maximum differential deflections are both around 0.03 in. If the differential deflections were large, the possibility exists that

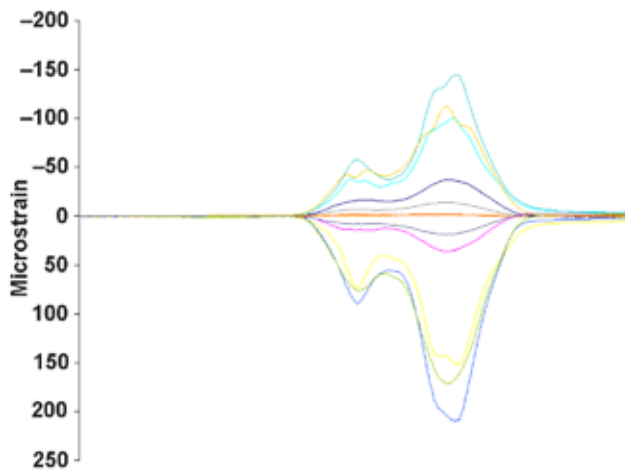
Figure N27. Strain at midspan for load path 1.

Strain data for timber bridges should be considered supplementary as the intrinsic properties of wood limits their use for primary analysis. Nevertheless, Figures N27 to N29 do show a reasonable relationship between the truck position and strain pattern. Assuming that the maximum values of compressive and tensile strain are in fact correct, the maximum compressive and tensile stresses can be obtained. The maximum overall compressive and tensile strains obtained from the three load paths are 145 and 211 microstrain, respectively. These strains equate to maximum stresses of 167 and 243 lb/in<sup>2</sup>, respectively. If the strains are normalized to the AASHTO tandem load design, stresses of 297 and 433 lb/in<sup>2</sup> are obtained. Allowable stress design limits the total compressive and tensile stresses anywhere from 1,150 to 1,750 lb/in<sup>2</sup>, depending on the wood grade and moisture content. Therefore it appears that allowable stresses are not exceeded by standard load trucks.

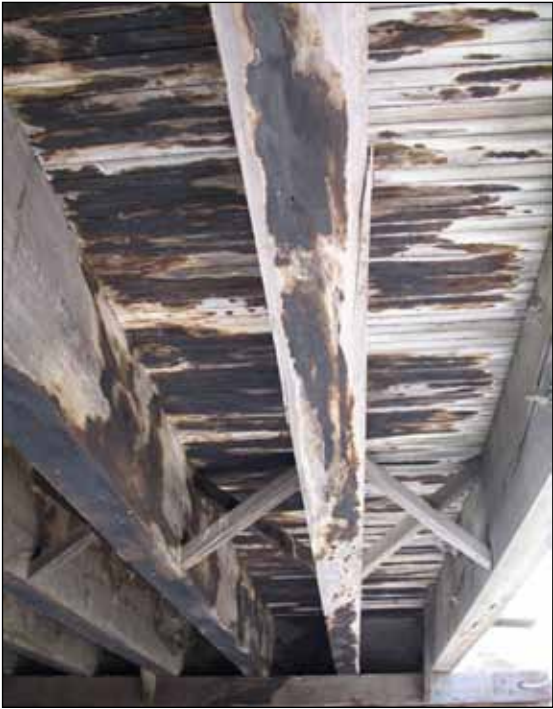
Figure O13. White residue formation on deck.

According to the MDT 2004 report, minor water staining was present on the underside of the decking. This water staining was verified by the ISU research team during the visual inspection of summer 2006. Some white residue was also forming on the underside of the decking, and this may be a condition of continued seepage (see Fig. O13). The

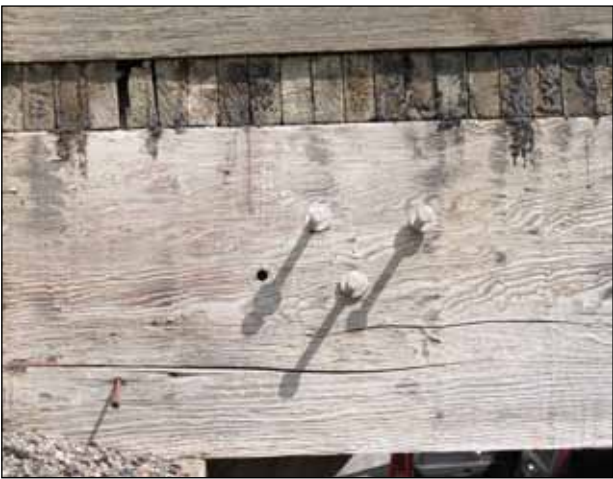
Figure O14. Checking in exterior girders.

the superstructure, presumably from water seepage. Exterior girders were in worse condition than interior girders, presumably a result of more exposure to weathering conditions (see Fig. O14). The checks in the exterior girders were deep in some locations. The girder bearing on the sill was sufficient, and no misalignment was observed except for girder number 2, where some twisting has taken place.

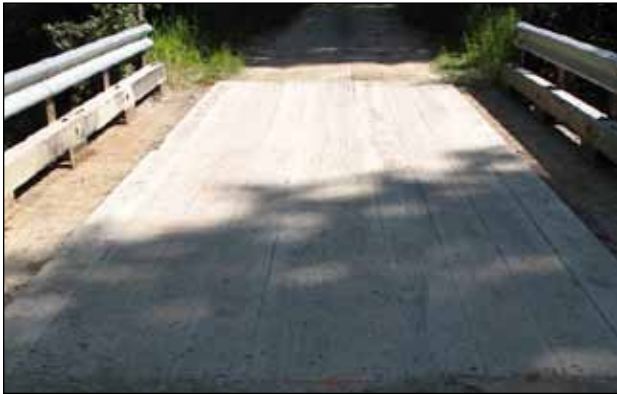
Figure P13. Wearing surface.

Overall, the wearing surface appeared in good condition. No checking or cracking was observed in the timber running planks. The wearing surface is shown in Figure P13.

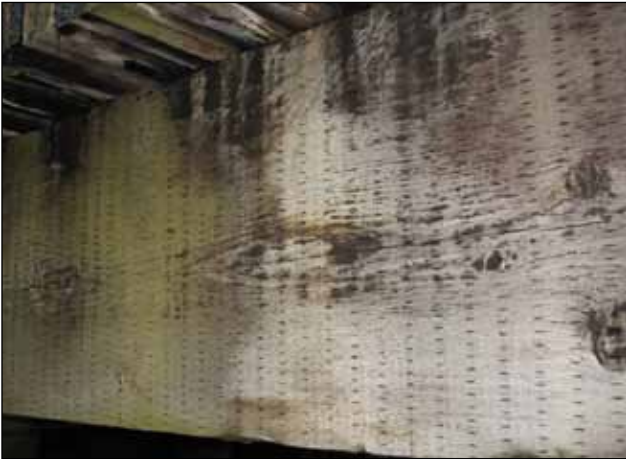
Water staining was also present on the girders in various locations throughout the superstructure and was presumably a result of seepage through the deck boards. The interior girders looked in good condition as no visual degradation such as checking was observed. Conversely, checking was observed on the two exterior girders at the girder midline (see Fig. P15). The checks in the exterior girders were deep in some locations and should be closely monitored with future inspections. If checking becomes severe, degradation effects can be accelerated and the structural integrity of the girder could be compromised. The girder bearing on the sill was sufficient and no misalignment was observed.

Figure P15. Checking in exterior girders.

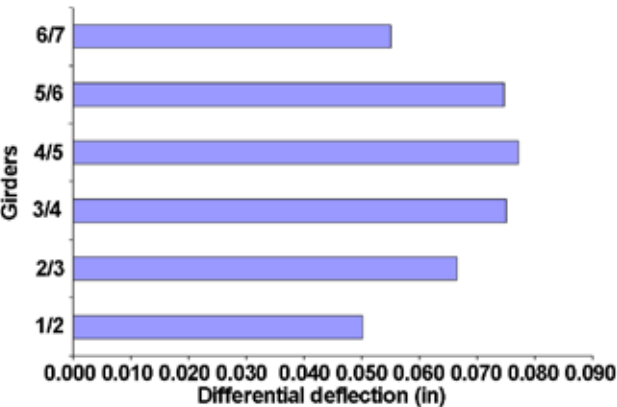
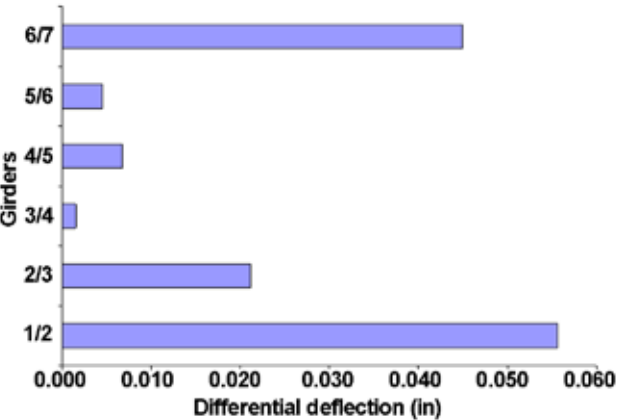
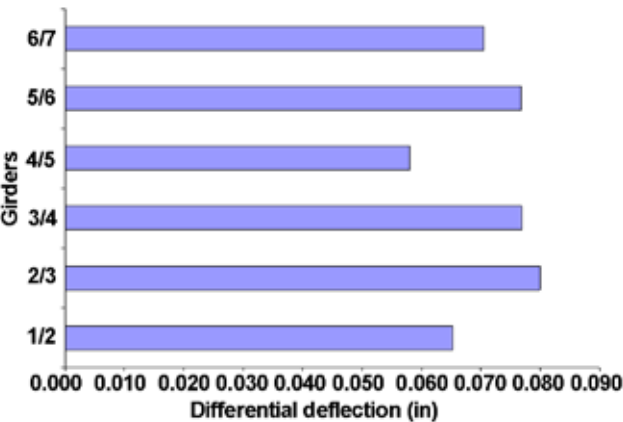
Appendix B discusses maximum recommended differential deflection between adjacent girders. Figures P24 to P26 show the differential deflections between adjacent girders for load paths 1, 2, and 3, respectively. The maximum differential deflections between adjacent girders are presented in Table P3.

The maximum differential deflection of 0.080 in. occurs in load path 3 and does not appear to be an issue as it is a relatively small amount. The same is true for load paths 1 and 2 as the maximum differential deflections are both below 0.08 in. If the differential deflections were large, the possibility exists that the load was not well distributed transversely between these two girders or the assumption that both girders are of equal stiffness was false.

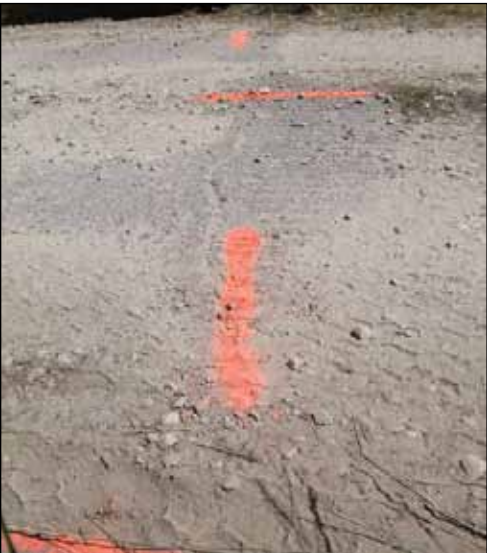
Overall, the wearing surface looked to be in good condition. Only single cracks were observed in the wearing surface at midspan and at the transitions between the roadway and ends of the bridge. In addition to the cracking, a large amount of gravel debris was observed on the wearing surface, which was noted in the 2005 Forest Service report. The cracking and accumulation of debris is shown in Figure Q13.

Figure Q13. Wearing surface cracking and debris.

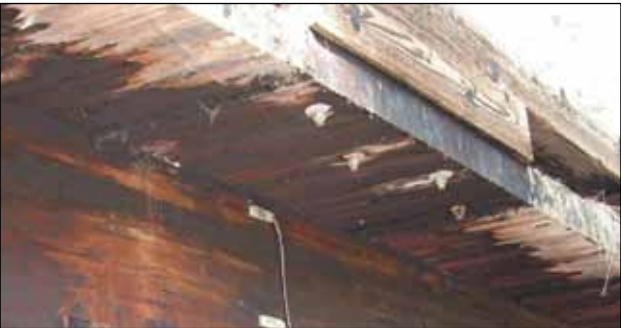
Figure Q14. Washing of creosote at panels ends.

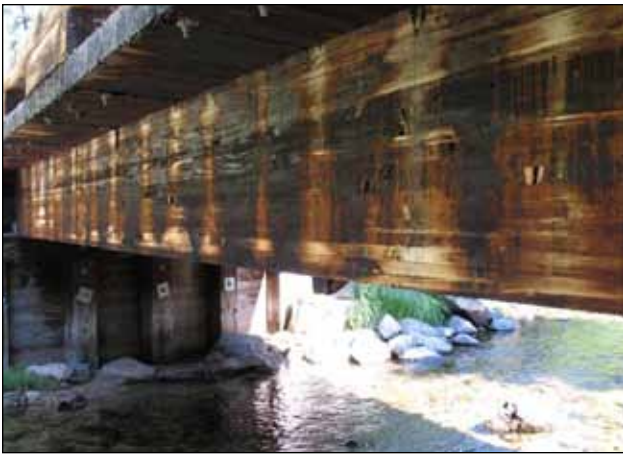
Figure Q15. Girder streaking and holes.

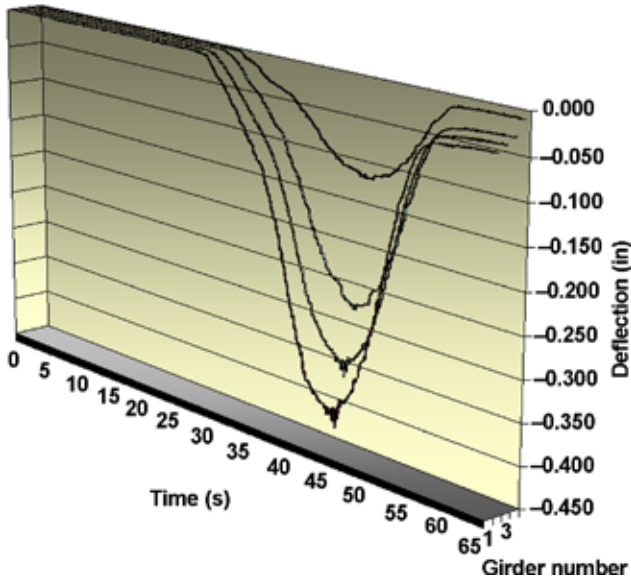
Figure Q16. Deflections for load path 1.

The deflection of the girders in and of itself does not exceed the deflection that would critically affect strength because timber strength is not critically affected until deflections become excessive. Also, each of the maximum girder deflections for each load path meets all recommended limit states

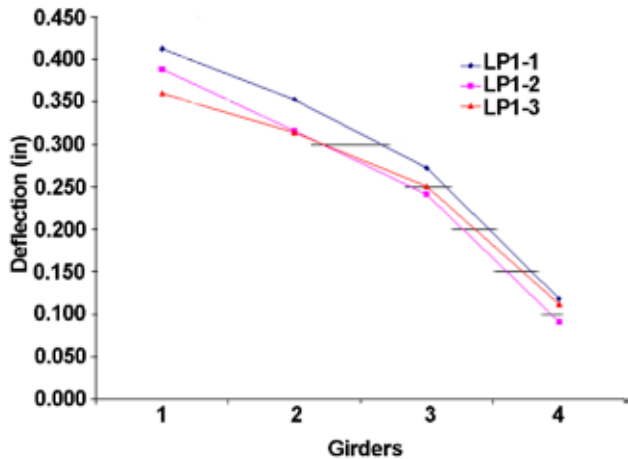
Figure Q19. Maximum deflections for load path 1.

The minimum  $n$  value of the three load paths was 760. This value is greater than all the minimum recommended values for timber girders stated in Table Q2.
