General  
Technical  
Report  
FPL-GTR-198

# Evaluation of Fleet Management Techniques for Timber Highway Bridges

Brent M. Phares  
Travis K. Hosteng  
Justin Dahlberg  
Michael A. Ritter

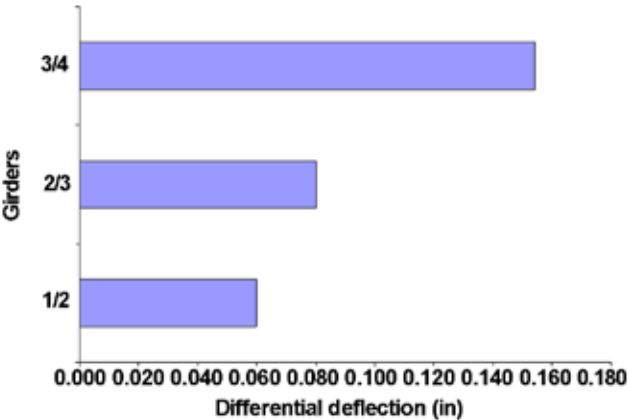
Figure Q24. Differential deflections for load path 1.

The maximum differential deflection of 0.154 in. occurs in load path 1 and equals 0.040 in. per ft of girders spacing.

This does not appear to be an issue as the amount is relatively small. The same is true for load paths 1 and 3 as the maximum differential deflections are also both small. If the differential deflections were large, the possibility exists that the load was not well distributed transversely between these two girders or the assumption that both girders are of equal stiffness was false.

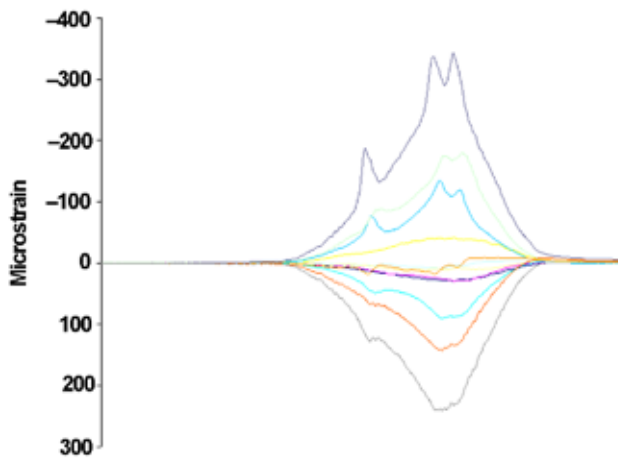
Figure Q27. Strain at midspan for load path 1.

Strain data for timber bridges should be considered supplementary as the intrinsic properties of wood limits their use for primary analysis. Nevertheless, Figures Q27 to Q29 do show a reasonable relationship between the truck position and strain pattern. Assuming that the maximum values of compressive and tensile strain are in fact correct, the maximum compressive and tensile stresses can be obtained. The maximum overall compressive and tensile strains obtained from the three load paths are 342 and 241 microstrain, respectively. These strains equate to maximum stresses of 393 and 277 lb/in<sup>2</sup>, respectively. If the strains are normalized to the AASHTO tandem load design, stresses of 509 and 359 b/in<sup>2</sup> are obtained. Allowable stress design limits the total compressive and tensile stresses anywhere from 1,150 to 1,750 b/in<sup>2</sup>, depending on the wood grade and moisture content. Therefore it appears that allowable stresses are not exceeded by standard load trucks.
