## Condition Assessment of the Timber Structures of a Century-Old Industrial Building Using a Nondestructive Inspection Procedure

**Abstract.** This paper reports an in situ inspection project conducted on heavy timber structures of a century-old industrial building at a paper manufacturing facility. A nondestructive inspection procedure was employed to evaluate the true condition of the heavy timbers that serve as the main framing structure of the building. The on-site investigation involved monitoring of the microclimate environment resulting from the paper machine operations, wood species identification, wood moisture content measurements, and internal decay detection using sounding, stress wave timing, and resistance micro-drilling methods. The testing results revealed that numerous locations were in poor condition indicated by widespread internal and external deterioration, reduced cross-sections from fire damages, and multiple failed members. Many timber members in the first floor exhibited a very high level of moisture condition (23 to 55%) as a result of high humidity air created by the paper making operations. This paper also showcases a new way of interpreting the evalua

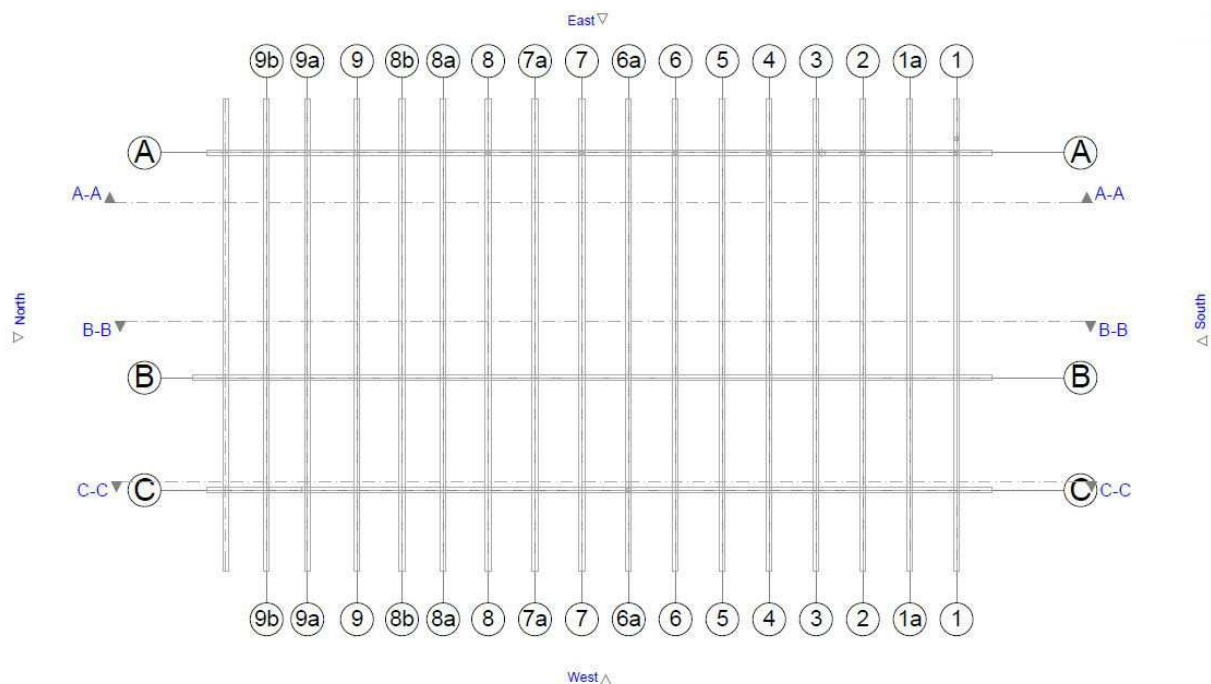
Figure 2. Plan view of the paper mill building (Level 1)

The scope of the in situ physical inspection was limited to the areas that were under concern and specified by the facility engineers. The key structural members that were inspected included: 1) First floor (Fig. 1a): the timber columns at row A, B, and C, the longitudinal beams of row A, B, and C (see Fig. 2), and the transverse beams at cross sections 1 – 9 (see Fig. 2); and 2) Second floor (Fig. 1b): the timber columns at row B, the bottom chords of the roof trusses (Truss No. 1 – No.5), and the connections of the roof trusses (bottom chord level).

**Stress Wave Timing.** Stress wave timing (SWT) measurement for decay detection is based on the concept that stress wave propagation is sensitive to the presence of deterioration of wood members [3]. Stress waves travel faster through sound wood than they travel through decayed wood. Conducting stress wave timing measurement on a wood member requires access to two opposite sides of the member for attaching sensor probes. The timber members tested with stress wave timing method included the columns and beams in sections No. 1 to No. 9 in the first floor (see Fig. 2) and the columns and truss members in the second floor.
