# Exterior Decay of Wood–Plastic Composite Boards: Characterization and Magnetic Resonance Imaging

Forest Prod. J. 66(1/2):4–17.

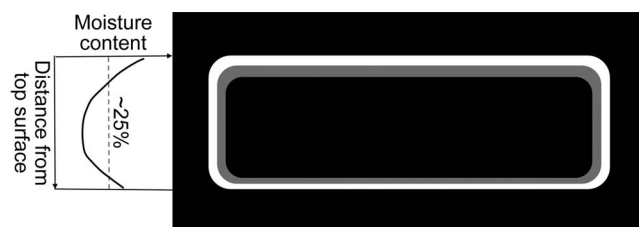
exterior portion of the extrudates and particularly in board support areas, along the “drip edge” on the back side of the board, and in the vicinity of the exposed board surface and its edges. Figure 1 shows a cross-sectional schematic of the typical moisture distribution in a WPC board exposed to exterior conditions, as seen in MRI images.

Figure 1.—Cross-sectional schematic of the typical moisture distribution in a wood-plastic composite board exposed to exterior conditions as seen in magnetic resonance images, with the light area indicating presence of free water.
