# Residential Tornado Safe Room from Commodity Wood Products

## Impact and Wind Pressure Testing

General Technical Report  
FPL–GTR–254

February  
2018

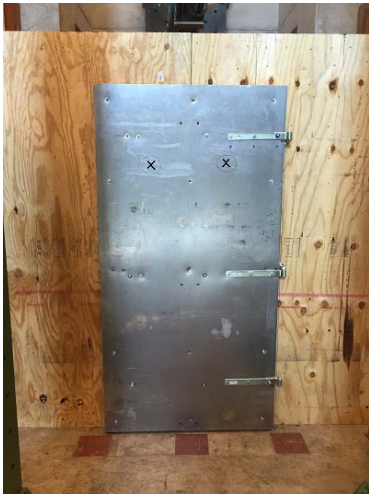
**Figure 9. Impact locations (marked by X).**

requirements of ICC/NSSA-500, impact testing is required at several locations. The standard calls for one impact test within 6 in. of the main latch as well as the top hinge and center primary latches or operators. Because there was no center primary latch nor operator, two impact tests were performed to evaluate the hinge and latch impact resistance. As indicated in Figure 9, the first impact was directed at a spot within 6 in. of the upper hinge of the door. The second shot was directed at a spot within 6 in. of the cane bolt latch of the door.

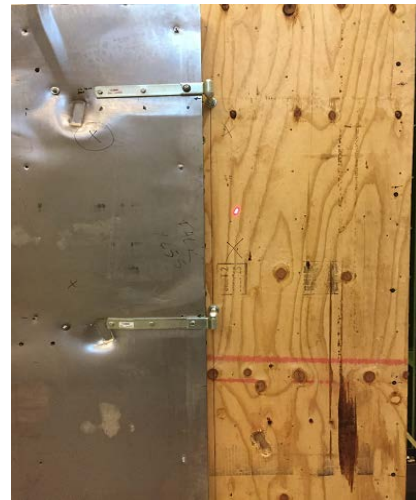
**Figure 11. Impact location adjacent to door opening (target is red laser dot midway between the two hinges and slightly to the right).**

Impact tests were also performed to evaluate impact resistance of the area around the door perimeter. This is a potential weak area because the 2 by 8 wall beams butt into the door jamb. Also, the door opening itself affects panel strength and stiffness. As shown in Figure 11, a missile was directed at the panel adjacent to the door. Figure 12 and Appendix C indicate the result of this impact. It is clear that the 2 by 8 wall beam to door jamb connection itself is not strong enough to resist the impact of the 2 by 4 missile.

To rectify this problem, three 14-gauge (0.07-in.-thick) sheet steel angles (4 by 4 in.) were fabricated to reinforce the door jamb (Figs. 13 and 14). Initially, these angles were

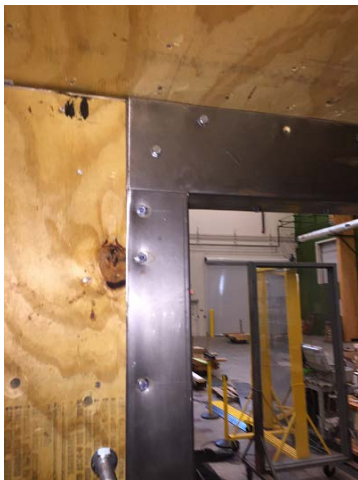
**Figure 13.** 14-gauge steel angles used to reinforce door frame.

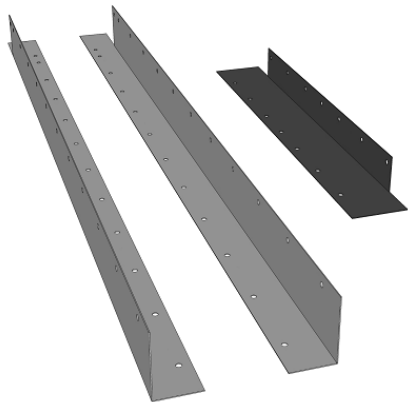
**Figure 14.** Schematic of door reinforcement angles.

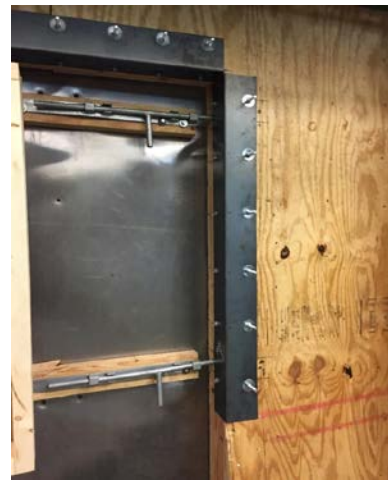
**Figure 15.** 14-gauge jamb reinforcement. Note use of both lag and through bolts to secure angle.

secured to the door jamb using a combination of both lag bolts (3/8 by 3 in.) and through bolts (3/8 in.) spaced at 8 in. (Fig. 15).

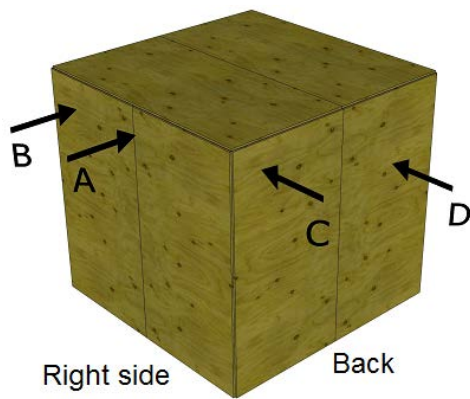
Figures 21 and 22 indicate the locations of impact on the full-sized room, and Appendix D provides the results for each test. In all cases, the room adequately resisted the missile impact with no debris created, with no piercing of the missile into the room, and with permanent deflection less than 3 in. Impact tests A through F were performed in sequence on the same safe room.

**Figure 21. Location of impact tests on safe room (right side and back) (Letters correspond to Column 1 in Appendix D).**

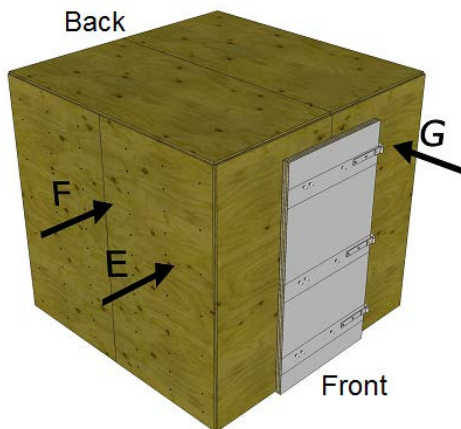
**Figure 22. Location of impact tests on safe room (left side and front) (Letters correspond to Column 1 in Appendix D).**

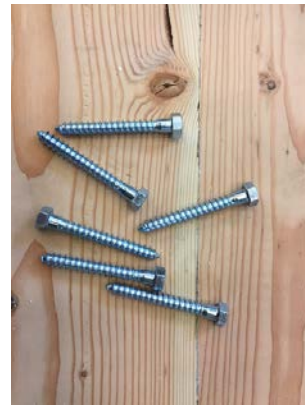
Although the door and door frame had been previously tested (see Door and Door Jamb section) and this testing indicated the need for sheet metal reinforcement around the door jamb, a final impact test (G) was performed to evaluate the use of lag bolts instead of through bolts for the door reinforcement. As indicated in Appendix D, 3/8- by 3-in. lag bolts at a spacing of 8 in. were adequate to secure the door reinforcement to the door jamb (Fig. 23).

**Figure 23. 3/8- by 3-in. lag bolts to secure door jamb reinforcement to safe room.**

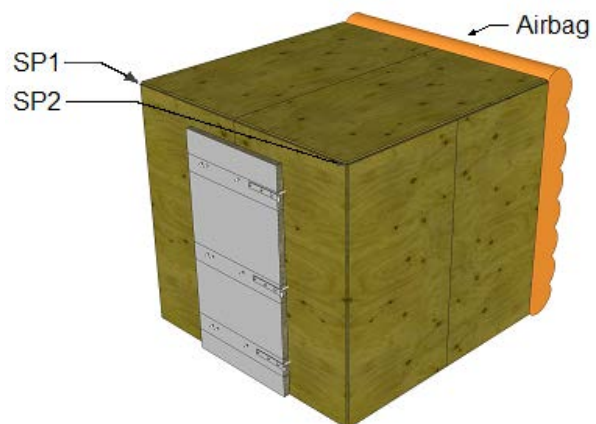
When the room was oriented as shown in Figure 30, deflection measurements indicated that the room deflected symmetrically (for example, SP1 = SP2) (SP denotes string pot) up to maximum load (2 times design) (Fig. 32). The maximum deflection recorded was about 1.1 in.

Figure 30. String pot (SP) measuring locations for lateral wind pressure test. Door located opposite air bag.

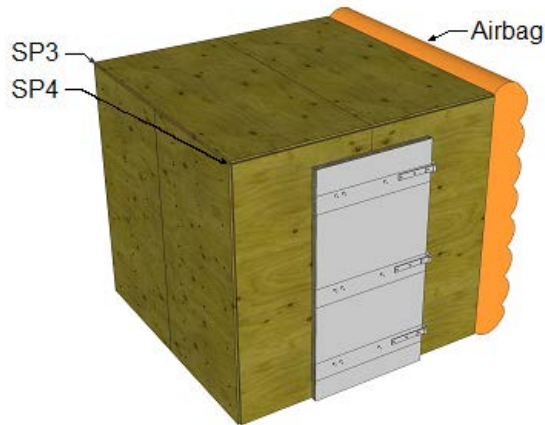
**Figure 31. String pot (SP) measuring locations for lateral wind pressure test. Door located 90 degrees to air bag.**

The room was reoriented as shown in Figure 31 and the test repeated. Because the door opening decreased the stiffness of one side of the room, the room did not deflect symmetrically. As shown in Figure 33, at 2 times design load, the room deflected about 1.8 in. (SP4) and 1.3 in. (SP3).

For both tests at 1.5 times design, the room and its components showed no major damage or distress. Increasing the load to 2 times design resulted in some bending of the tie-downs and some slight nail pullout from the tie-downs (Figs. 34 and 35). This pullout was more pronounced in the test when the room was oriented as in Figure 31.

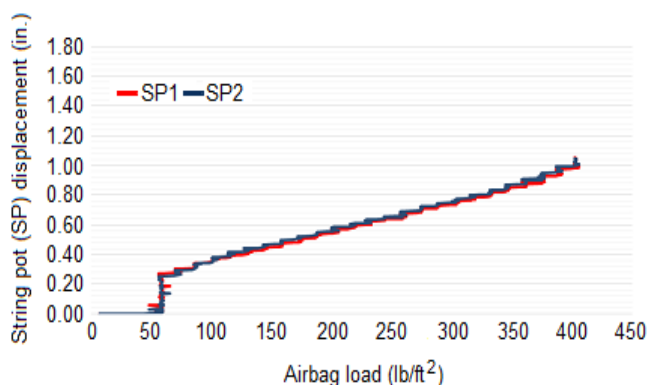
**Figure 32. String pot displacement vs. airbag load pressure test with door opposite to air bag. Deflection of safe room when room oriented as in Figure 30.**

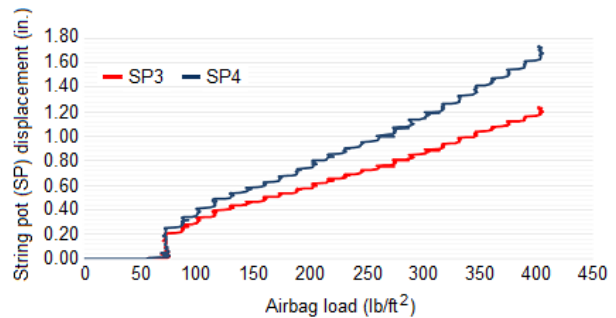
**Figure 33. String pot displacement vs. airbag load pressure test with door 90 degrees to air bag. Deflection of safe room when room oriented as in Figure 31.**
