# Assessment of Fastener Corrosion and Salt Damage in the Bilge of the *Eureka*

Research Note  
FPL–RN–0356

March  
2018

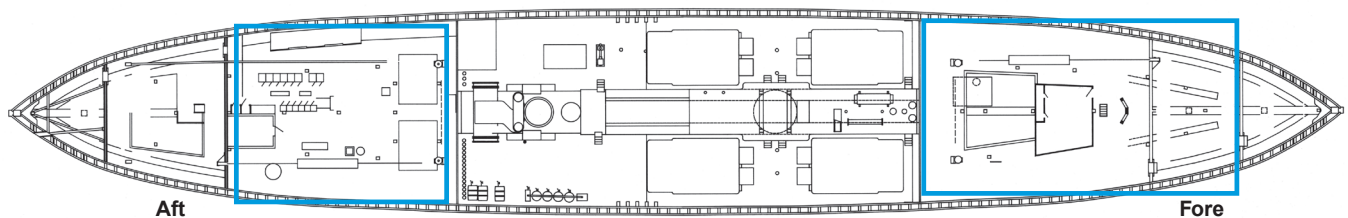
**Figure 2. Rendering of the *Eureka*. The blue boxes indicate the areas of the bilge that were analyzed.**

Observations were taken at two locations in the bilge of the *Eureka* (Fig. 2). The analysis area in the aft of the ship in the bilge below the deck area was referred to as the “junior’s hold”. There was no similar term for the analysis area in the forward bilge.

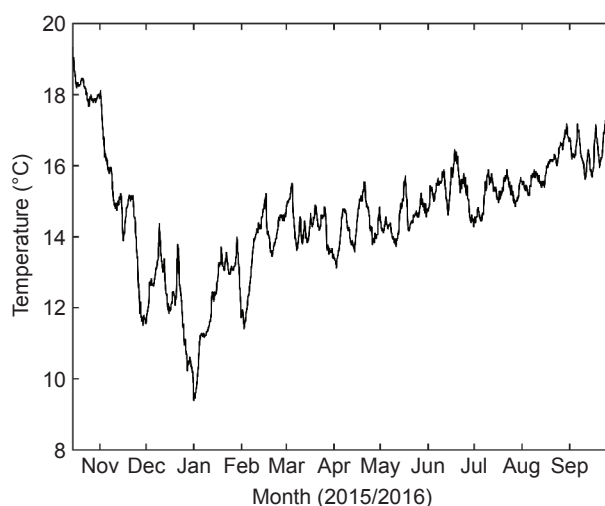
Figure 7. Hourly average temperature in the forward bilge of the *Eureka*.

Figure 7 shows the daily average temperature in the forward bilge during the observation period (October 2015 to October 2016). The temperatures were averaged because the temperature differences between the sensors were insignificant.
