Research  
Paper  
FPL-RP-581

# Performance of Back-Primed and Factory-Finished Hardboard Lap Siding in Southern Florida

February 2000

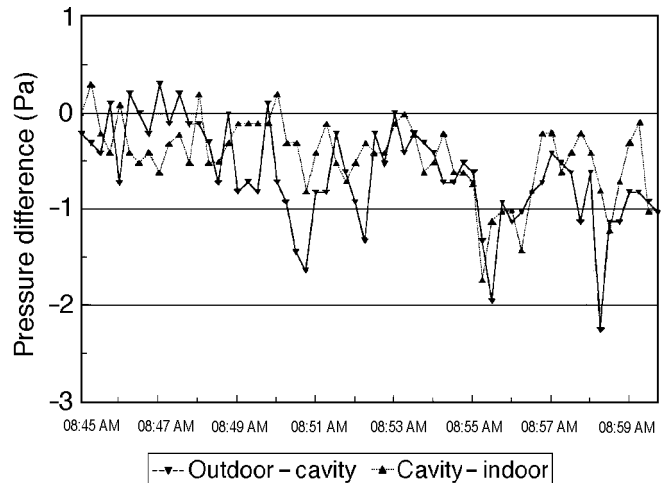
**Figure 34—Instantaneous pressure difference across siding, between the outside and the cavity, and across entire wall for wall ONa between 8:45 and 9:00 a.m. on Oct. 18, 1996 (winds were from the southeast; positive values indicate that the air pressure was infiltrative).**

Figures 34 and 35 show instantaneous pressures between 8:45 and 9:00 a.m. on October 18, 1996. Winds were from the east to southeast at 0.9 to 1.3 m/s (2 to 3 mi/h) (10-min average). Data are shown as 15-s averages. Pressures across the siding on wall ONa (Fig. 34) remained well below 1 Pa,

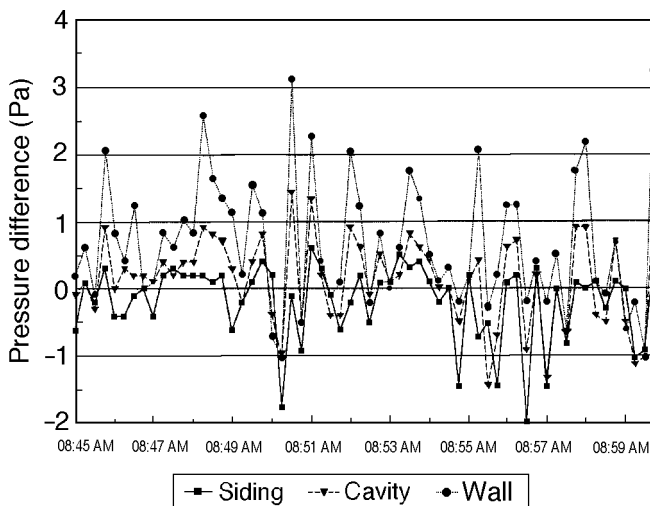
**Figure 35—Instantaneous pressure difference across siding, between the outside and the cavity, and across entire wall for wall OWd between 8:45 and 9:00 a.m. on Oct. 18, 1996 (winds were from the southeast; positive values indicate that the air pressure was infiltrative).**

while exfiltrative pressures across the wall at times reached 3 Pa. Pressures on the windward wall OWd (Fig. 35) were of the same magnitude but fluctuated between infiltrative (positive) and exfiltrative (negative). This demonstrates that even a windward-facing wall can experience significant periods of exfiltrative airflows. The data also suggest that hourly average pressure data can be quite misleading when infiltrative and exfiltrative flows cancel each other in the averaging process. Figures 36 and 37 show the difference between pressure in the cavity and outside and inside pressure.

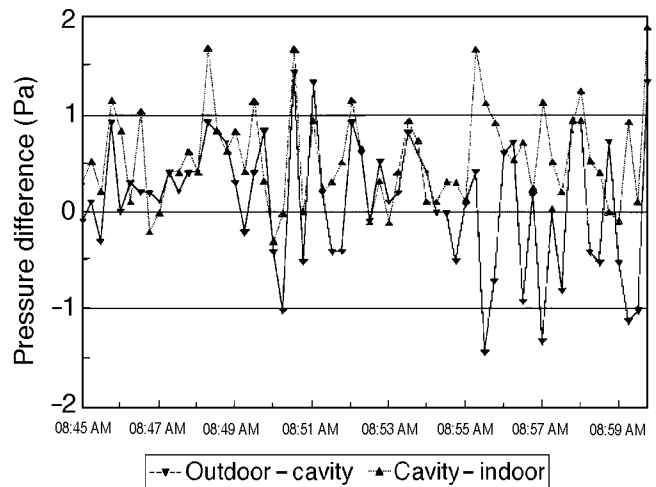
**Figure 36—Instantaneous pressure difference between cavity of wall ONa and outside and inside air, respectively, between 8:45 and 9:00 a.m. on October 18, 1996 (winds were from the southeast; positive values indicate that the air pressure was infiltrative).**

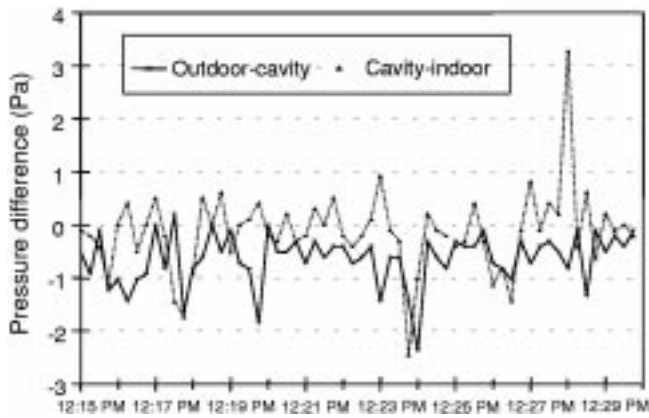
**Figure 38**—Instantaneous pressure difference between cavity of wall OWd and outside and inside air, respectively, between 8:45 and 9:00 a.m. on October 18, 1996 (winds were from the southeast; positive values indicate that the air pressure was infiltrative).

It appears that in both walls, pressure drops across the sheathing and siding were often similar in magnitude to pressure drops across the gypsum board, even though the sheathing with the weather barrier had been expected to resist most of the pressure. The large gap at the top plate that was revealed during inspection of wall section OWd explains the results for that wall, but in wall ONa, air apparently also bypassed the exterior sheathing and barrier to a considerable degree. Windward wall OWd also shows periods when the cavity appears simultaneously pressurized compared with inside and outside. We first observed and reported a similar phenomenon in walls with vents to the outside in a test building in Madison (TenWolde and others 1995). The current data indicate that the same effect takes place in conventional wood-framed walls. Figure 38 shows that 3½ h later, with slightly more southerly winds, the cavity of wall ONa also

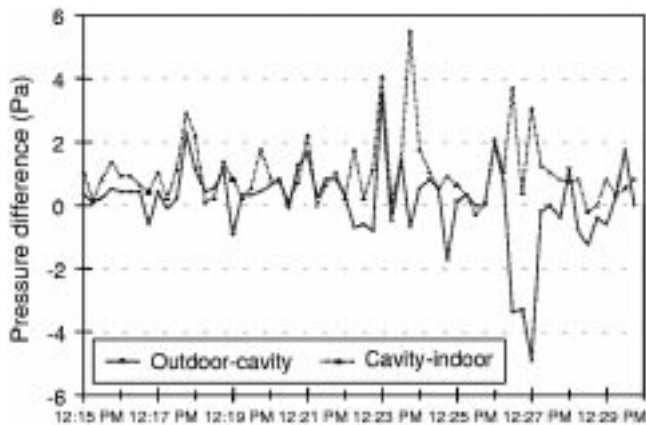
**Figure 39**—Instantaneous pressure difference between cavity of wall OWd and outside and inside air, respectively, between 12:15 and 12:30 p.m. on October 18, 1996 (winds were from the south-southeast; positive values indicate that the air pressure was infiltrative).

was pressurized for short periods of time. The cavity of wall OWd continued to be pressurized at times as well (Fig. 39). This pressurization was probably due to air infiltrating through the top of the wall. Finally, with winds from the north at 11:00 p.m., both walls were on the leeward side of the building and under exfiltrative pressure (Figs. 40 and 41). Pressurization of the cavity of either wall rarely occurred during that period.

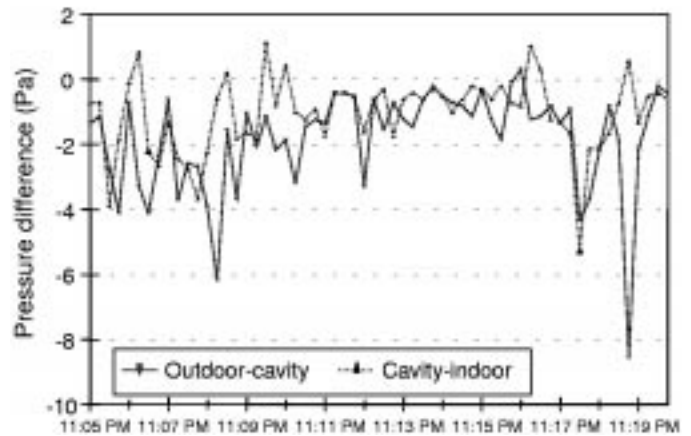
**Figure 40**—Instantaneous pressure difference between cavity of wall ONa and outside and inside air, respectively, between 11:05 and 11:20 p.m. on October 18, 1996 (winds were from the north-northeast; positive values indicate that the air pressure was infiltrative).

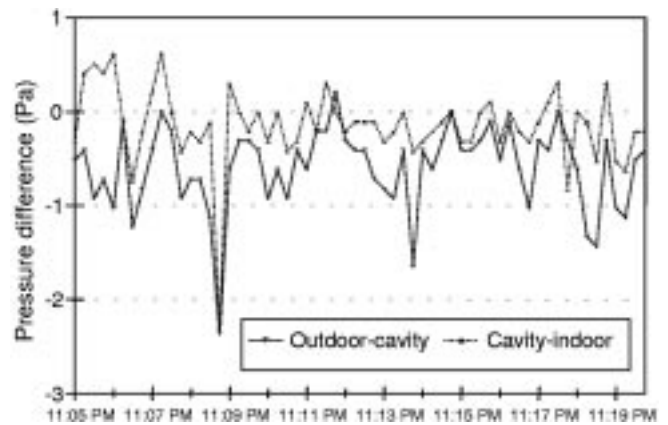
**Figure 41**—Instantaneous pressure difference between cavity of wall OWd and outside and inside air, respectively, between 11:05 and 11:20 p.m. on October 18, 1996 (winds were from the north-northeast; positive values indicate that the air pressure was infiltrative).

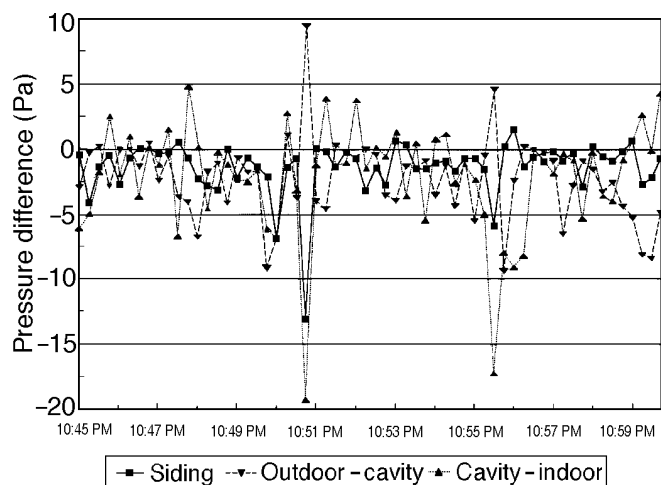
Figures 42 and 43 present similar pressure data for November 15. Around 11:00 p.m., winds were strong from the east to northeast with windspeeds of around 8.1 m/s (18 mi/h) (10-min average). Pressure across the siding was still relatively modest, usually less than 2 Pa, with some spikes of 10 to 15 Pa. Some pressure spikes of 15 to 20 Pa occurred across the gypsum board, especially in wall ONa.

**Figure 42—Instantaneous pressure difference across siding, between the outside and the cavity, and across entire wall for wall ONa between 10:45 and 11:00 p.m. on Nov. 15, 1996 (winds were from the north to northeast; positive values indicate that the air pressure was infiltrative).**

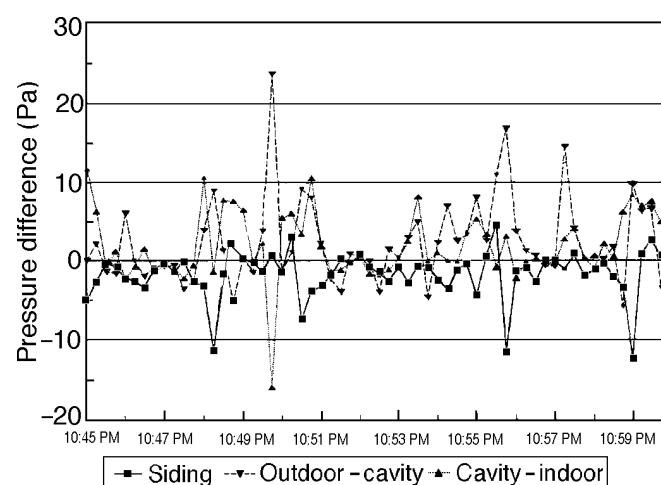
**Figure 43—Instantaneous pressure difference across siding, between the outside and the cavity, and across entire wall for wall OWd between 10:45 and 11:00 p.m. on Nov. 15, 1996 (winds were from the east to northeast; positive values indicate that the air pressure was infiltrative).**

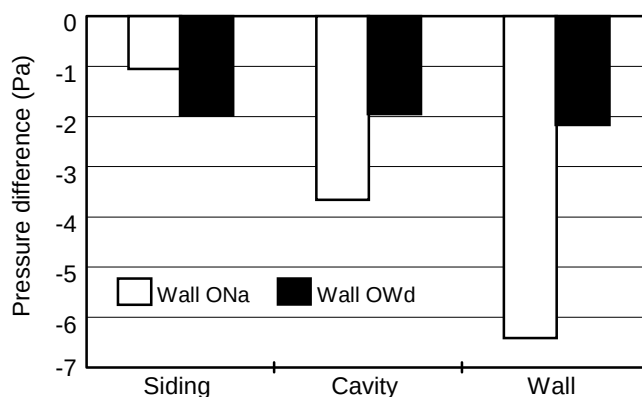
Figure 44 shows pressures averaged across the same 15-min period. It shows that wall ONa had an average exfiltrative pressure of about 6 Pa, and the sheathing–weather barrier–siding combination exhibited a pressure of almost 4 Pa. This means that the gypsum board sustained an average pressure of about 2 Pa. The siding pressure difference was slightly greater than 1 Pa. The average pressure across wall OWd was in the inward direction but was only about 2 Pa,

**Figure 44—Fifteen-minute average pressure difference across siding, between the outside and the cavity, and across entire wall for walls ONa and OWd between 10:45 and 11:00 p.m. on Nov. 15, 1996 (winds were from the east to northeast; positive values indicate that the air pressure was infiltrative).**

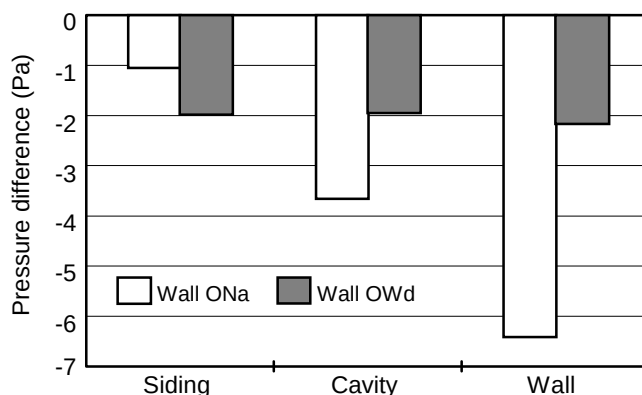
**Figure 45—Ten-minute average pressure difference across siding, between the outside and the cavity, and across entire wall for walls ONa and OWd between 10:05 and 10:15 p.m. on Nov. 15, 1996 (winds were probably from the east to northeast; positive values indicate that the air pressure was infiltrative).**

primarily because there were many pressure reversals (OWd was on the windward corner of the building). Pressure across the gypsum board was about 2 Pa (inward direction). Finally, Figure 45 shows averages for data taken 45 min earlier. These average pressures for the downwind wall (ONa) were very similar, but the pressures across wall OWd are reversed in direction, indicating a slightly different (probably more northerly) wind direction during that period.

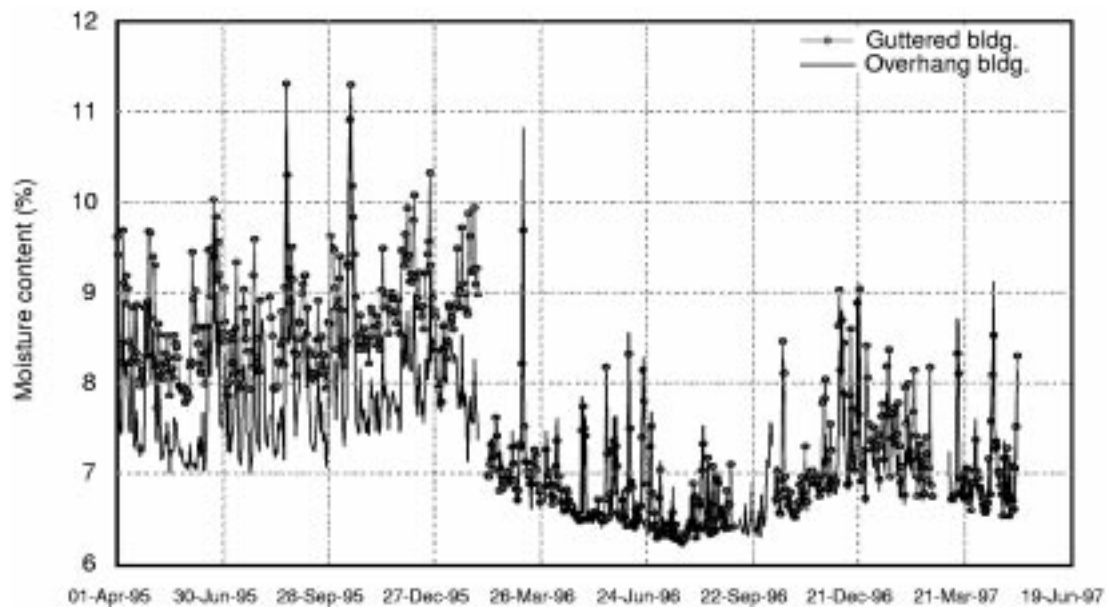
There was no significant difference between measured average MCs of the two buildings after the repairs of the MC pins in February 1996 (Fig. 46).

Figure 46—Daily average moisture content of all siding on both buildings for April 1, 1995, through May 5, 1997.

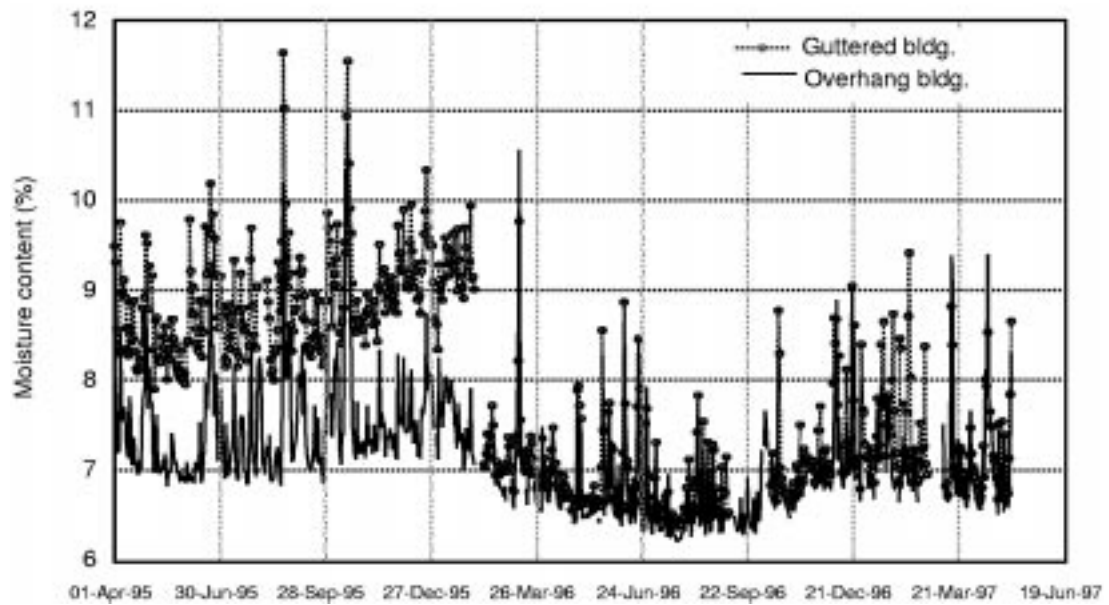
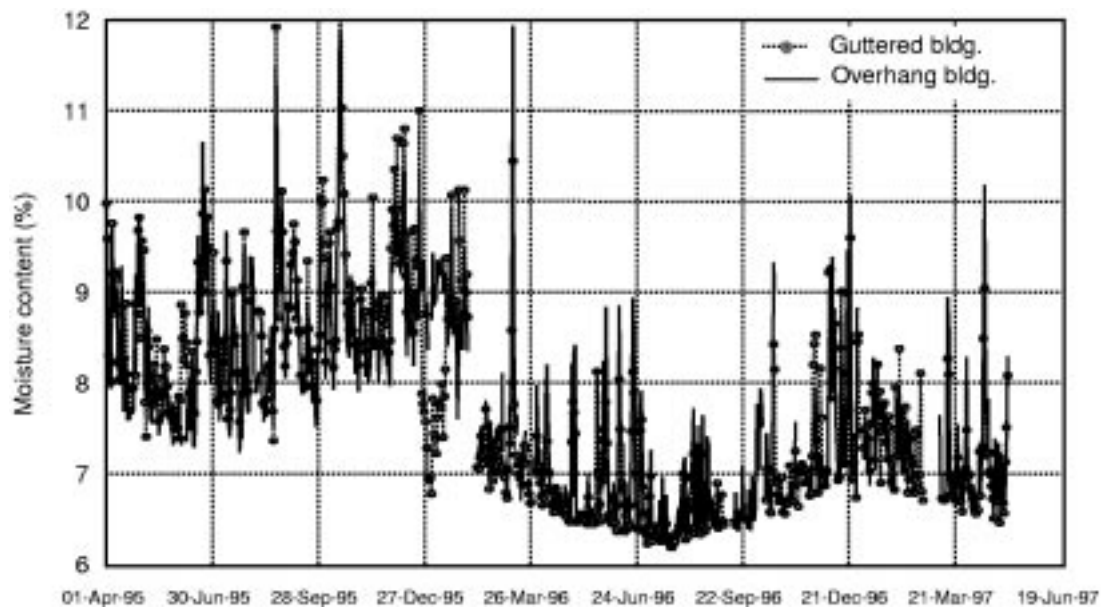
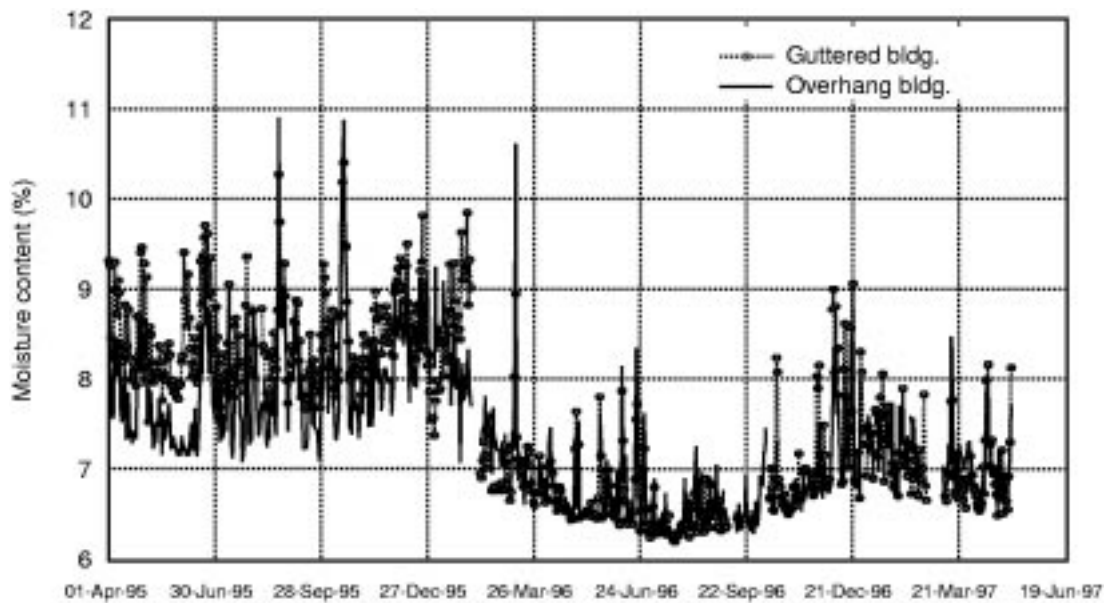
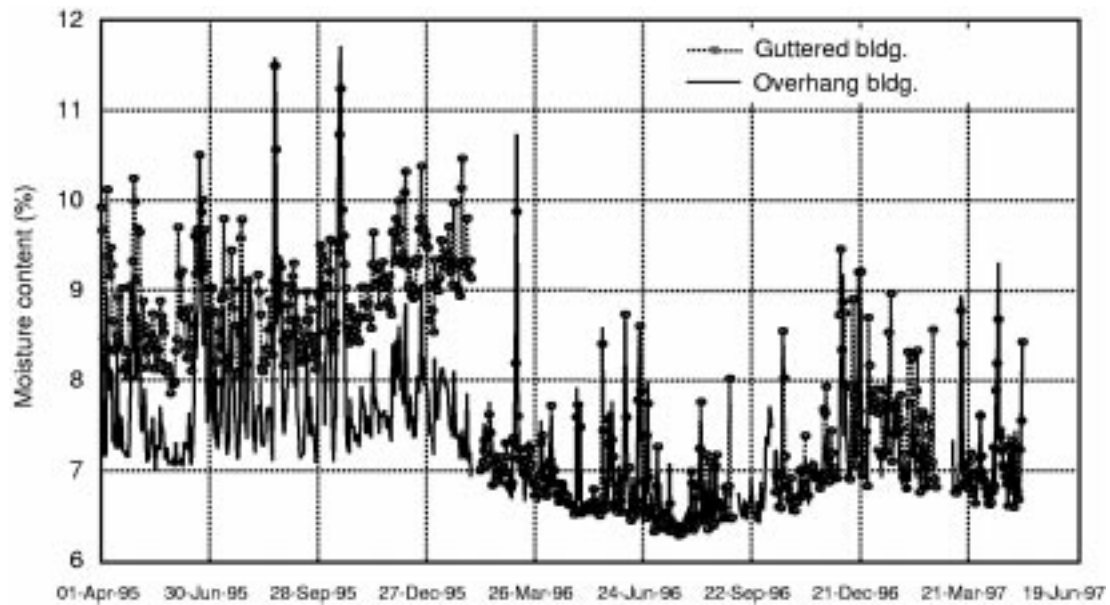
Figures 47 to 50 show no discernable effect of finishing treatments on the MC readings after February 15, 1996. All boards were essentially dry.

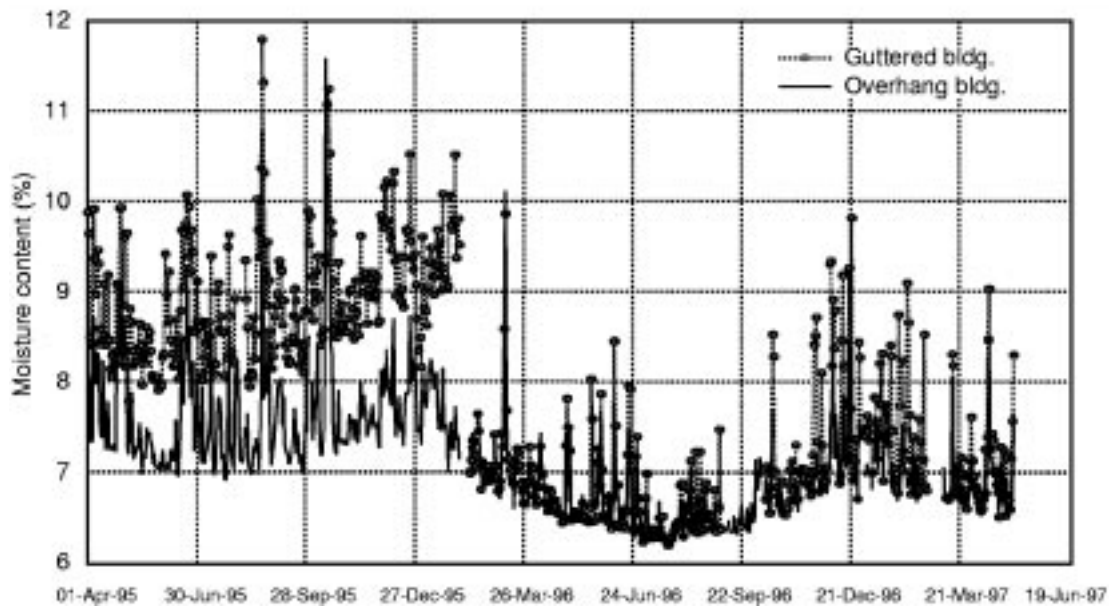
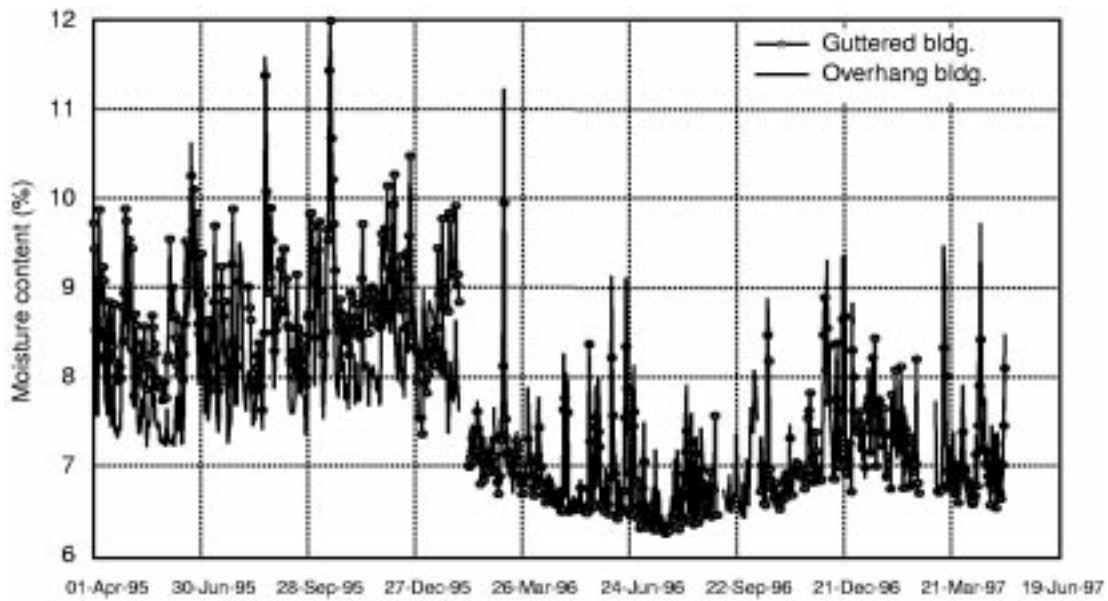
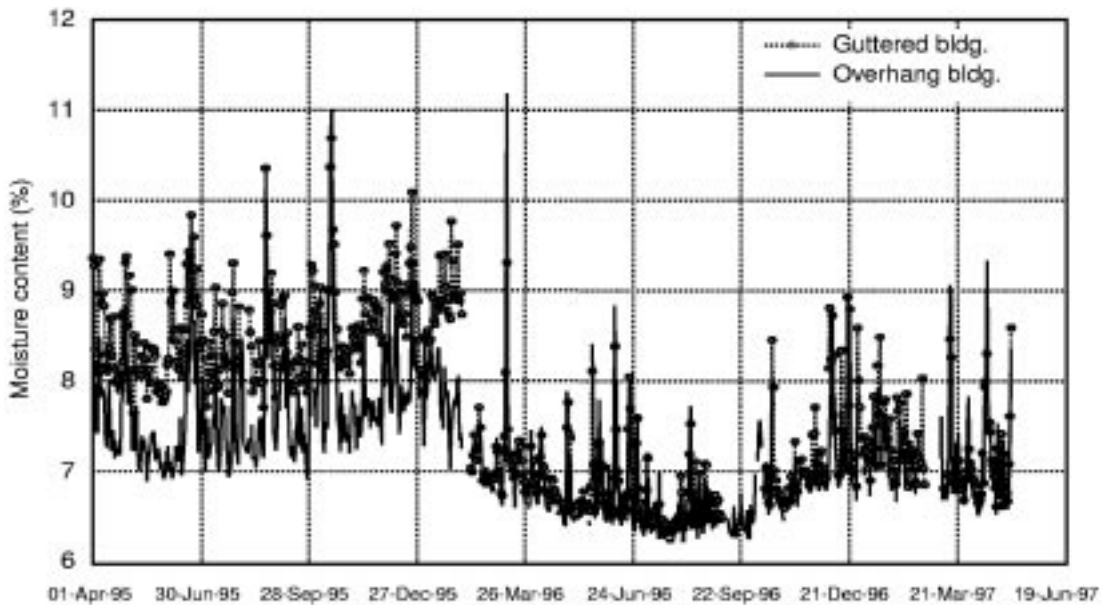
Figures 51 to 53 show no discernable effect of the type of wall construction (open with felt, plywood with felt, or plywood with polyolefin weather barrier) on the MC readings after February 15, 1996. All boards were essentially dry.

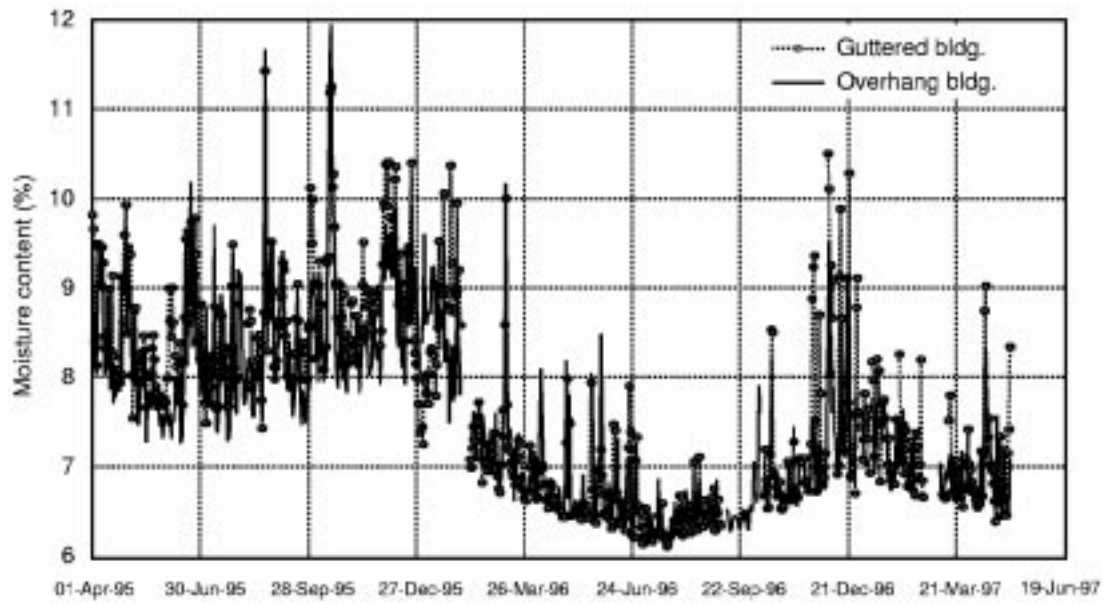
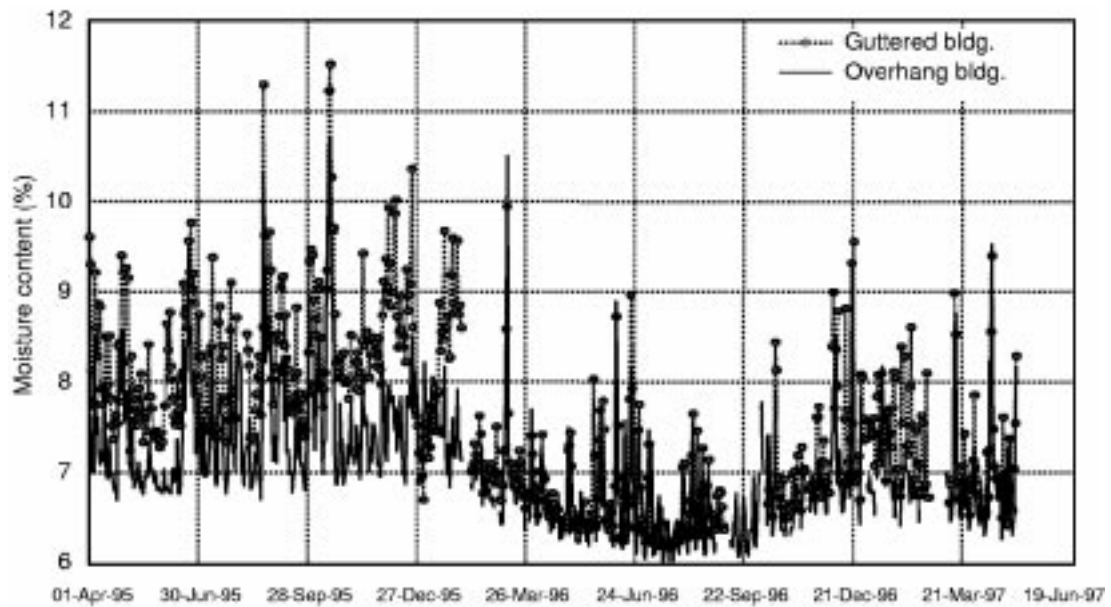
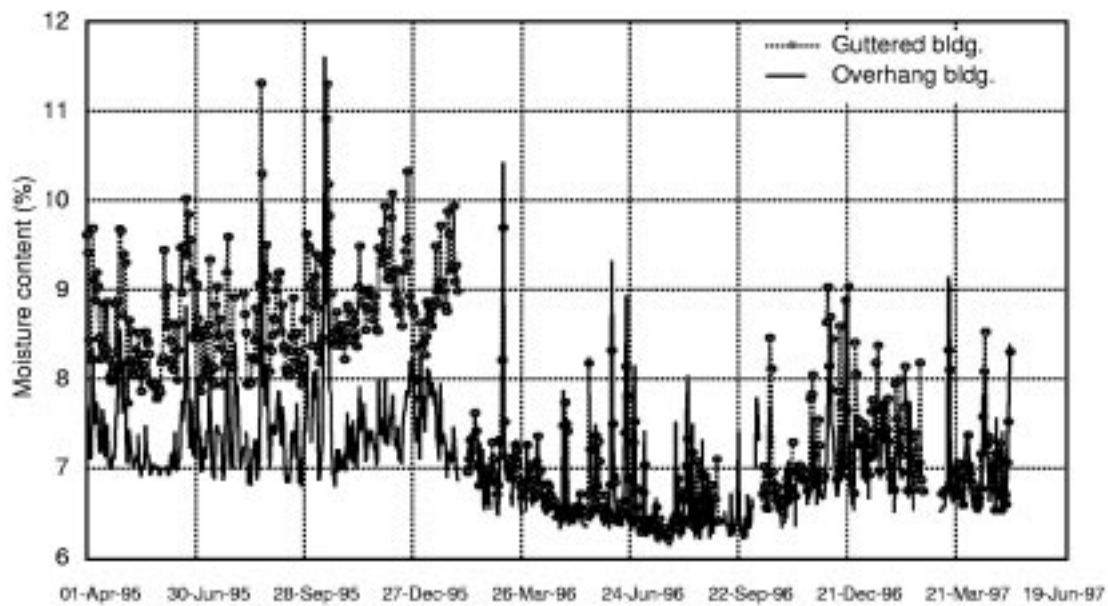
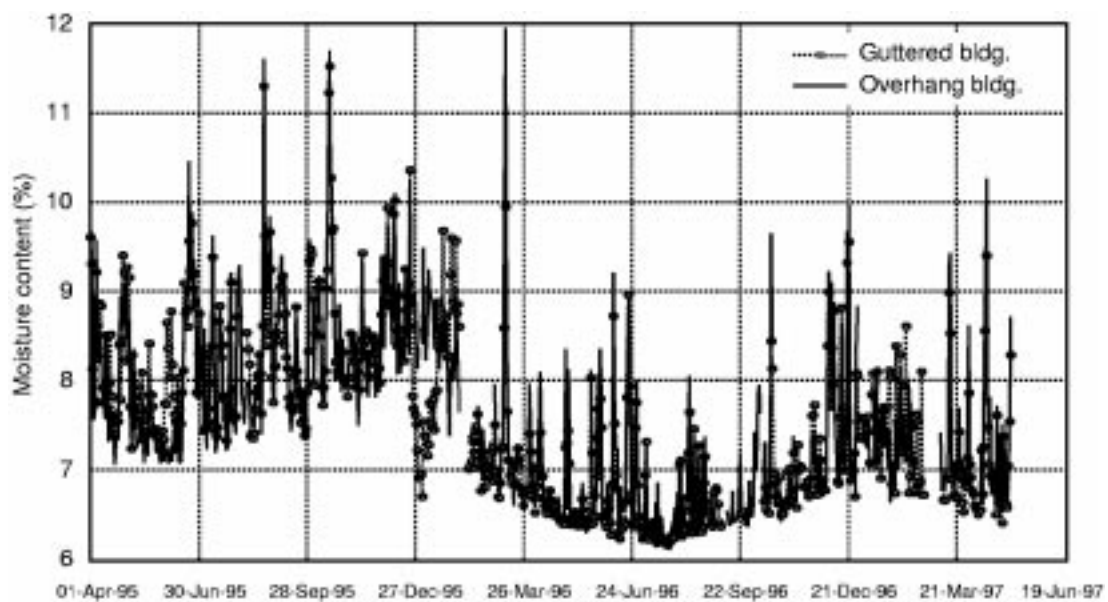
Figures 54 to 57 show no discernable effect of wall orientation on the MC readings after February 15, 1996. All boards were essentially dry.

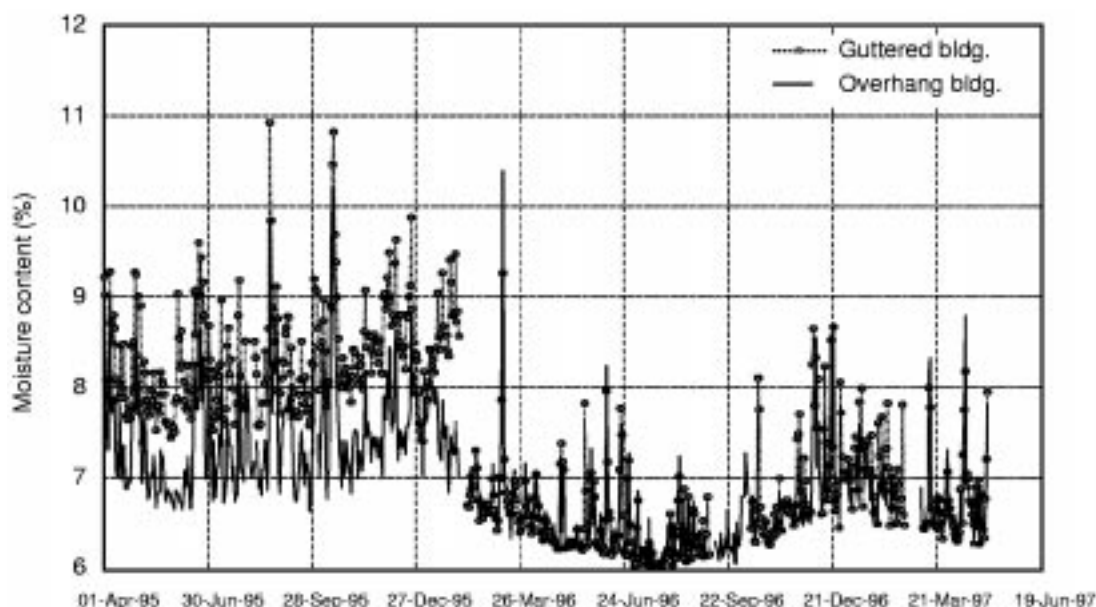
After February 15, 1996, the data show no discernable difference in MC between bottom boards and boards in other locations (Fig. 58).

**Figure 58—Daily average moisture content of bottom boards on both buildings for April 1, 1995, through May 5, 1997.**

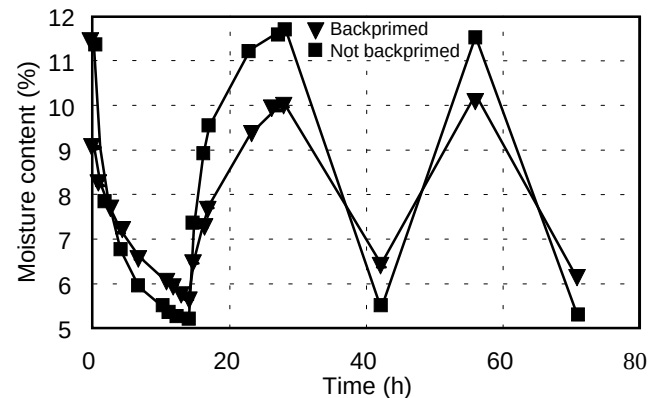
Figure 60 illustrates the effect of back-priming under cyclical conditions. We placed four 203-mm (8-in.) specimen squares (retrieved from the test buildings) in humidity rooms and monitored their MC. The rooms were at 27°C (80°F) and at 30% and 90% RH, respectively. Samples remained in one room for 2 weeks and were then moved to the other room. Figure 60 shows drying and wetting curves for the first full exposure cycle, along with MCs at the ends of the 2-week exposure periods during the second cycle. Figure 60 shows that back-priming can significantly retard both vapor sorption and desorption, that is, back-priming retards both wetting and drying. Our site-collected data suggest that unusually heavy rains occurred in the months prior to removal and dry weather occurred for the week prior to removal. In light of this, it seems likely that back-primed siding had a slightly but consistently higher MC at time of removal because it had not yet fully dried out. However, all the siding, including that not back-primed, had at least some primer or paint coverage on the back at the laps.

**Figure 60—Average moisture content of siding with and without back-priming when exposed cyclically to 30% and 90% RH.**
