# Reliability of acoustic tomography and ground-penetrating radar for tree decay detection

**METHODS:** One hundred and forty-seven individual trees of 33 species were inspected at a historic park in Yangzhou, Jiangsu Province, China, using a combination of visual inspection, acoustic tomography, GPR scanning, and resistance micro-drilling methods. Special image processing procedures were developed to analyze the acoustic and radar images and to estimate the proportion of compromised wood.

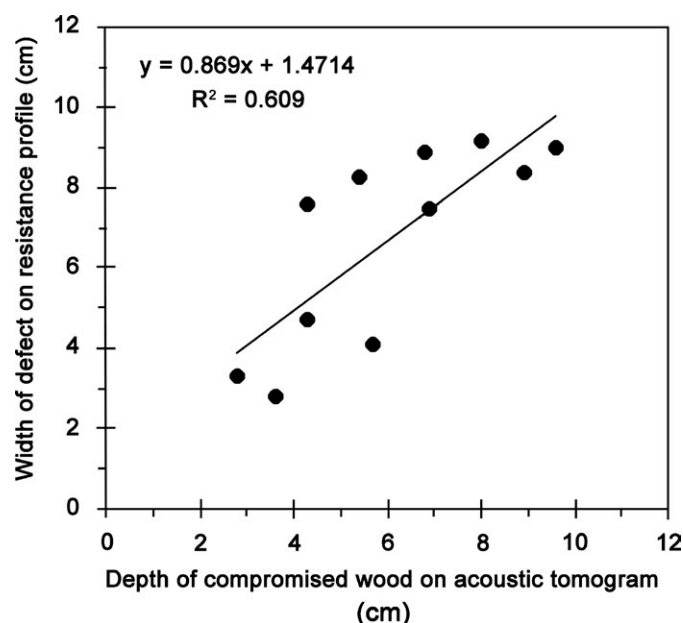
**FIGURE 3.** Relationship between the depth of the compromised wood as indicated by the acoustic tomograms and the defect length detected on the resistance profiles.

width of decay detected on the resistance profiles (Fig. 3). Despite some mismatches, the depth of the compromised wood shown on the acoustic tomograms had a good linear relationship with the defect width determined by the resistance drilling test ( $R^2 = 0.61$ ), indicating that acoustic tomography is a reliable inspection tool.

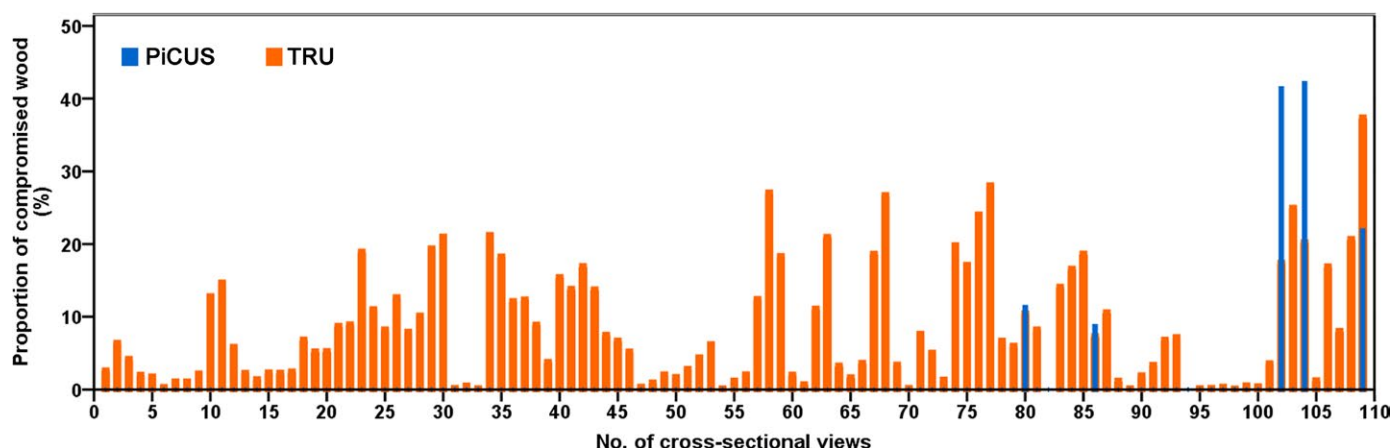
**FIGURE 4.** Percentage of compromised wood predicted by TRU and PiCUS (109 elevations measured on 60 trees).

The TRU scan data from 60 trees resulted in 109 radar images, one for each elevation scanned on each tree. The results of quantitative analysis of the radar images are shown in Fig. 4, along with the analysis results of the PiCUS tomograms. Among all of the elevations tested, radar images detected 37 elevations with areas of compromised wood of more than 10% of the cross section and 11 elevations with areas of compromised wood of more than 20% of the cross section. It was found that TRU radar images resulted in false positive predictions on 51 trees and 99 elevations, where both visual inspection and acoustic tomography testing indicated sound and healthy trunks but radar images showed compromised wood.
