Research  
Paper  
FPL-RP-552

# Field Performance of Timber Bridges

## 9. Big Erick's Stress-Laminated Deck Bridge

November 1996

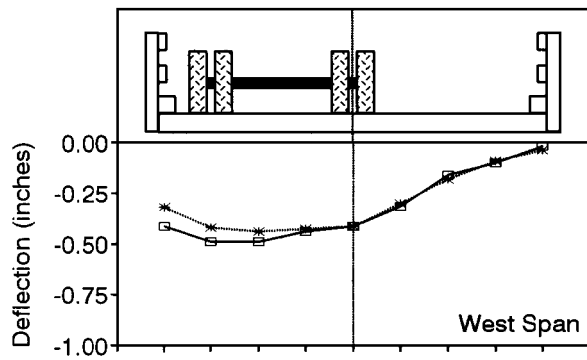
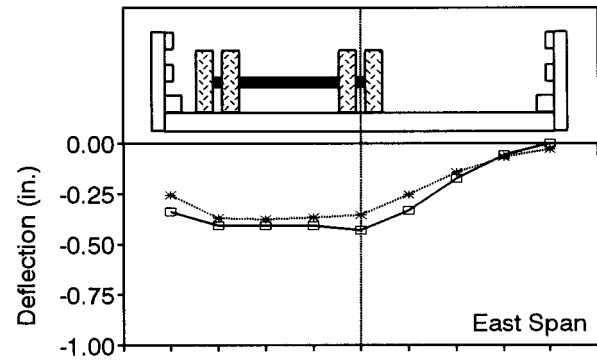
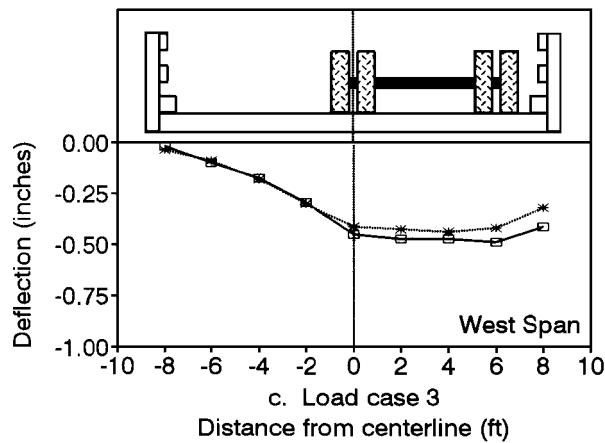
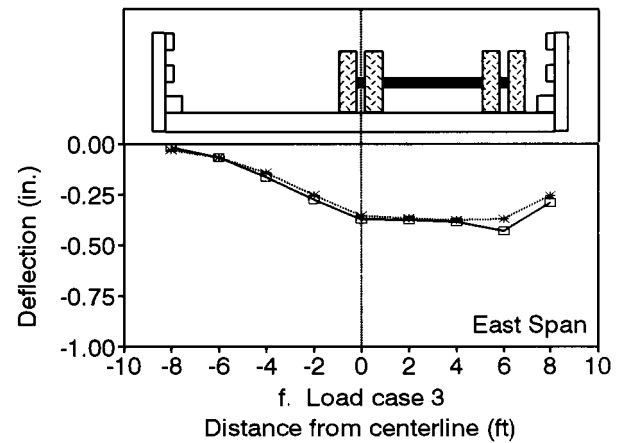
Analytical assessment was completed only for the approach spans. Results of the measured deflections compared with the predicted bridge response based on orthotropic plate analysis are shown in Figure 24 for load test 1 and Figure 25 for load test 2. As shown, the predicted response was similar to the measured response with minor variations. The differences at the bridge edges were expected because the curb and railing do provide some stiffness, which was not accounted for in the analysis. Other variations were relatively minor and within the measurement reading error.

Figure 24—Comparison of the approach span measured deflections for load test 1 and the theoretical deflection based on orthotropic plate analysis (looking west).

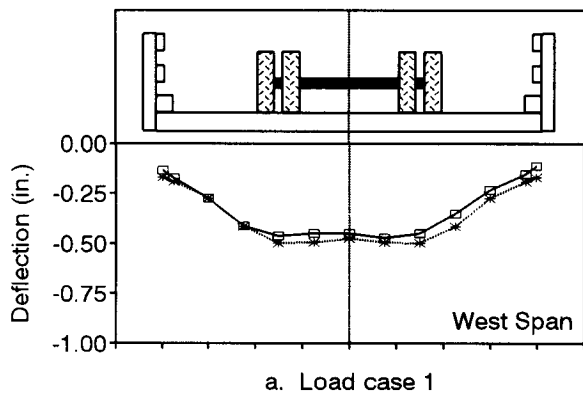
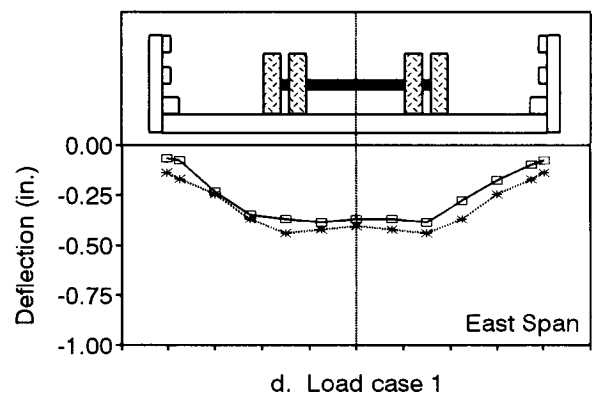
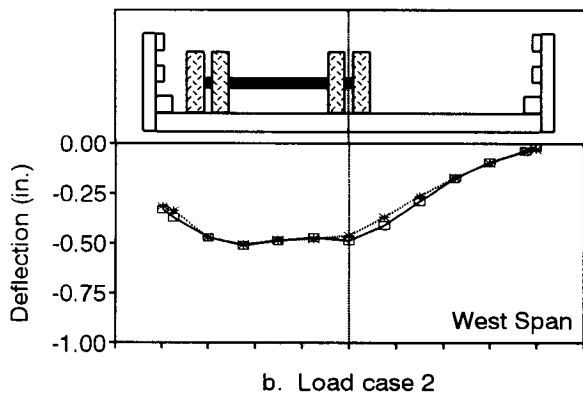
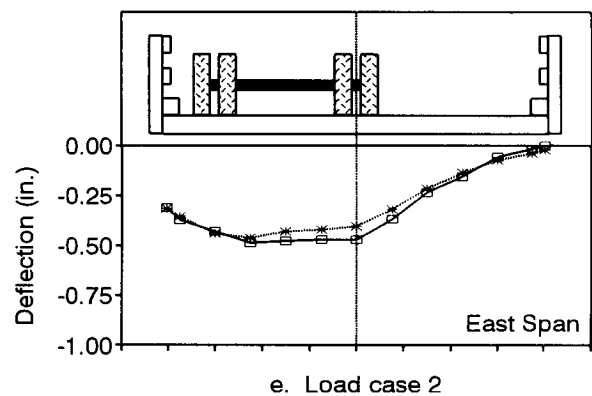
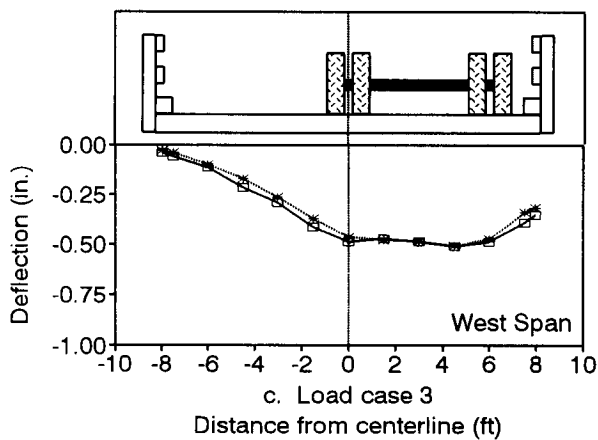
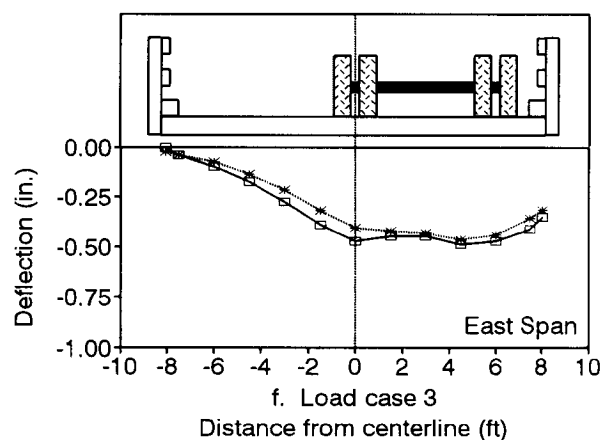
Figure 25—Comparison of the approach span measured deflections for load test 2 and the theoretical deflection based on orthotropic plate analysis (looking west).

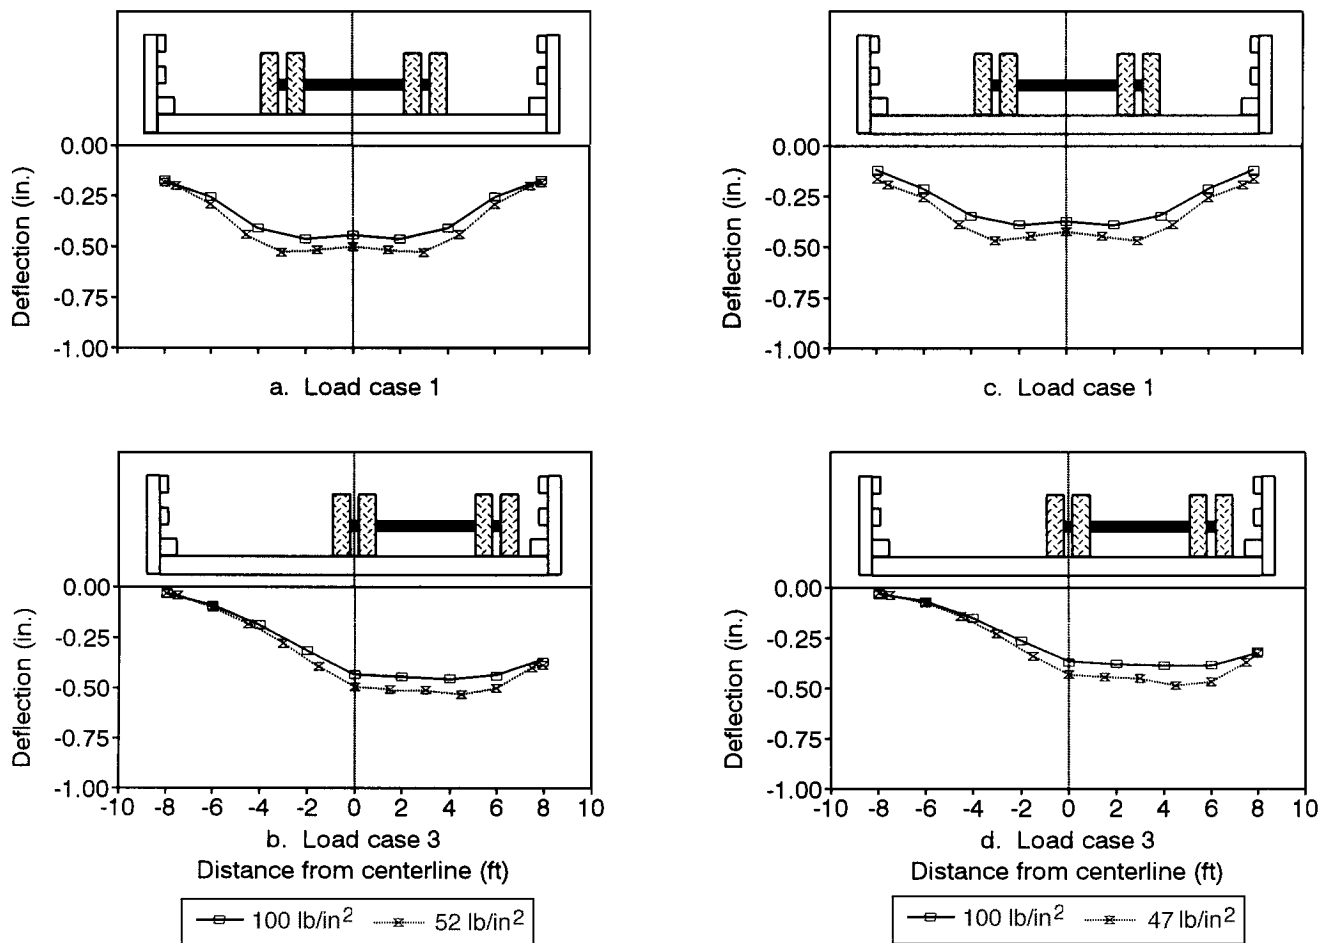
For further analysis, the same analytic parameters used for the load tests were used to determine the predicted response of an AASHTO HS 25–44 truck for load cases 1 and 3. (Load case 2 is a mirror image of load case 3.) Figure 26 displays the predicted response at the respective bar force levels for load tests 1A and 2. For load tests 1A and 2, the theoretical maximum deflection obtained for the HS 25–44 truck occurred in load case 3. The theoretical maximum deflections for load test 1A were 0.46 in., or 1/490 for the west span and 0.39 in., or 1/578 for the east span. For load test 2, the maximum theoretical deflection was 0.54 in., or 1/417 for the west span and 0.49 in., or 1/460 for the east span. Deflections computed using AASHTO recommended design procedures for the specified MOE were 0.66 in., or L/340 on the approach spans and 0.61 in., or L/610 on the center span.

**Figure 26—Maximum theoretical deflection at approach span midspan for AASHTO HS 25–44 truck loading at 100 lb/in<sup>2</sup> (both spans), 52 lb/in<sup>2</sup> (west span), and 47 lb/in<sup>2</sup> (east span).**
