# 100-Year Performance of Timber–Concrete Composite Bridges in the United States

James P. Wacker, M.ASCE<sup>1</sup>; Alfredo M. P. G. Dias<sup>2</sup>; and Travis K. Hosteng, M.ASCE<sup>3</sup>

**Abstract:** The use of timber–concrete composite (TCC) bridges in the United States dates back to approximately 1924 when the first bridge was constructed. Since then a large number of bridges have been built, of which more than 1,400 remain in service. The oldest bridges still in service are now more than 84 years old and predominately consist of two different TCC systems. The first system is a slab-type system that includes a longitudinal nail-laminated deck composite with a concrete deck top layer. The second system is a stringer system that includes either sawn timber or glulam stringers supporting a concrete deck top layer. The records indicate that most of the TCC highway bridges were constructed during the period of 1930–1960. The study presented in this paper discusses the experience and performance of these bridge systems in the US. The analysis is based on a review of the relevant literature and databases complemented with field inspections conducted within various research pr

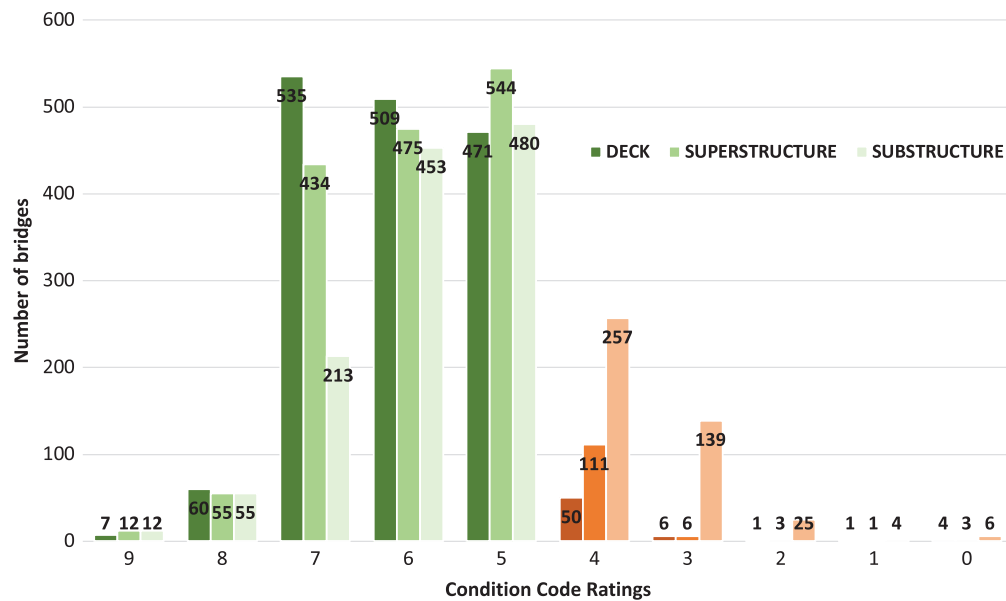
**Fig. 9.** (Color) Bridge condition ratings according to the NBI (FHWA 2016). The orange condition ratings indicate those conditions deemed poor or worse in the NBI ratings system.

Fig. 9 indicates that the large majority of TCC bridges are in relatively good condition, especially considering that many have been in service for more than 50 years and up to 84 years. This is strong evidence that this bridge solution is durable and suitable for a long service life.
