# Field Evaluation of Stress-Laminated Hardwood Timber Bridges with Extended Service Life

Justin M. Dahlberg<sup>1</sup>, James P. Wacker<sup>2</sup>

In: Proceedings of the World Conference on Timber Engineering, August 9-12, 2021, Santiago, Chile. Paper No: TE0503.

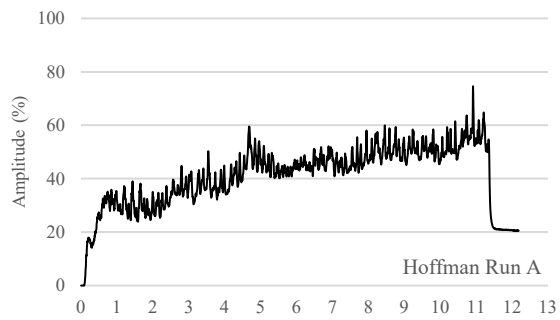
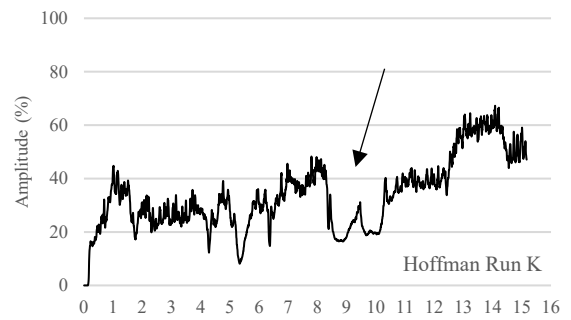
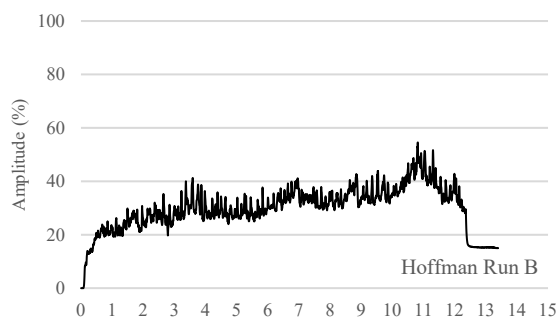
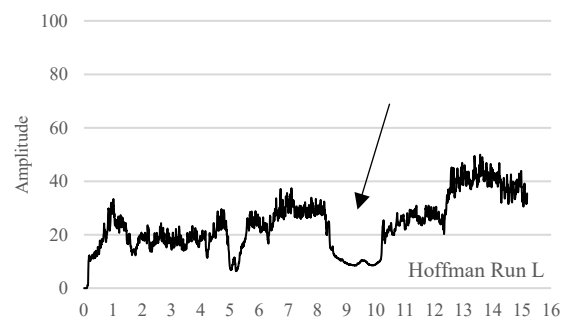
**Figure 22** Hibbsville and Hoffman Run micro-drill resistance measurements versus depth (inches) of penetration (1 in = 25.4 mm)

Micro-drilling resistance measurements were taken at several locations at the Hibbsville and Hoffman Run bridges. The results are plotted in Figure 22 showing the relative resistance through the depth of the drill bit penetration. The depth of drilling and drilling resistance are plotted along the horizontal and vertical axes, respectively. One should note any abrupt changes to the drilling resistance and assume these areas to be voids (if no resistance) or decayed (if reduced resistance).

The results for each bridge generally show the timber is sound with few areas of reduced density. Specifically, Hoffman Run locations E, K, and L show areas where the density changes. The orientation of the drilling at location E is vertical (from the top side downward) which indicates the bit is penetrating a single timber lamination across its depth. This is pointed out by the arrows. A small area may be experiencing the onset of decay. The orientation of the drilling at locations K and L is horizontal (from outside inward at deck edge) which indicates the bit is penetrating multiple timber laminations across their widths. The reduction in density pointed out by the arrow is likely a result of reduced density in a single timber lamination.
