# UAV-aided bridge inspection protocol through machine learning with improved visibility images

Euiseok Jeong<sup>a,2</sup>, Junwon Seo<sup>b,1,\*</sup>, P.E. James Wacker<sup>c</sup>

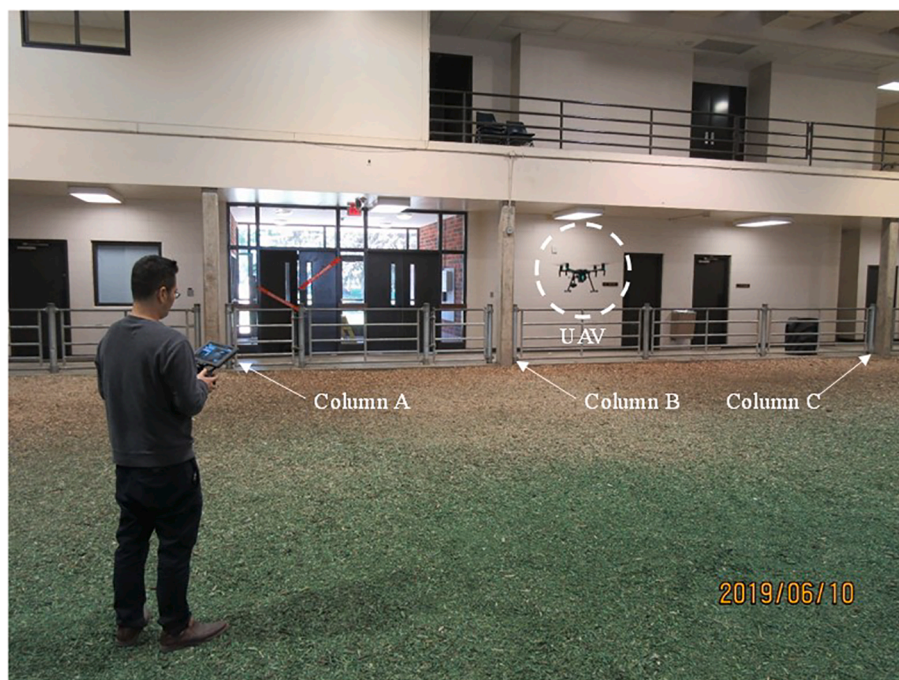
Fig. 3. Inspected concrete columns during indoor inspections.

In the first indoor inspection, UAVs captured 24,867 images of columns A through C in Animal Science Arena to identify any damage as displayed in Fig. 3. The images of the columns were examined in detail and a total of three noticeable cracks were visually observed on columns A through C. The damage classification using CNN-based machine learning coupled with the Residual Networks having 50 layers through MATLAB, 2020 was made as shown in Fig. 4 for three cracks on each of the columns.

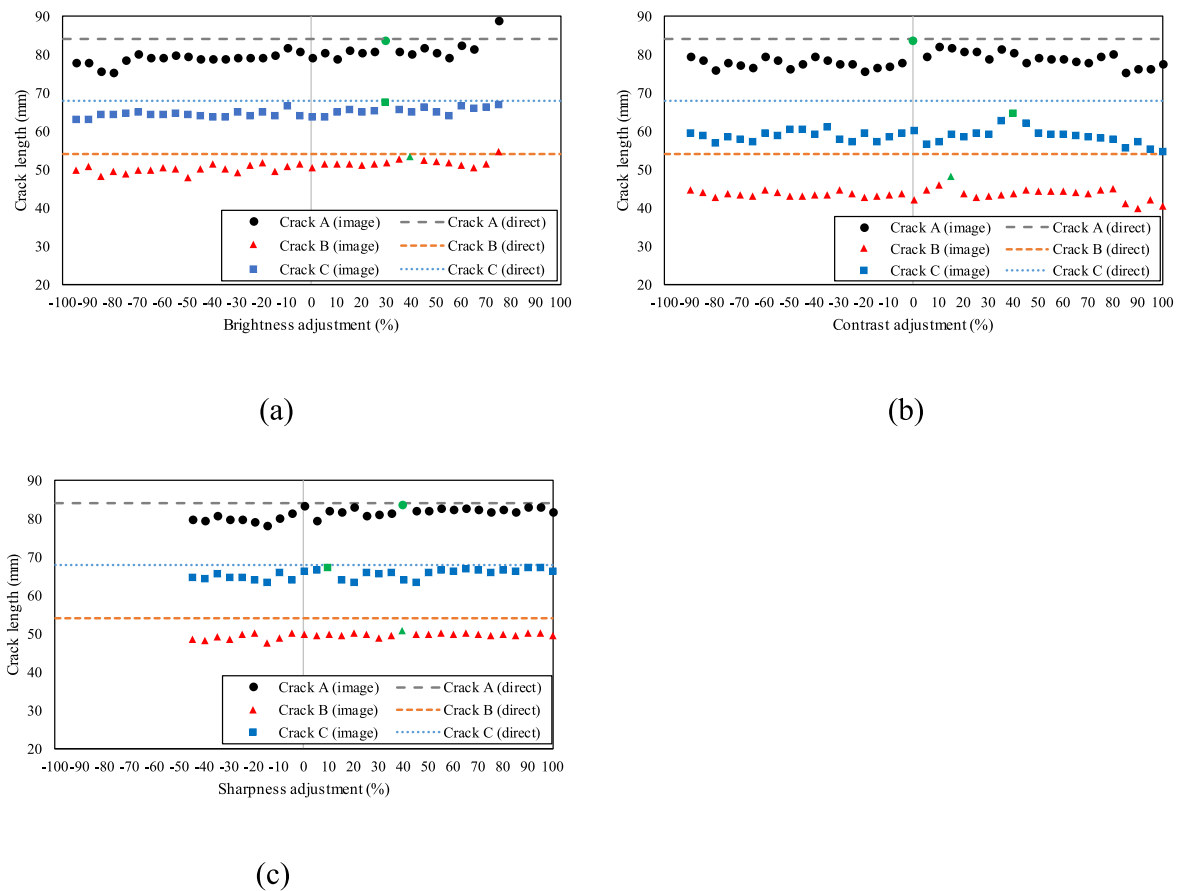
**Fig. 5.** Accuracy of the image analysis-based crack measurement with variation in brightness, contrast, and sharpness: (a) brightness adjustment for crack length; (b) contrast adjustment for crack length with the optimized brightness; and (c) sharpness adjustment for crack length with the optimized brightness and contrast.

Upon completion of UAV-aided inspections, the cracks on the columns were also measured directly using a measuring tape, and the direct measurements were compared to those obtained from image analysis of UAV inspection images to examine the accuracy of the UAV-aided inspection protocol. It should be noted that UAV inspection images filtered by adjusting their brightness, contrast, and sharpness were initially used for the image analysis-based crack quantification. Fig. 5 shows the accuracy of damage quantification through the image analysis with the filtered UAV images. The error percentages calculated between the direct measurements and corresponding values obtained from the image analysis with the filtered images with variance in brightness, contrast, and sharpness are illustrated in Fig. 5a through 5c, respectively. In Fig. 5a, dashed lines indicate the direct measurement of column A crack (gray line), B (orange line), and C (blue line), individually, and black circles for column A crack, red triangles for column B crack, and blue boxes for column C crack are defined as the results from the image analysis specific to brightness adjustment. The values having the lowest error against direct measurement are marked with green dots. Similar to Fig. 5a, b and c show the accuracy of contrast and sharpness adjustment,

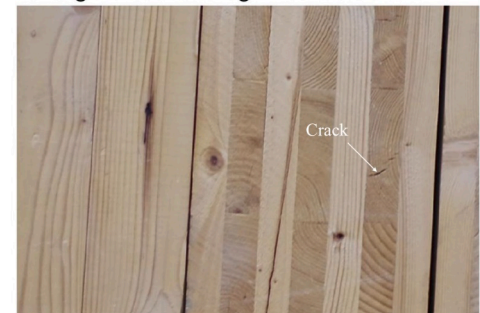
Fig. 8. Sample of damage classification using machine learning.

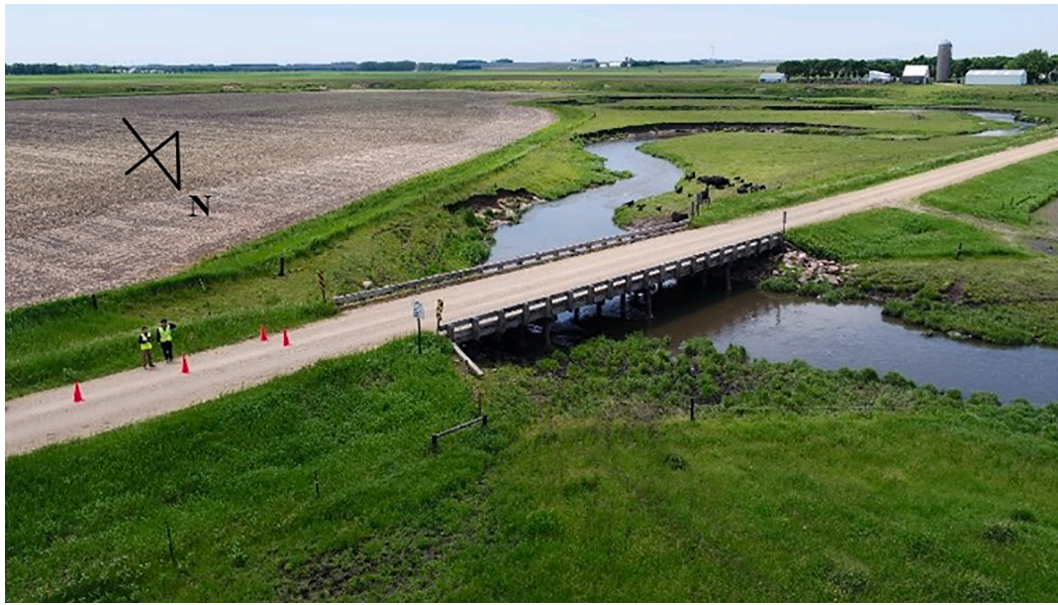
Fig. 10. Photograph of the inspected bridge taken by Matrice 210.

four-span timber bridge with a total structure length of 31.7 m, a maximum span length of 7.9 m, and a deck width of 9.1 m. According to the NBI condition rating scale (FHWA, 2018, 1995, 2012), the deck, superstructure, and substructure were recently evaluated in 2017 (FHWA, 2017) and assigned condition ratings of 6 (satisfactory), 6, and 5 (fair), respectively.

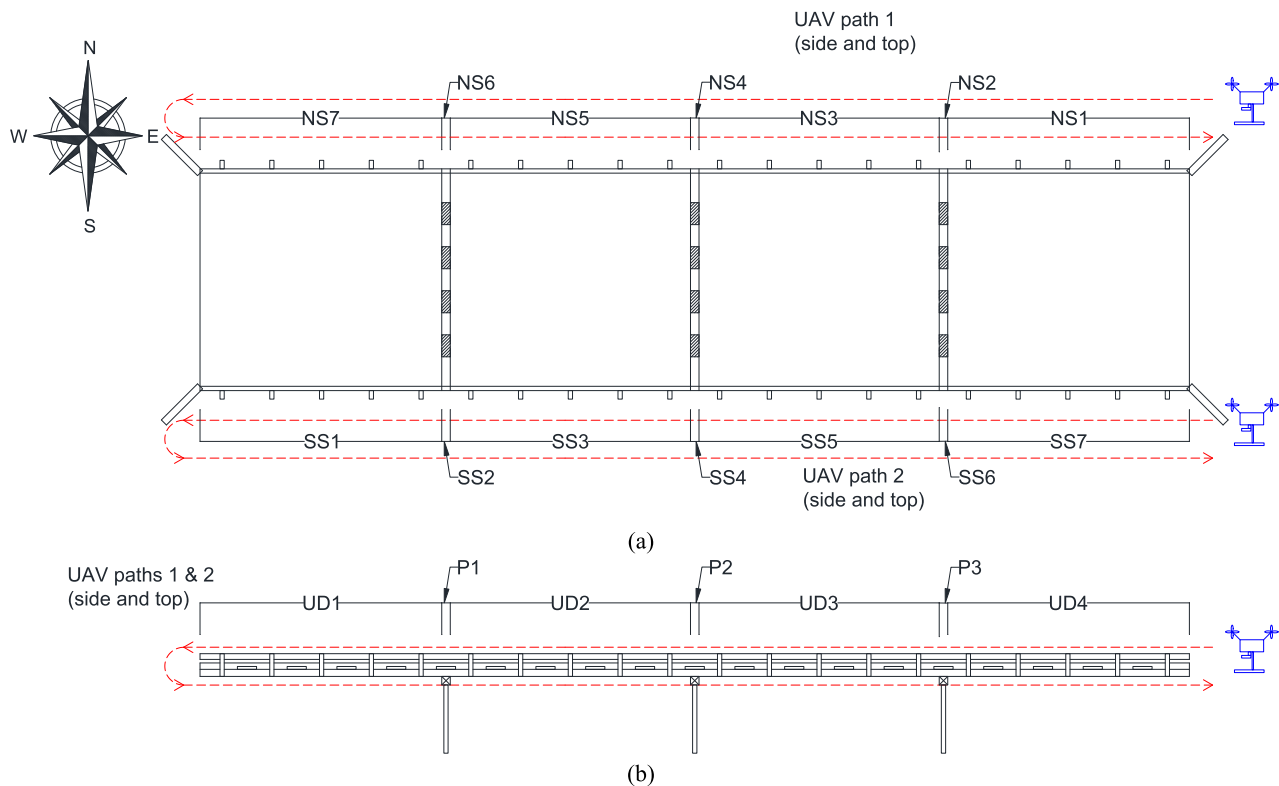
Fig. 11. Four-span timber girder bridge sketch with inspected sections: (a) plan view and (b) elevation view.

A sketch for this bridge was generated as shown in Fig. 11, including the plan view (Fig. 11a) and elevation view (Fig. 11b). Specifically, for effective damage identification, the superstructure of the bridge is divided into seven sections on each side as shown in Fig. 11a. In this figure, NS represents the north side of the bridge, and SS indicates the

south side of the bridge. As shown in Fig. 11b, underneath the bridge deck is also divided into seven individual sections, including UD1 through UD4, and the bridge pier sections are denoted as P1 through P3. Note, UD indicates underneath deck and P is defined as a pier. The UAV-aided bridge inspection was conducted by following UAV paths 1 and 2 as depicted in Fig. 11. Each UAV path includes inspection of the side of the bridge and top of the railings.

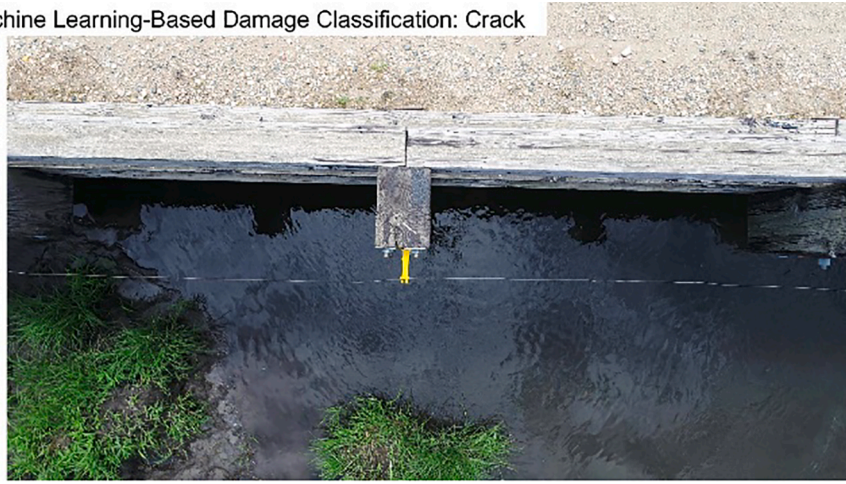
Fig. 12. Representative damage image showing damage classification result.
