# Bridge Deterioration Quantification Protocol Using UAV

Luis Duque, S.M.ASCE<sup>1</sup>; Junwon Seo, Ph.D., P.E., M.ASCE<sup>2</sup>; and James Wacker, M.ASCE<sup>3</sup>

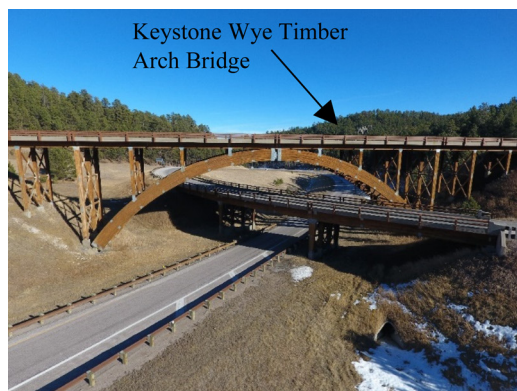
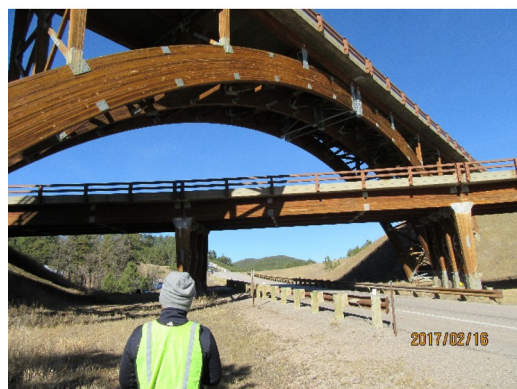
**Fig. 2.** Selected Keystone Wye timber arch bridge: (a) overview of bridge; and (b) view from under the arch. (Images by Luis Duque.)

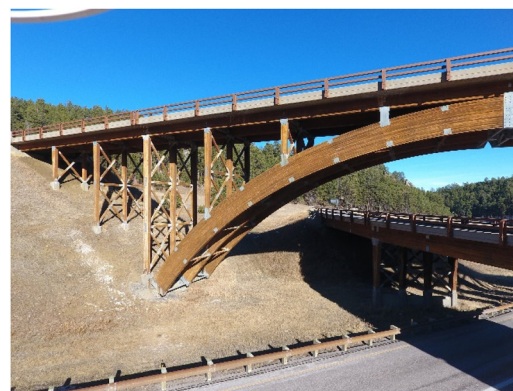
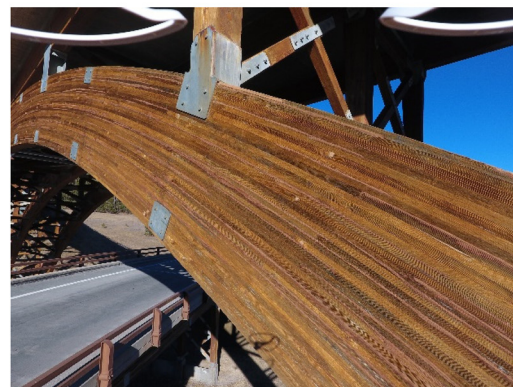
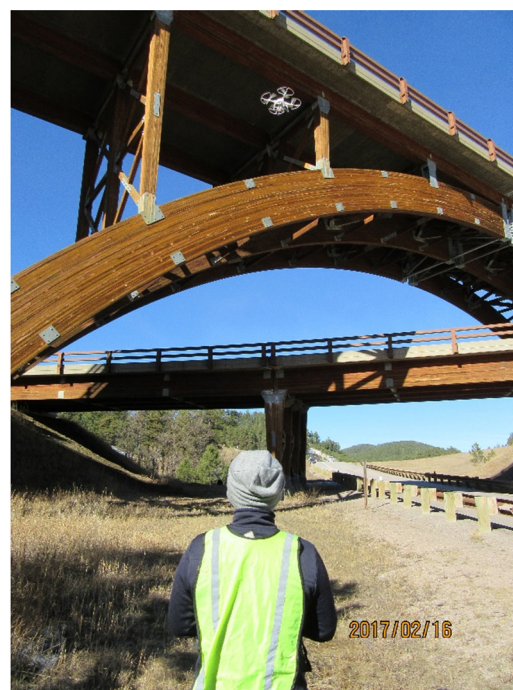
**Fig. 5.** Sample images obtained from the inspection of the Keystone Wye Bridge: (a) overall view of the bridge; (b) detailed view of arch; and (c) UAV flying near Keystone Wye Bridge. (Images by Luis Duque.)

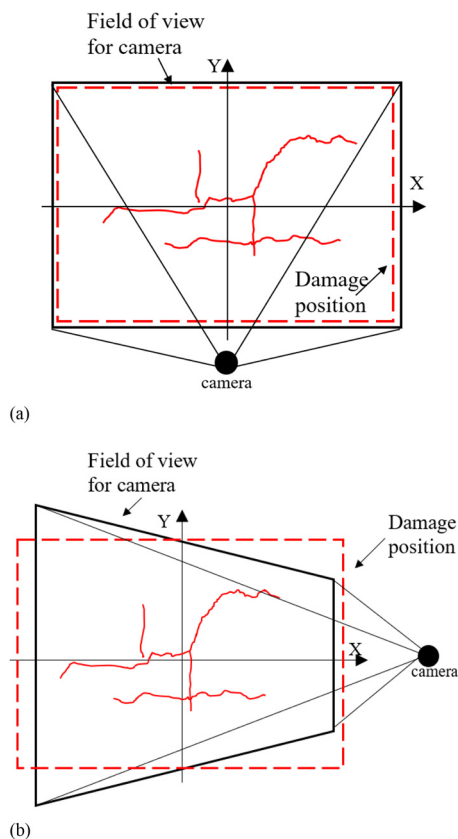
can be seen in Fig. 8(a), where the solid line represents the field of view for the camera, and the dashed line represents the damage position. For this case, both the field of view and the damage location were aligned; thus, there was not image distortion. A second image to the side of the damage [Fig. 8(b)] was taken at the same distance as in the inspection to capture the first image. This case shows how the solid line representing the field of view for the camera did not match the dashed line showing the damage location; therefore, some image distortion was observed. The study of these two images was considered necessary to evaluate the accuracy of the pixel-based method considering image distortion.

**Fig. 8.** Image comparison for different camera positions: (a) camera aligned to damage; and (b) camera to the side of damage.
