Forest Products Laboratory | Research Note FPL–RN–0428 | November 2024

# Condition Assessment of the Northern Climatic Research House at the USDA Forest Service, Forest Products Laboratory

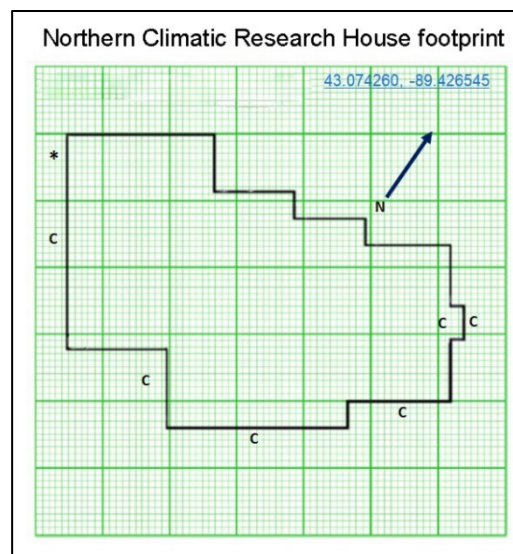
**Figure 2—Footprint of the research house with GPS coordinates and cardinal direction north indicated. The letter C indicates conditions present for future intrusion of wood-destroying insects if not addressed, and \* indicates where a drain is emptying near an underground electrical supply (image property of Mississippi State University, used with permission).**
