Forest Products Laboratory | Research Note FPL–RN–0429 | March 2025

# Condition Assessment of the Timber Frame Supporting USS *Cairo* at Vicksburg National Military Park, Vicksburg, Mississippi

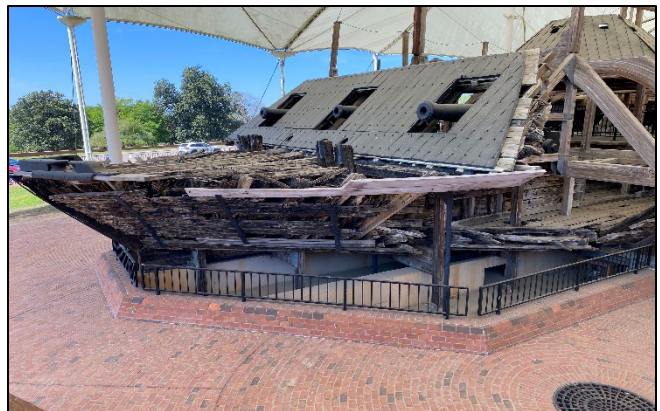
**Figure 1—USS *Cairo* in Vicksburg National Military Park on display outdoors under a canopy and supported by a glulam crib structure.**

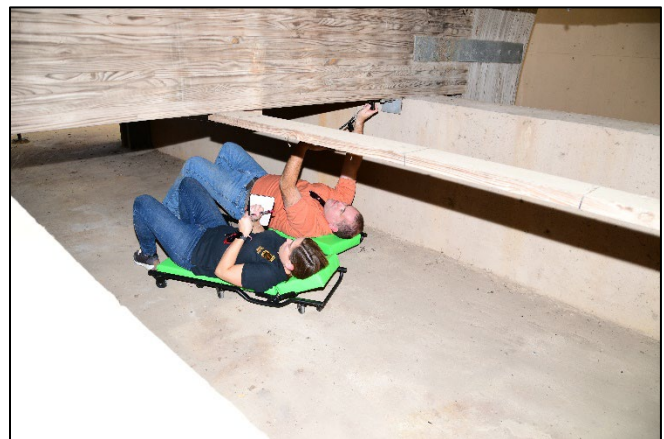
type moisture meter ranged between 8% and 15% MC, with most values falling within the 10% to 13% range. These ranges of MC, as shown in Figure 6, are slightly elevated but still below the required 17% to 20% MC range needed for growth of mold and decay fungi. The MC measurements are summarized in Figure 6, and Figure 7 shows how team members performed the moisture measurements.

**Figure 7—Team members performing moisture measurements of USS *Cairo* glulam support structure.**

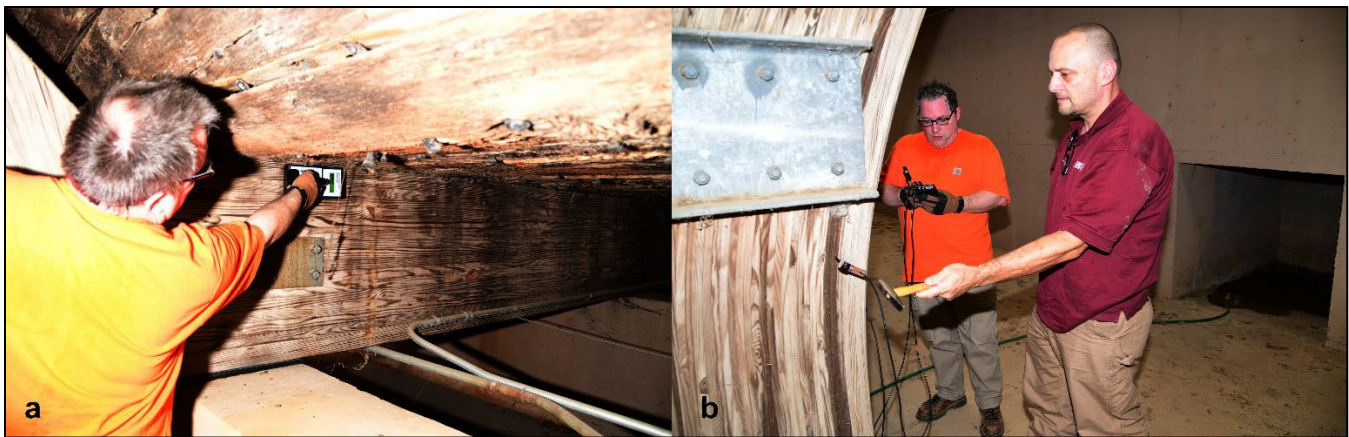
Moderate concern locations (17% to 20% MC) were further tested using stress wave time of flight (ToF). Stress wave time of travel was measured using a microsecond timer from Fakopp Enterprise Bt (Sopron, Hungary). Mechanical waves (sound or mechanical impact) travel faster in sturdy wood than in decayed wood. ToF less than 200  $\mu\text{s}/\text{ft}$  indicates sturdy wood; ToF between 200 and 300  $\mu\text{s}/\text{ft}$  should be monitored; ToF greater than 300  $\mu\text{s}/\text{ft}$  indicates decay. The Wagner L610 digital lumber moisture meter and Fakopp microsecond timer are shown in Figure 10a and b, respectively. No ToF measurements greater than 300  $\mu\text{s}/\text{ft}$  were observed. Several areas where MC was between 17% and 20% had ToF between 200 and 300  $\mu\text{s}/\text{ft}$ .

**Figure 10—Inspection tools used on USS *Cairo* glulam structure: (a) Wagner L610 digital lumber moisture meter; (b) Fakopp microsecond timer.**
