Forest Products Laboratory | General Technical Report FPL-GTR-308 | February 2026

# Condition Assessment of the Wooden Mast of Historic Schooner *Grace Bailey*

On October 9, 2023, the main mast of the historic schooner *Grace Bailey* unexpectedly snapped at about two-thirds of its height and fell onto the deck, killing one passenger and injuring three others. The United States Coast Guard promptly initiated a formal investigation into the cause of the mast's sudden failure. At the request of the Coast Guard, the U.S. Department of Agriculture, Forest Service, Forest Products Laboratory (FPL) conducted an on-site evaluation of the broken mast on December 19, 2023. The inspection used nondestructive testing methods and included visual analysis, stress wave scanning, resistance micro-drilling, and fungal identification at FPL. Severe decay was identified from stress wave transmission measurements taken between 26 and 56 ft above the mast base in the bow-to-stern axis. Suspect wood ranged from 20 to 26 ft and from 56 to 58 ft along the same axis. Along the starboard-to-port axis, suspect wood ranged from 24 to 56 ft, with decay at 37 to 38 ft and severe decay at 45 ft. Results from f

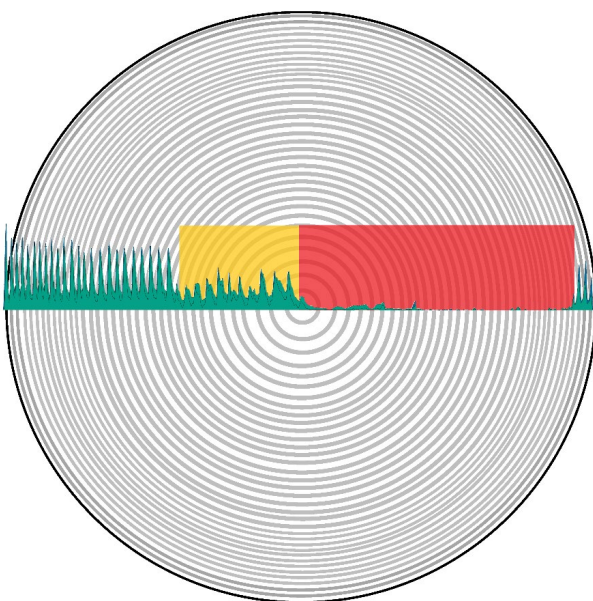
Figure 3 shows an idealized cross section of a timber pole with an overlay of a resistance drill output. The left side of the figure depicts good wood characterized by visible, distinct peaks corresponding to annual rings. The red shaded area on the right side depicts decayed wood. In the decayed wood, both the torque and the pushing force are very low when compared to the good wood. The yellow shaded area near the center is a suspect area. The height and distinctiveness of the peaks are decreased but still visible.
