Final Technical Report

CALIBRATION OF STREAMFLOW GAUGING STATIONS AT THE TENDERFOOT CREEK EXPERIMENTAL FOREST

USDA Joint Venture Agreement No. 02-JV-11222022-183

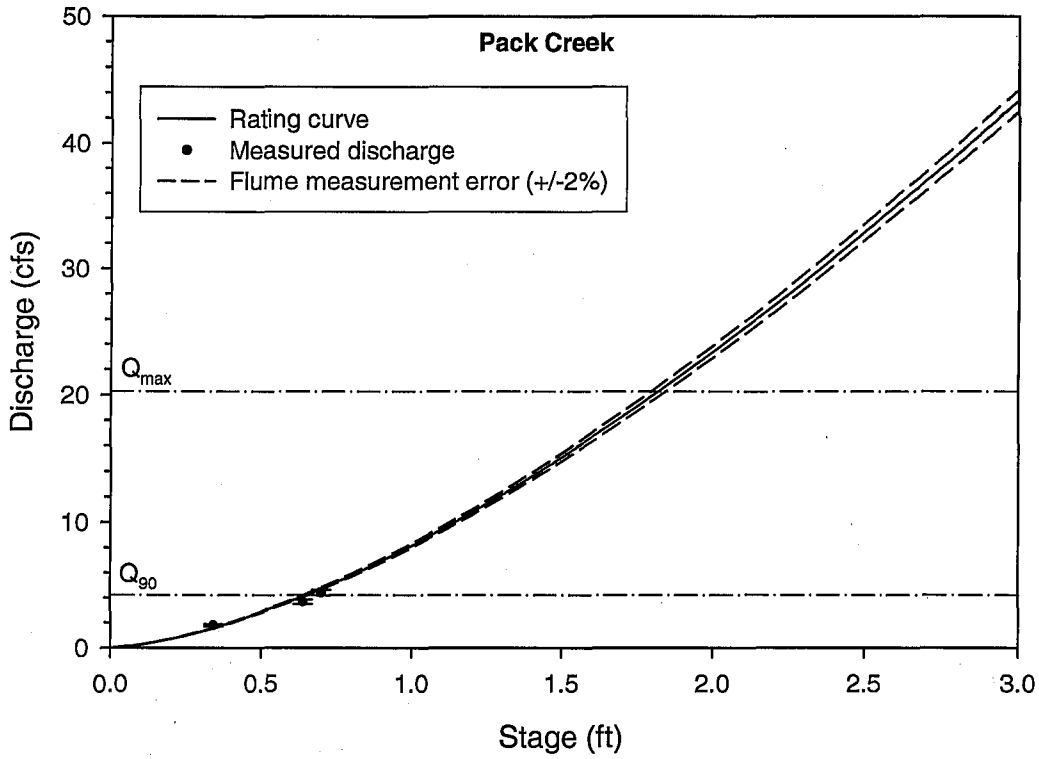
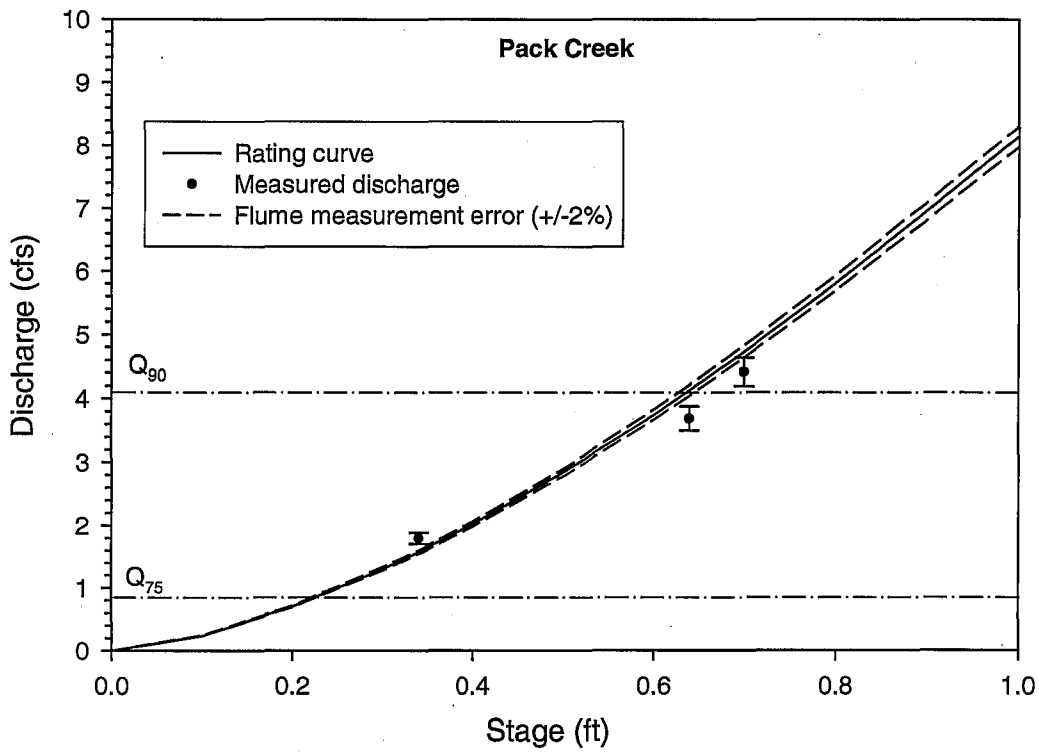
The 2-foot Parshall flume at the Pack Creek gauging station is rated to 44 cfs but the maximum mean daily flow of record is just 20.08 cfs (Table 2, Appendix I). All of the flow measurements at the gauging station on Pack Creek, which were obtained at calculated flows of 1.6, 4.1 and 4.7 cfs, exceeded the 75th percentile[1] of the mean daily flow and the highest measurement exceeded the 90th percentile of the mean daily flow (Table 2, Figure 2). For the measurements obtained at 1.6 and 4.1 cfs, the difference between the measured flow and the calculated flow was greater than the total error in the measurements, indicating that the flume flow was inaccurate. However, at 1.6 cfs Q_m was greater than Q_c while the opposite was true at 4.1 cfs. Given the lack of consistency in the results of the three calibration measurements, and the fact that these measurements encompassed only a limited range of the total range of flows, there is insufficient evidence to support a change to the existing rating curve for the Pack Creek gauging site.

Figure 2. Stage rating curve and measured flows at Pack Creek. Error in flume measurements (indicated by dashed lines) is ±2% and error in discharge measurements (indicated by error bars) is ±5%. Q_{75} and Q_{90} are the 75th and 90th percentile mean daily flows and Q_{max} is the highest mean daily flow.

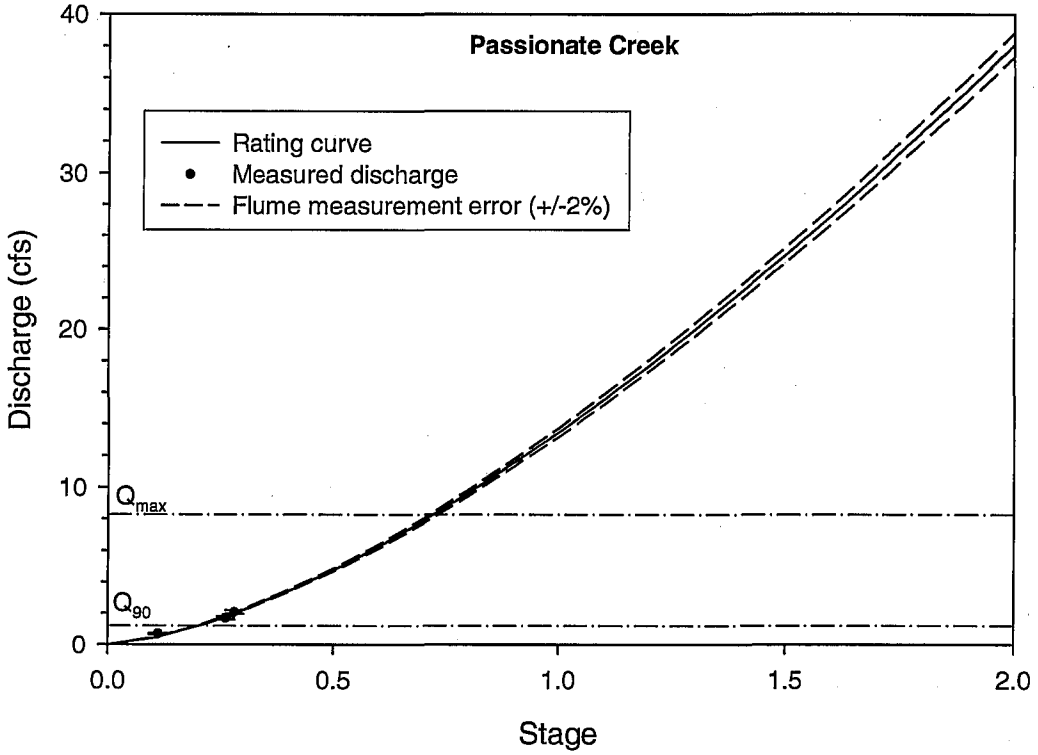
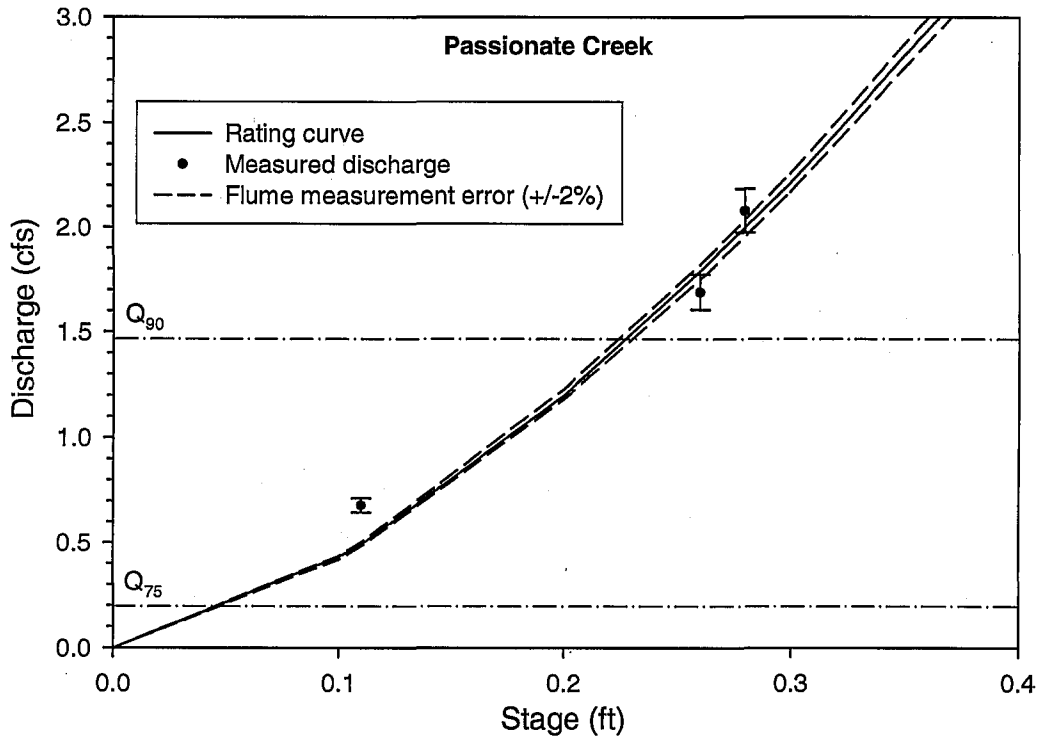
The 4-foot Cipolletti weir at the Passionate Creek gauging station is rated to 39 cfs, but the highest mean daily flow of record is just 8.40 cfs (Table 2, Appendix I). All three flow measurements at Passionate Creek were greater than the 75th percentile of mean daily flows and two of the measurements exceeded the 90th percentile (Table 2, Figure 3). Only one of the three flow measurements differed from the calculated flows by more than the total error in the measurements. We conclude that the flume at the Passionate Creek gauging site is performing properly within the range of flows included in this study and that no corrective action is required.

Figure 3. Stage rating curve and measured flows at Passionate Creek. Error in flume measurements (indicated by dashed lines) is ±2% and error in discharge measurements (indicated by error bars) is ±5%. Q_{75} and Q_{90} are the 75th and 90th percentile mean daily flows and Q_{max} is the highest mean daily flow.

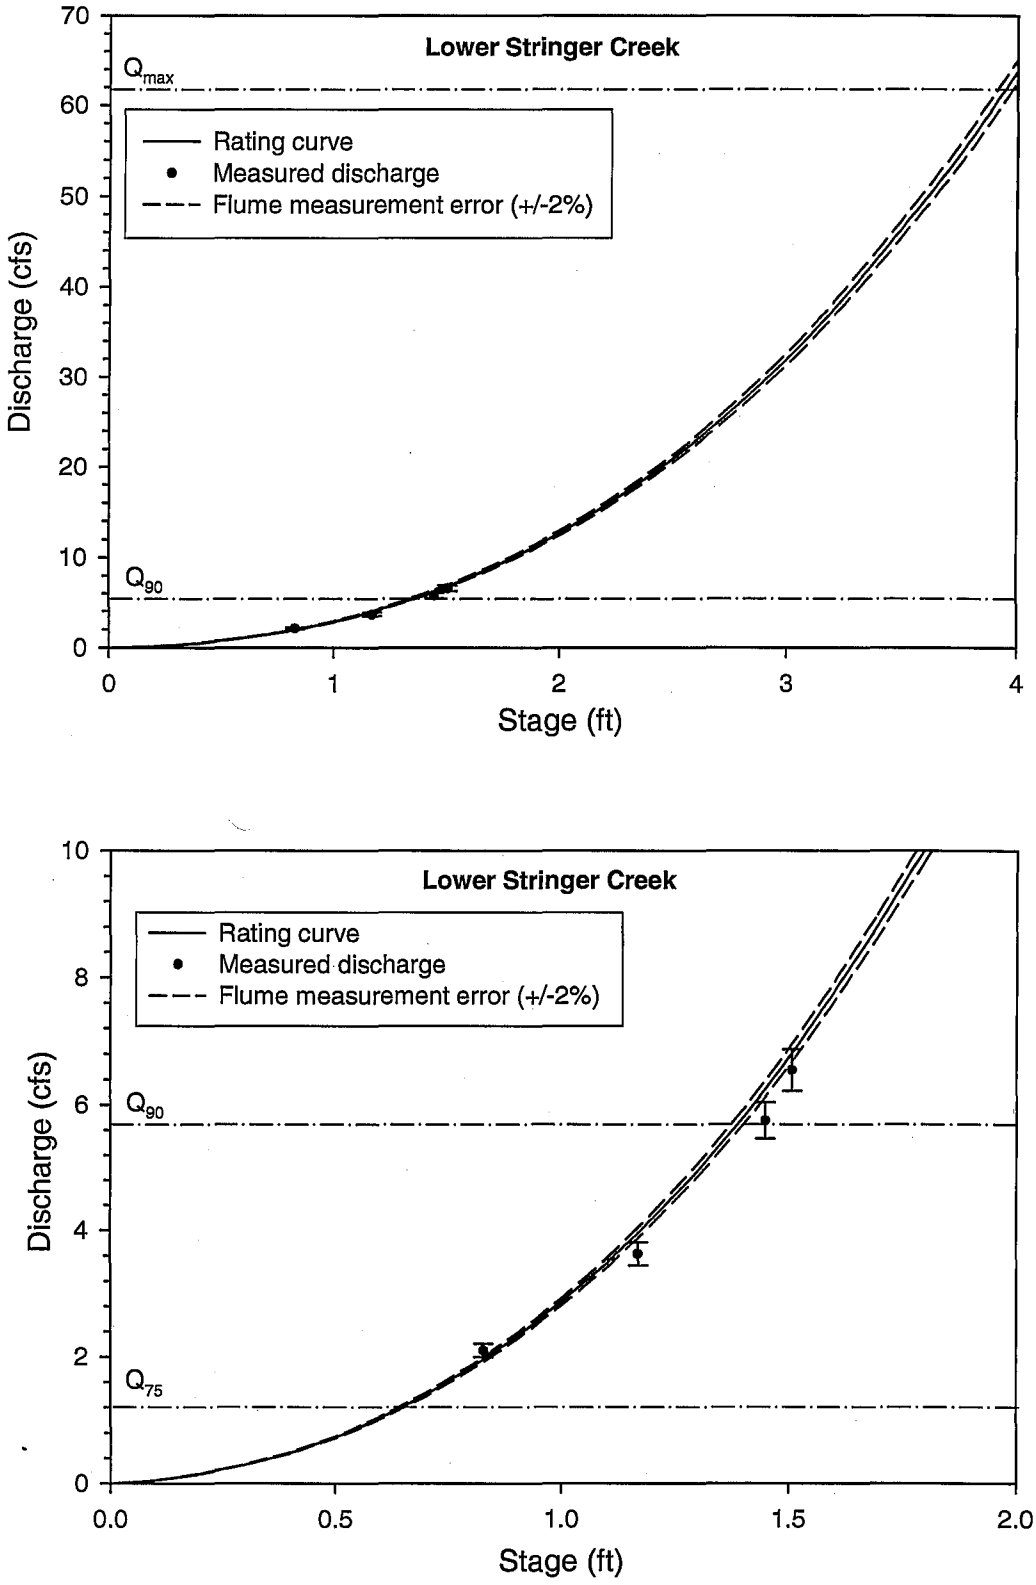
The 4-foot H flume at the Lower Stringer Creek gauging station is rated to 63.7 cfs and the highest mean daily flow of record is 61.80 cfs (Table 2, Appendix I). All four flow measurements at Lower Stringer Creek were greater than the 75th percentile of mean daily flows and two measurements exceeded the 90th percentile (Table 2, Figure 4). Two of the flow measurements differed from the calculated flows by more than the total error in the measurements and the results suggest that flows are currently being overestimated by 0.25 – 0.45 cfs when the discharge at the flume exceeds 3.5 cfs (Figure 4). An overestimate of flow in a flume may be caused by an improper flume installation, by damage to the flume following installation, by the presence of debris in the flume throat, or by inaccurate measurement and recording of the stage height in the flume. We recommend that the Lower Stringer Creek flume be examined for evidence of the cause of the inaccurate measurements. Specific points to address include 1) verifying that the flume geometry is correct, that the flume is straight and horizontal, and that the flume has not been damaged; 2) clearing debris from within or around the flume; and 3) comparing electronically recorded stage values to those observed on the flume staff plate. In the event that there is no evidence of the cause of the observed measurement discrepancy we recommend additional measurements at this flume to verify the measurements already obtained.

Figure 4. Stage rating curve and measured flows at Lower Stringer Creek. Error in flume measurements (indicated by dashed lines) is ±2% and error in discharge measurements (indicated by error bars) is ±5%. Q_{75} and Q_{90} are the 75th and 90th percentile mean daily flows and Q_{max} is the highest mean daily flow.

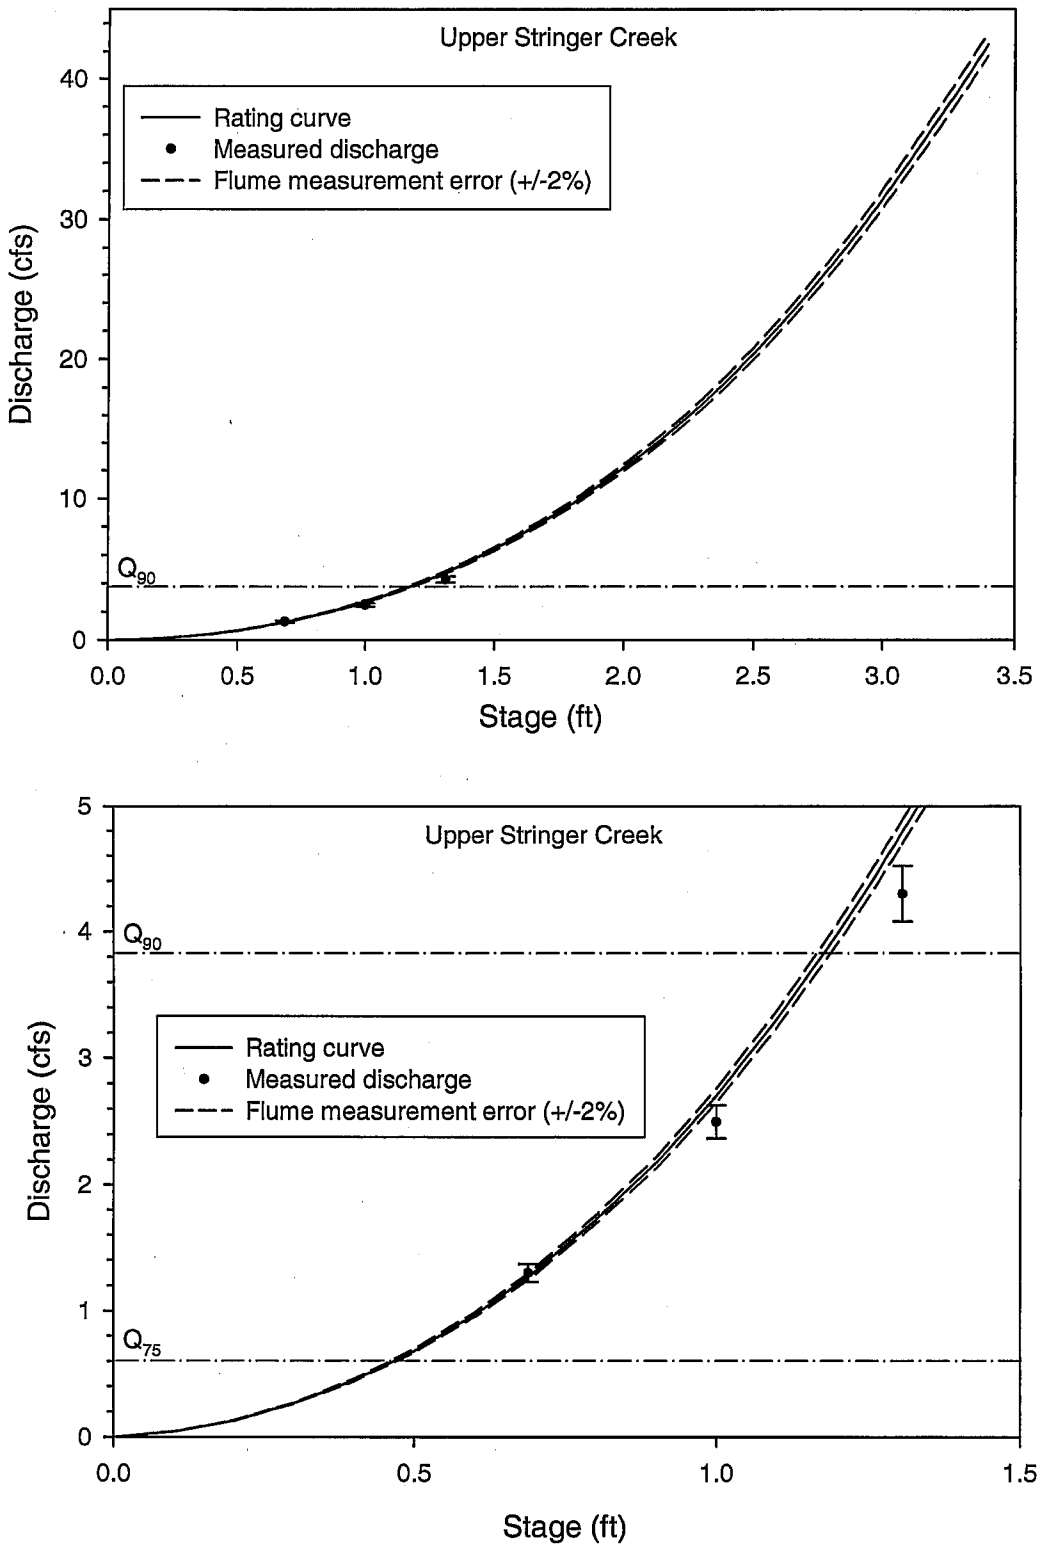
The 3.5-foot H flume at the Upper Stringer Creek gauging station is rated to 42.5 cfs, but the highest mean daily flow of record is just 26.74 cfs (Table 2, Appendix I). All three flow measurements at Upper Stringer Creek were greater than the 75th percentile of mean daily flows and one exceeded the 90th percentile (Table 2, Figure 5). Two of the flow measurements differed from the calculated flows by more than the total error in the measurements and the magnitude of the difference between the measured and calculated flow increased with increasing discharge. Similar to Lower Stringer Creek, the results suggest that flows are currently being overestimated by 0.2 – 0.5 cfs when the discharge at the flume exceeds 2.5 cfs (Figure 4). As stated previously, an overestimate of flow in a flume may be caused by an improper flume installation, by damage to the flume following installation, by the presence of debris in the flume throat, or by inaccurate measurement and recording of the stage height in the flume. We recommend that the Upper Stringer Creek flume be examined for evidence of the cause of the inaccurate measurements. The same issues should be addressed at this flume as were previously discussed for the Lower Stringer Creek flume.

Figure 5. Stage rating curve and measured flows at Upper Stringer Creek. Error in flume measurements (indicated by dashed lines) is ±2% and error in discharge measurements (indicated by error bars) is ±5%. Q_{75} and Q_{90} are the 75th and 90th percentile mean daily flows and Q_{max} is the highest mean daily flow.

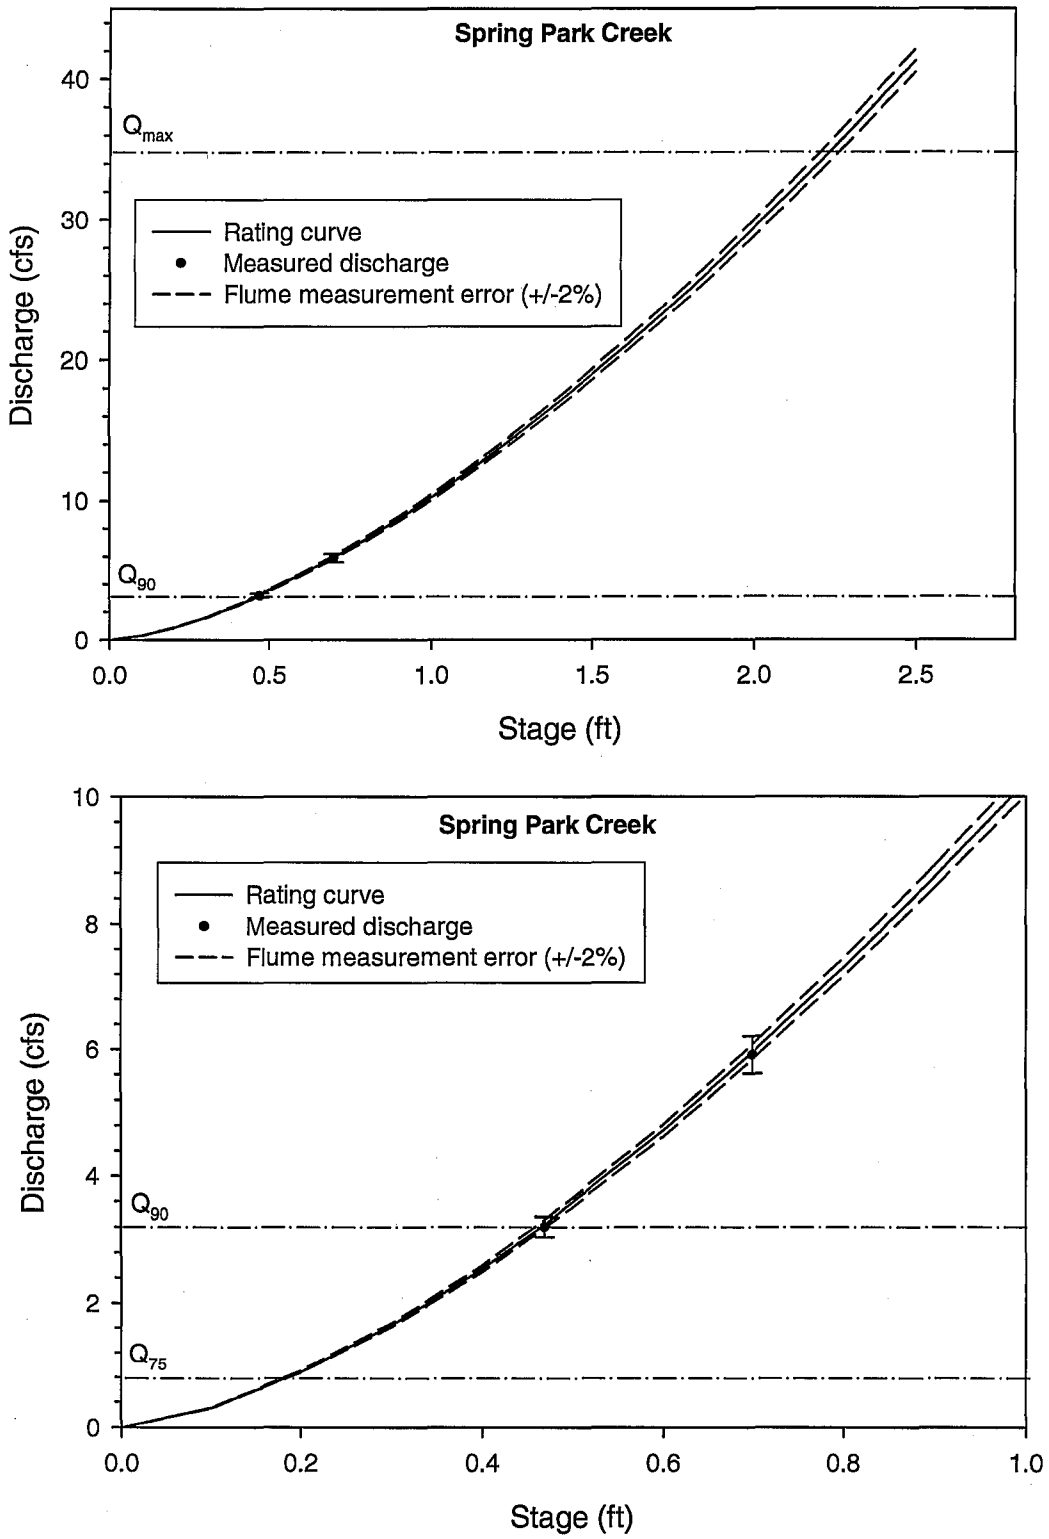
The highest mean daily flow of record at the 2.5-foot Parshall flume at the Spring Park Creek gauging station is 34.9 cfs, 83% of the maximum range of 41.7 cfs (Table 2). Only two measurements were obtained at Spring Park Creek, and neither differed from the calculated flow by more than the total error in the measurements (Figure 6). We therefore conclude that the flume at the Spring Park Creek gauging site is performing properly within the range of flows included in this study and that no corrective action is required.

Figure 6. Stage rating curve and measured flows at Spring Park Creek. Error in flume measurements (indicated by dashed lines) is ±2% and error in discharge measurements (indicated by error bars) is ±5%. Q_{75} and Q_{90} are the 75th and 90th percentile mean daily flows and Q_{max} is the highest mean daily flow.

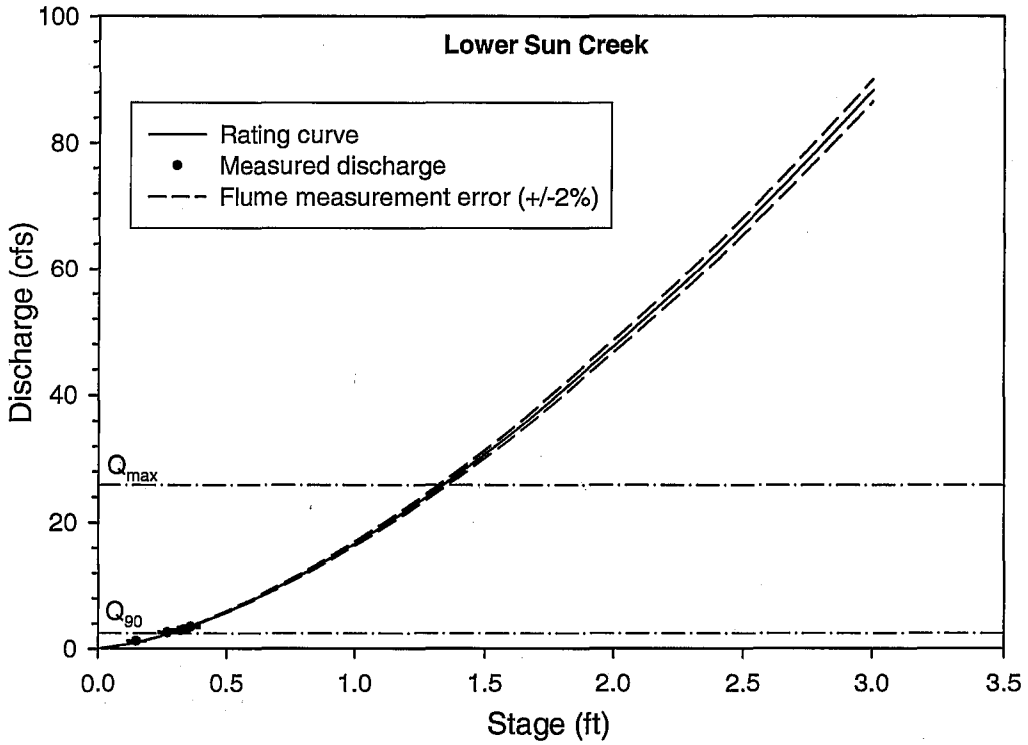
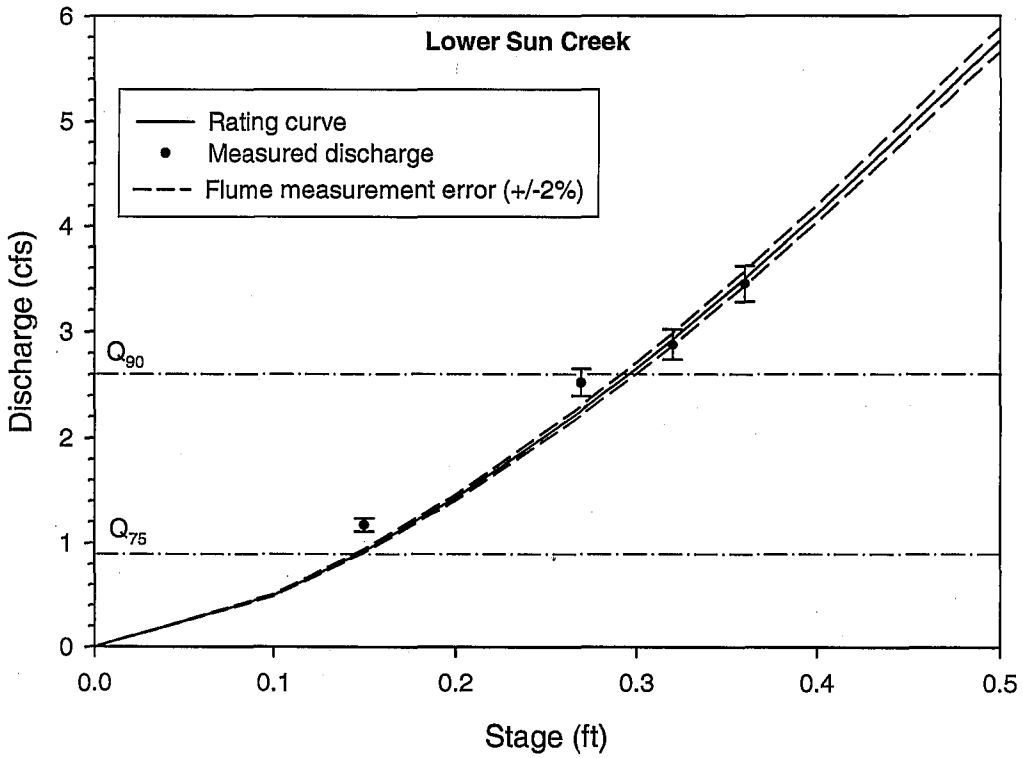
The 4-foot Parshall flume at the Lower Sun Creek gauging station is rated to 90.6 cfs, but the highest mean daily flow of record is just 26.30 cfs (Table 2, Appendix I). All four flow measurements at Lower Sun Creek were greater than the 75th percentile of mean daily flows and two exceeded the 90th percentile (Table 2, Figure 7). The two lowest flow measurements, 2.52 and 1.17 cfs, exceeded the calculated flows by more than the total error in the measurements, indicating that flows are currently being under-estimated (Figure 7). We also note that, historically, the mean daily flows at Lower Sun Creek at baseflow have often been less than the corresponding flows at Upper Sun Creek (Figure 8). Given the confined nature of Sun Creek in its upper reaches, it is highly likely that the stream is gaining between the two gauging stations, so that base flows at Lower Sun Creek should be higher than those at Upper Sun Creek. The apparent underestimate of low flows at Lower Sun Creek could indicate that water is leaking around the flume. We recommend that the site be checked for leaks around or under the flume structure. In addition, the flume installation should be checked for evidence of improper installation or damage, and the recorded stage values should be checked against direct observations of the stage on the flume staff plate.

Figure 7. Stage rating curve and measured flows at Lower Sun Creek. Error in flume measurements (indicated by dashed lines) is ±2% and error in discharge measurements (indicated by error bars) is ±5%. Q_{75} and Q_{90} are the 75th and 90th percentile mean daily flows and Q_{max} is the highest mean daily flow.

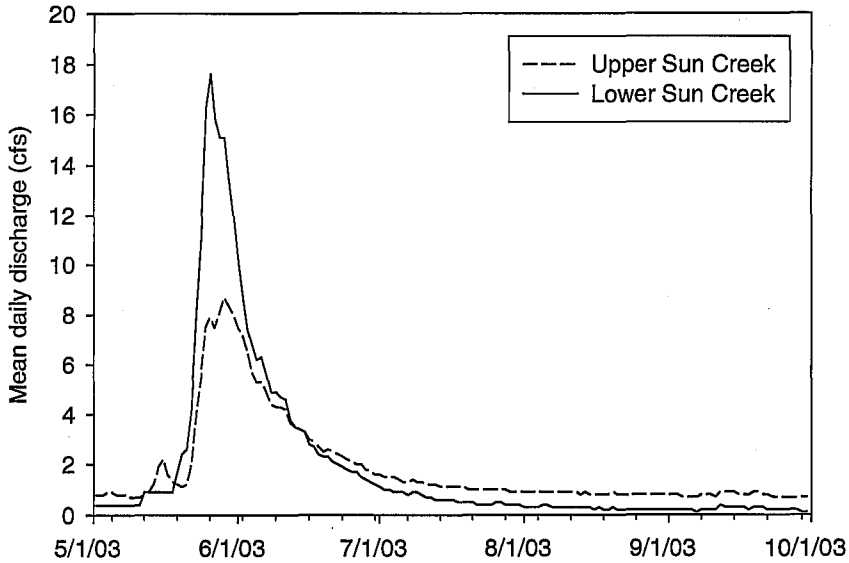
Figure 8. Mean daily discharge at Upper and Lower Sun Creek gauging sites, 1 May – 30 September 2003.

The cross section at the Upper Sun Creek gauging station is rated to 5.67 cfs, 35% less than the highest daily mean flow of record of 8.70 cfs (Table 2, Appendix I). All three flow measurements at Upper Sun Creek were greater than the 75th percentile of mean daily flows and two exceeded the 90th percentile (Table 2, Figure 9). In all three cases the difference between the measured and calculated flows exceeded the total error in the measurements. In all three cases the measured values were lower than the calculated values, indicating that flows are currently being overestimated by 0.5 to 1.0 cfs. Overestimation of

flows at the Upper Sun Creek site most likely reflects a change in the geometry of the cross sectional profile since the site was installed. Such changes are fairly common in uncontrolled stream cross sections. Given the limited range of values over which flows were measured (2.63 to 3.61 cfs) it is not possible to determine a new rating equation for the entire range of flows that occur at this site. We recommend obtaining additional flow measurements in the 0 to 1cfs and 4.5 to 6 cfs ranges, after which a new rating curve should be developed.

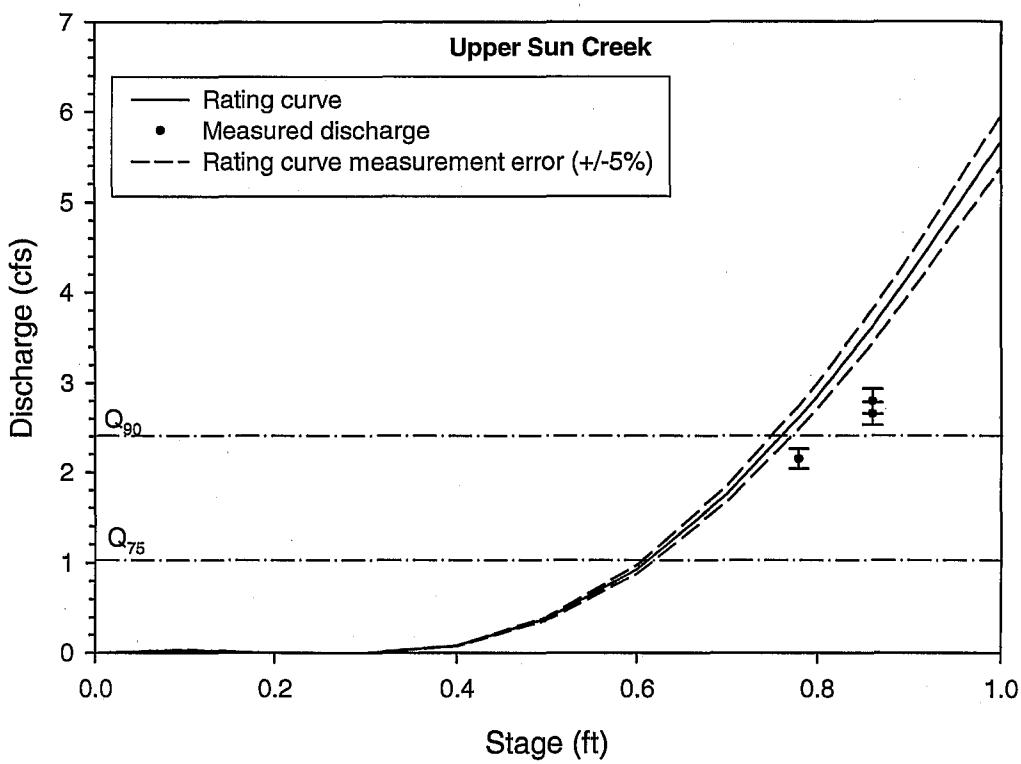
Figure 9. Stage rating curve and measured flows at Upper Sun Creek. Error in cross section rating curve (indicated by dashed lines) is ±5% and error in discharge measurements (indicated by error bars) is ±5%. Q_{75} and Q_{90} are the 75th and 90th percentile mean daily flows.

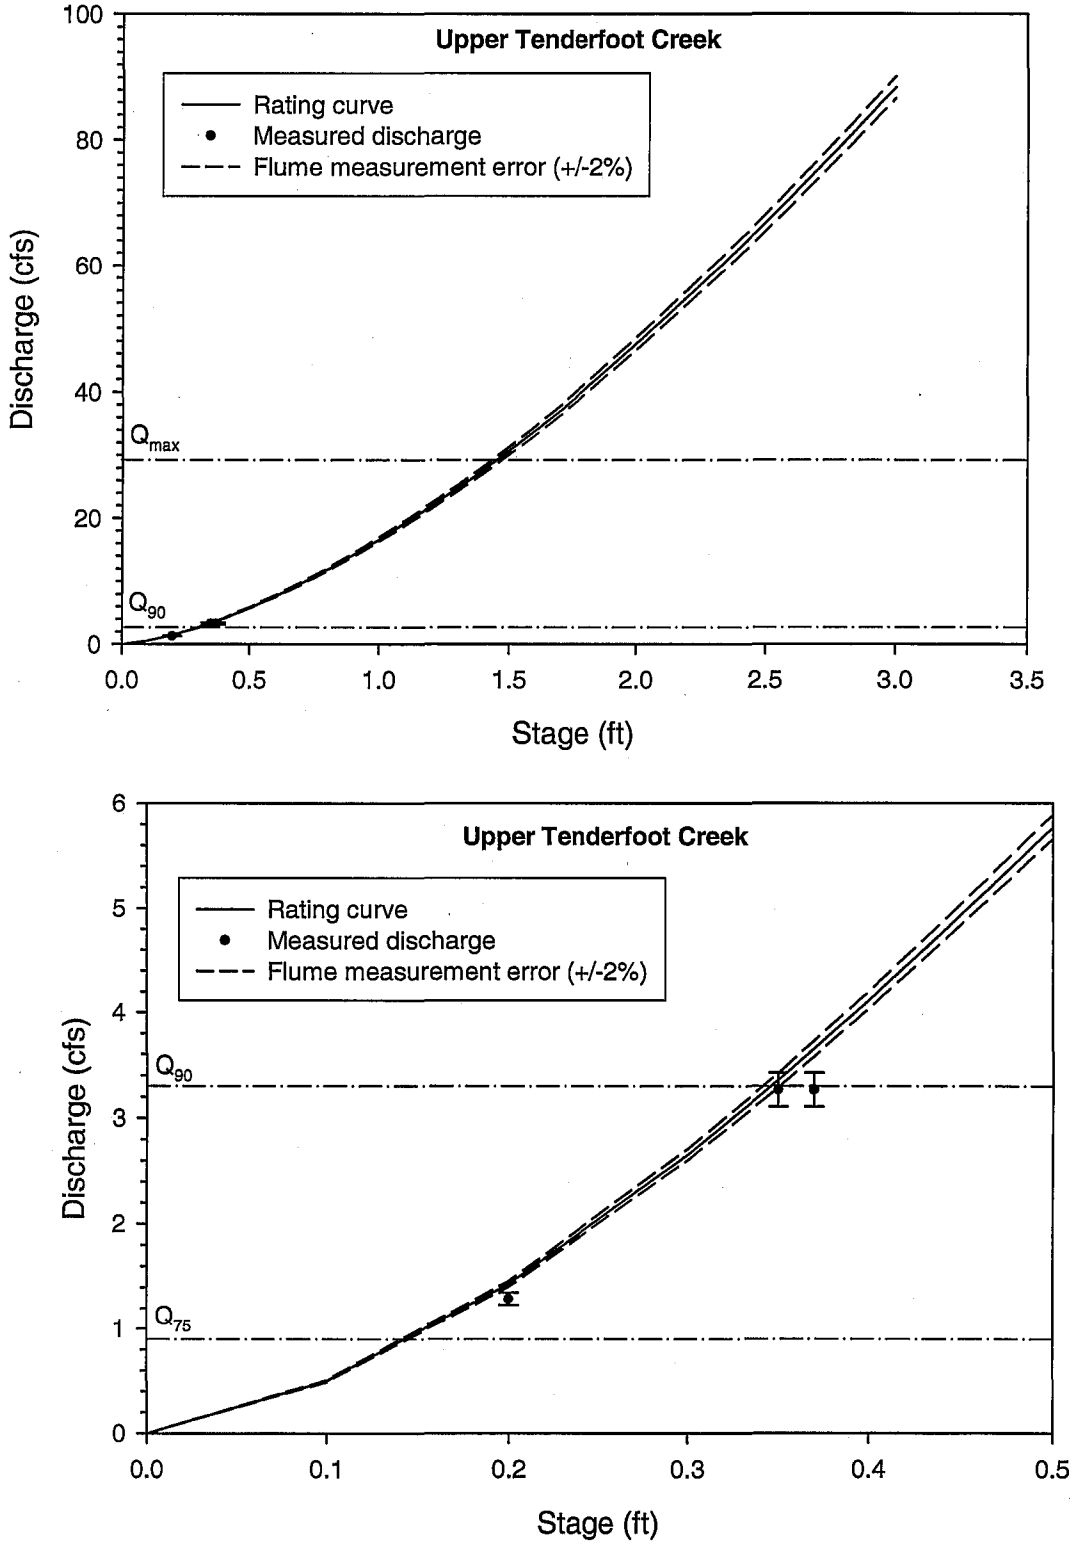
The 4-foot Parshall flume at the Upper Tenderfoot Creek gauging station is rated to 90.6 cfs, but the highest mean daily flow of record is just 29.70 cfs (Table 2, Appendix I). All three flow measurements at Lower Sun Creek were greater than the 75th percentile of mean daily flows but none exceeded the 90th percentile (Table 2, Figure 11). Two of the three measurements differed from the calculated flow by more than the total error in the measurements, indicating that flows are currently being overestimated by 0.1 to 0.3 cfs when flows are in the 1 to 4 cfs range. As stated previously, an overestimate of flow in a flume may be caused by an improper flume installation, by damage to the flume following installation, by the presence of debris in the flume throat, or by inaccurate measurement and recording of the stage height in the flume. We recommend that the Upper Tenderfoot Creek flume be examined for evidence of the cause of the inaccurate measurements. The same issues should be addressed at this flume as were previously discussed for the Lower Stringer Creek flume.

Figure 11. Stage rating curve and measured flows at Upper Tenderfoot Creek. Error in flume measurements (indicated by dashed lines) is ±2% and error in discharge measurements (indicated by error bars) is ±5%. Q_{75} and Q_{90} are the 75th and 90th percentile mean daily flows and Q_{max} is the highest mean daily flow.

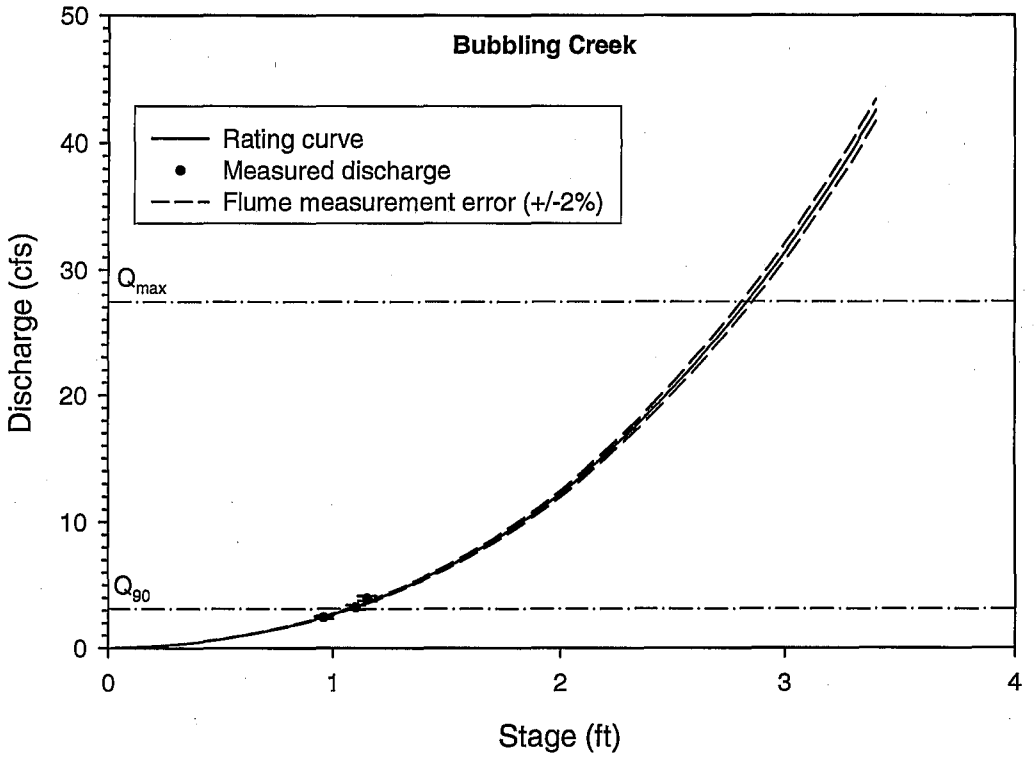
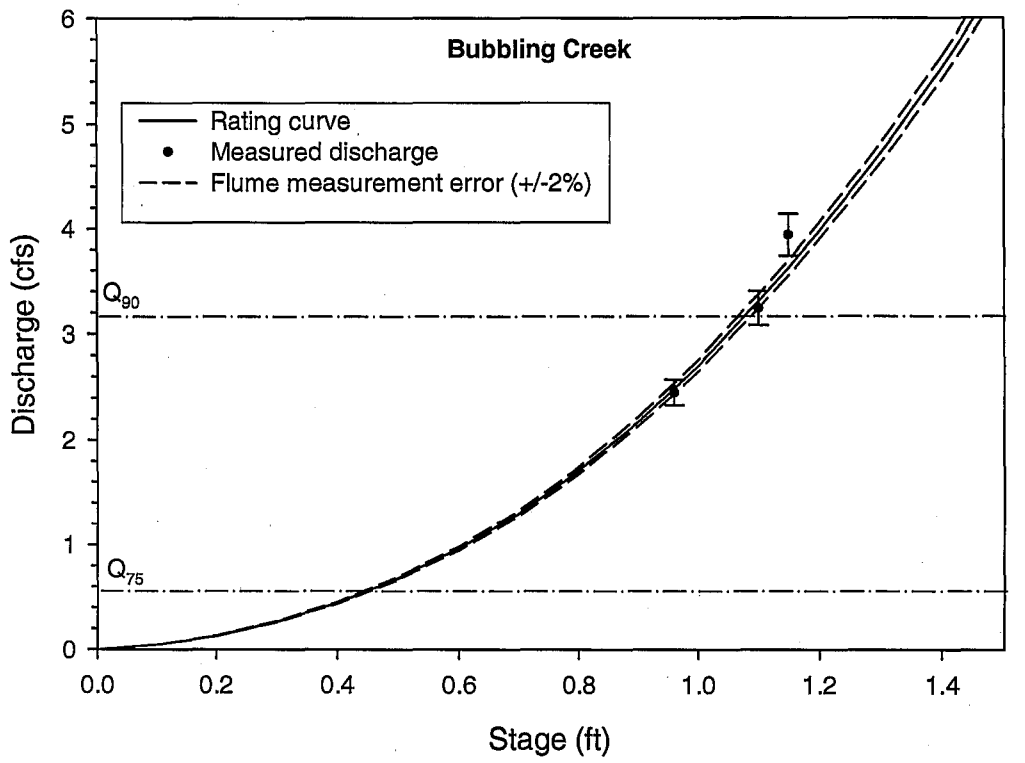
The 3.5 foot H flume at Bubbling Creek is rated to 42.5 cfs, but the highest mean daily flow of record is just 27.3 cfs (Table 2, Appendix I). All three measurements exceeded

the 75th percentile of mean daily flows and two exceeded the 90th percentile (Figure 12). Only the highest measurement differed from the calculated flow by more than the total error in the measurement. We conclude that the flume at the Bubbling Creek gauging site is performing properly within the range of flows included in this study and that no corrective action is presently required.

Figure 12. Stage rating curve and measured flows at Bubbling Creek. Error in flume measurements (indicated by dashed lines) is ±2% and error in discharge measurements (indicated by error bars) is ±5%. Q_{75} and Q_{90} are the 75th and 90th percentile mean daily flows and Q_{max} is the highest mean daily flow.

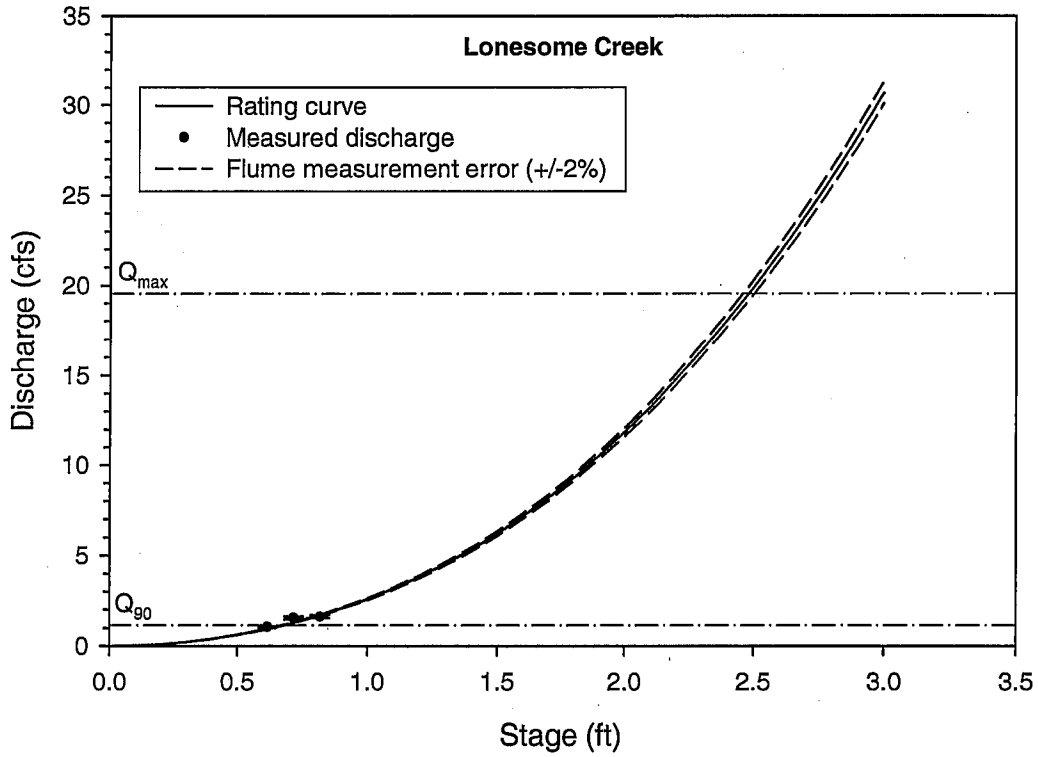
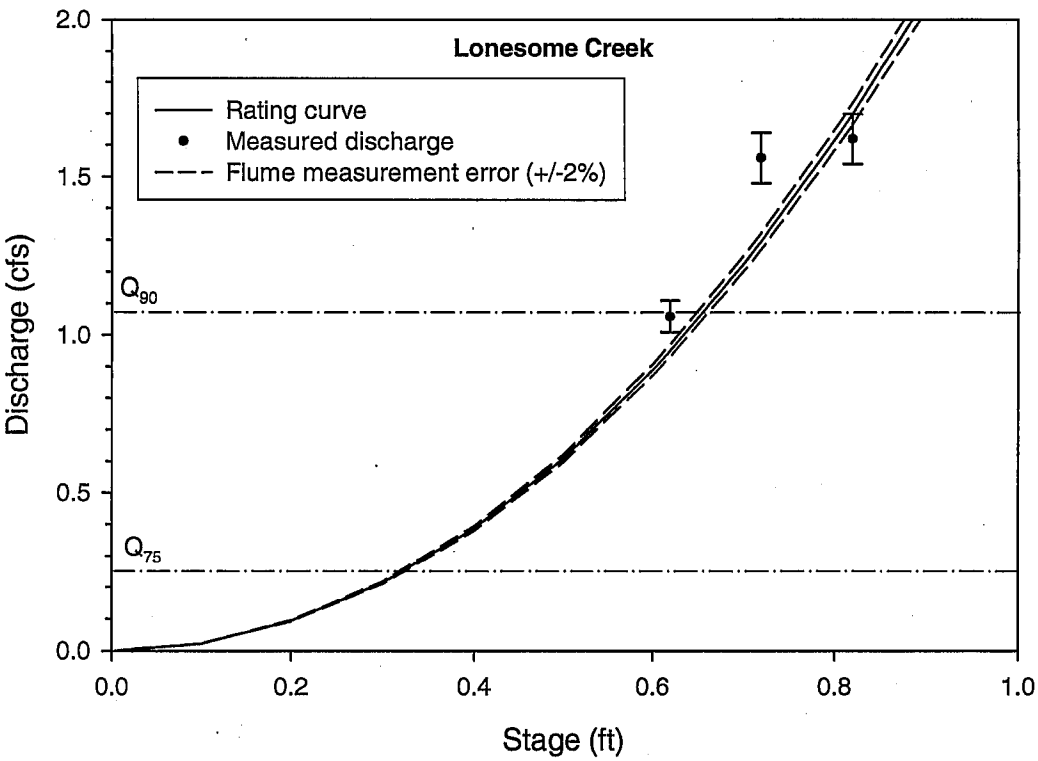
The 3-foot H flume at Lonesome Creek is rated to 30.7 cfs, although the highest flow of record is just 19.6 cfs (Table 2, Appendix I). All three measurements exceeded the 75th percentile of mean daily flows and two exceeded the 90th percentile (Figure 13). Two measurements differed from the calculated flow by more than the total error in the measurements, and both indicated that the actual flow was higher than the flow calculated from the flume rating curve. However the third measurement, conducted at a similar flow to the second highest measurement, did not indicate a discrepancy. Given the lack of consistency in the results of the three calibration measurements, and the fact that these measurements encompassed only a limited range of the total range of flows, there is insufficient evidence to support a change to the existing rating curve for the Lonesome Creek gauging site.

Figure 13. Stage rating curve and measured flows at Lonesome Creek. Error in flume measurements (indicated by dashed lines) is ±2% and error in discharge measurements (indicated by error bars) is ±5%. Q_{75} and Q_{90} are the 75th and 90th percentile mean daily flows and Q_{max} is the highest mean daily flow.
