## Turbidity Changes During Culvert to Bridge Upgrades at Carmen Creek, Idaho

Randy B. Foltz<sup>1</sup>, Breann Westfall<sup>2</sup>, and Ben Kopyscianski<sup>3</sup>

**Abstract:** *Carmen Creek, a tributary to the Salmon River in Idaho, was the site of two culvert to bridge upgrade operations in September and October 2011. Both locations were upgraded from multiple, large diameter culverts to bridge crossings. Turbidity readings measured at the end of the mixing zone during the nearly three weeks of upgrade construction activities did not exceed the Idaho state instantaneous criteria of 50 NTU above the background. The sediment mitigation measures of diverting the creek around the road crossing and temporary in-creek dams were effective in keeping the turbidity values within state regulatory requirements.*

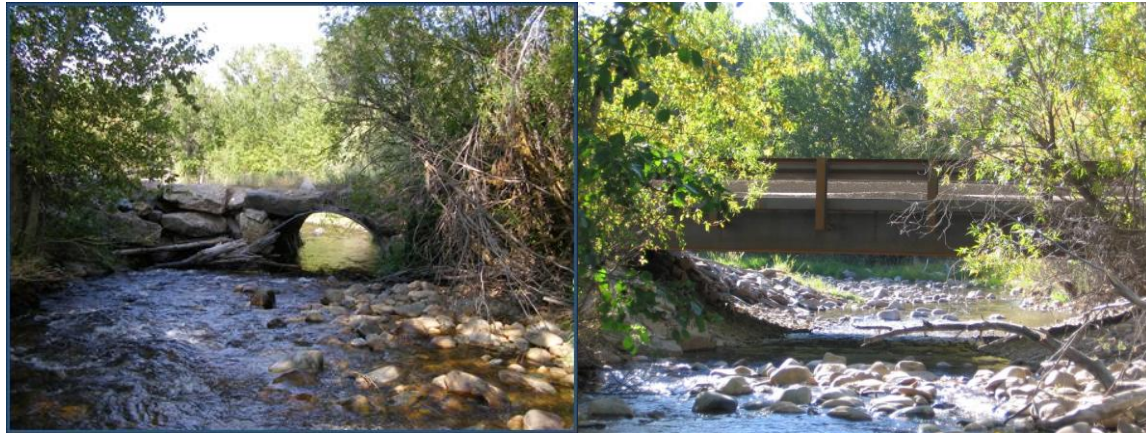
Figure 2 - Parmenter Lane road crossing before and after culvert to bridge replacement.

Between September 14 and 27, 2011 the Parmenter Lane road crossing was upgraded from multiple 6 and 7 foot diameter CMP culverts to a pre-fabricated steel bridge 24 feet wide and 50 feet in length. Between October 4 and 13, 2011 the Archie Lane road crossing was upgraded from multiple 6 and 7 foot diameter CMP culverts to a pre-fabricated steel bridge, 16 feet wide and 45 feet in length. Before and after photographs are shown in Figures 2 and 3.

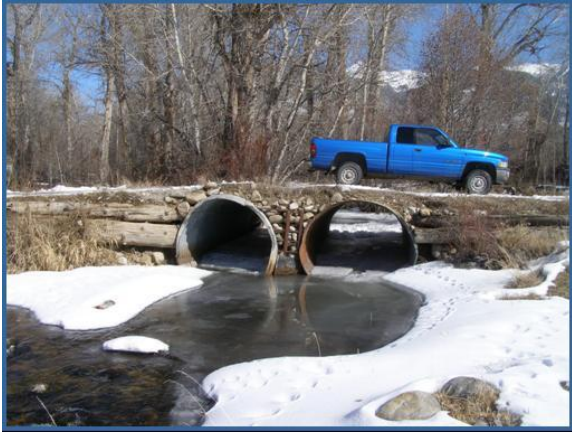
Figure 3 - Archie Lane road crossing before culvert to bridge replacement. Bridge here similar to Parmenter Lane.

Culverts at some road crossings were barriers to fish migration, preventing fish passage above the culvert during low flows. During spring run-off, large woody debris was continually pinned against the culverts, allowing large amounts of debris to catch in the culvert and create a barrier for aquatic species. Parmenter Lane, Figure 2, and Archie Lane, Figure 3, were two of these fish barrier road-stream crossings.

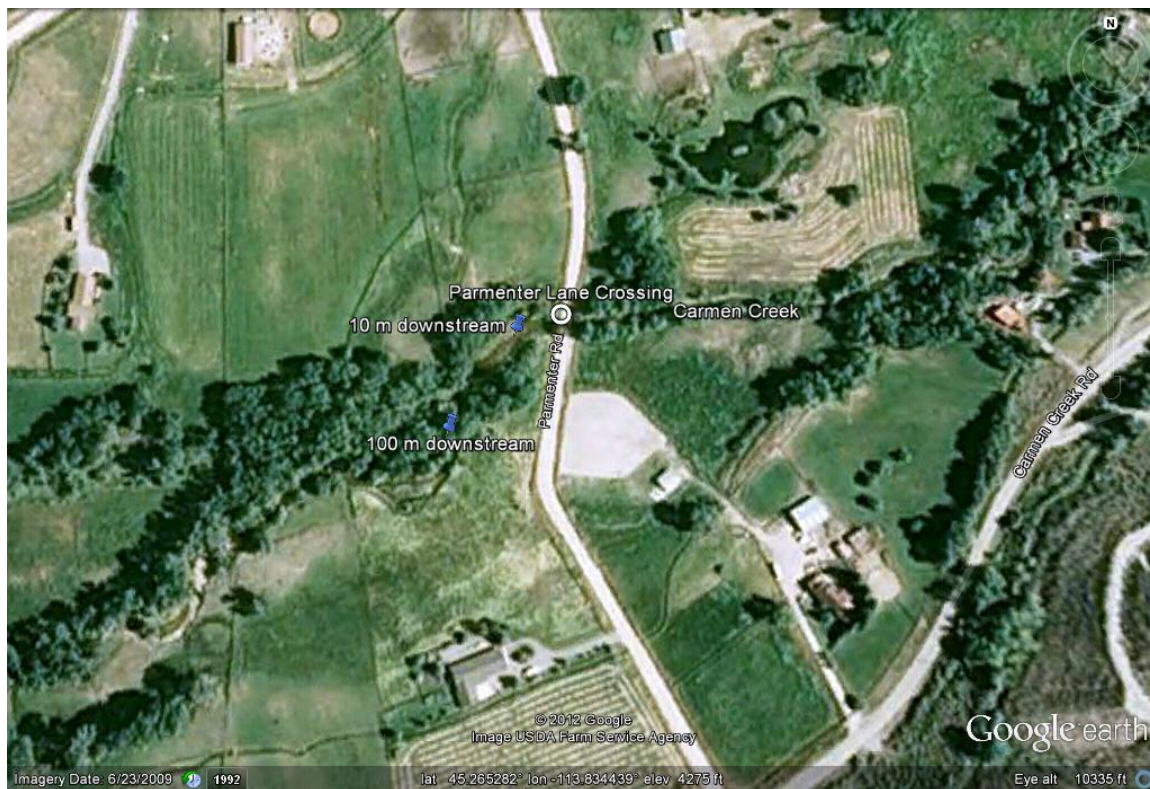
Figure 5 - Sampling locations at Parmenter Lane Crossing.

Turbidity measurements were made using two HANNA HI 93703 Turbidity Meters. Both meters were calibrated with zero and 10 NTU standard solutions. A turbidity sample was taken above the upper temporary diversion dam at the beginning and again at the end of each work day to establish the background turbidity. A second sampling point was located 10 m downstream of the bypass culvert outlet. This point was representative of the maximum turbidity immediately downstream of the construction activity. A third sampling point was located 100 m downstream of the bypass culvert outlet. This point was chosen with the expectation that it was near the end of the mixing zone. Inspection of the sediment plume during construction activities verified that it satisfied the “end of mixing zone” requirement. Location of the three sampling points is indicated in Figure 5. Samples were taken in 10 ml cuvetts at a depth of 6 inches in the center of the channel. Turbidity readings were taken immediately after sampling.
