# Stream Channel Designs for Riparian and Wet Meadow Rangelands in the Southwestern United States

Roy Jemison<sup>1</sup> and Daniel G. Neary<sup>2</sup>

**Abstract.**—Inappropriate land uses have degraded wetland and riparian ecosystems throughout the Southwestern United States. In 1996, the Cibola National Forest in New Mexico implemented a channel relocation project, as part of a road improvement project, to determine the feasibility of restoring wet meadow and riparian ecosystems degraded by inappropriately located roads and drainage structures. Results show that channel relocation can provide the hydrologic inputs needed to restore these degraded ecosystems.

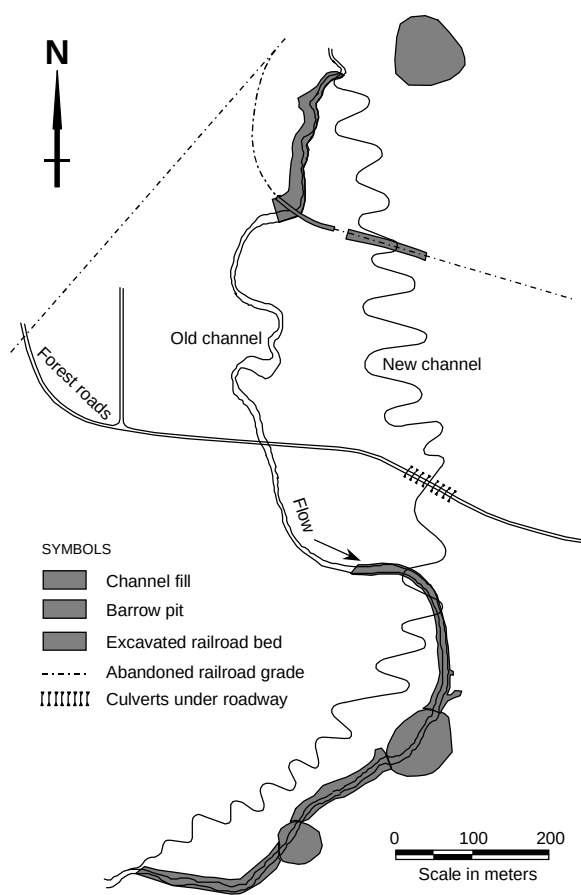
Figure 1. Layout of the Agua Fria channel reconstruction site.

The Cibola National Forest in New Mexico implemented the Agua Fria riparian meadow reestablishment project as part of a forest road improvement program in 1995 (Jemison et al. 1997). An assessment of the impacts of the old road on meadow ecosystem suggested that construction of the roadbeds altered the hydrologic conditions of the meadow surface where they were crossed. Before the project, an entrenched channel ran lengthwise down one side of the meadow passing below the road through a cement bridge, then diverting to the other side of the meadow (figure 1). Steps taken to implement the project included removal and earth fill of the bridge crossing; earth fill of the old channel in areas where it could be flooded by overland flow from the new channel; construction of a shallow, sinuous channel down the center of the meadow with a broad floodplain on each side; and installation of rock weirs at the beginning and end of each bend in the channel to create a step pool sequence.
