Research  
Note  
FPL-RN-0329

# USDA Forest Products Laboratory's Debris Launcher

James J. Bridwell  
Robert J. Ross  
Zhiyong Cai  
David E. Kretschmann

## Abstract

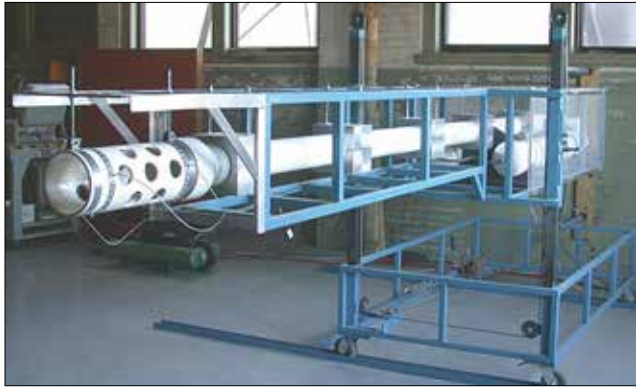
**Figure 3. Debris launcher housed in the mobile firing platform.**

As part of their ongoing efforts to improve safe room design, researchers at the U.S. Forest Service, Forest Products Laboratory (FPL), conducted performance tests on a series of materials and wall designs that might be used in the construction of safe rooms. These tests were performed using a specially designed debris launcher that meets ICC-500 criteria of launching 2-in. by 4-in. lumber missiles at speeds of approximately 100 miles per hour (Fig. 3).

The barrel of the debris launcher is made from a 150-in. long piece of 4-in.-diameter schedule 40 PVC pipe, which when housed in the mobile firing platform (Fig. 3), is supported every 24 in. by an aluminum block that is attached to the frame. These supports limit recoil and ensure accurate placement of the missile on the test target. Prior to firing,

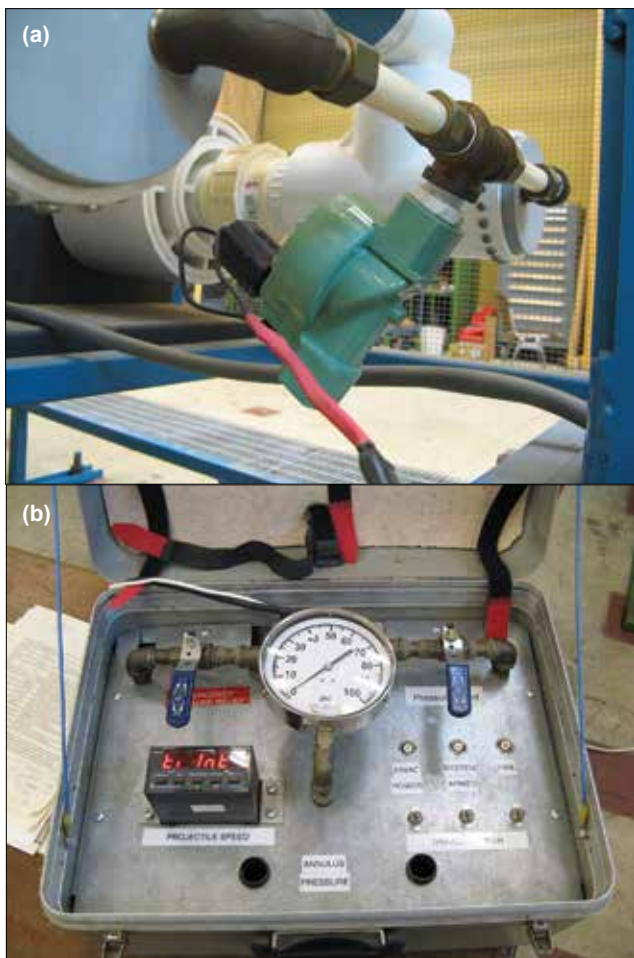
**Figure 5. Debris launcher's (a) control valve and (b) instrument panel.**

The pressure tanks are made of 52-in. long, 6-in. diameter schedule 40 PVC pipe and house the air needed to propel the missile to the target panel. The tanks are connected to the barrel by means of an electric solenoid control valve system (Fig. 5a). The control valve is a modified sprinkler valve that, via the instrument panel (Fig. 5b), allows the operator to remotely regulate air pressure in the tanks to ensure safety during testing.

Besides computing missile velocity, the instrument panel also serves as the control center for FPL's debris launcher. It enables the operator to route air to the pressure tanks, monitor tank air pressure, and activate the control valve to fire each missile all while maintaining a safe distance from any possible safety concern.

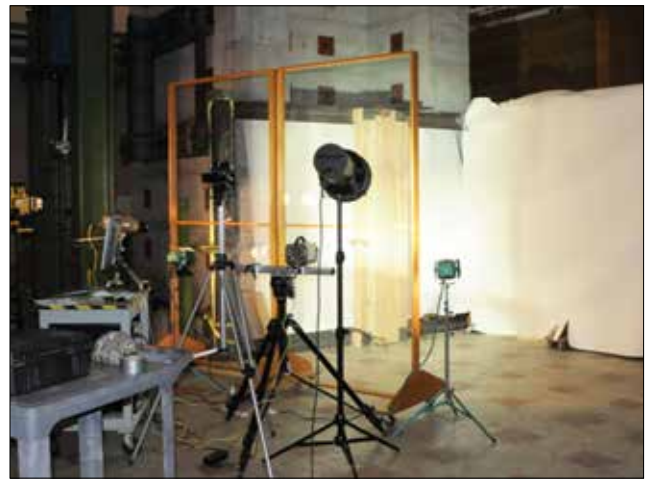
Figure 8. Configuration 4—CLT panel with high-speed photography.

Along with a variety of materials tested, there were four main configurations of panels. In the first configuration, panels were mounted to the front of a 6-in.-deep laminated lumber wall so that the missile impacted the panel first. In the second configuration, panels were mounted to the rear of the wall so that the missile struck the wall first. In the third configuration, panels were attached to a partially sheathed 2-in. by 4-in. stud frame, which itself was mounted to the wall (Fig. 7). The fourth configuration had the panel mounted to a steel frame in front of a laminated lumber backstop (Fig. 8).

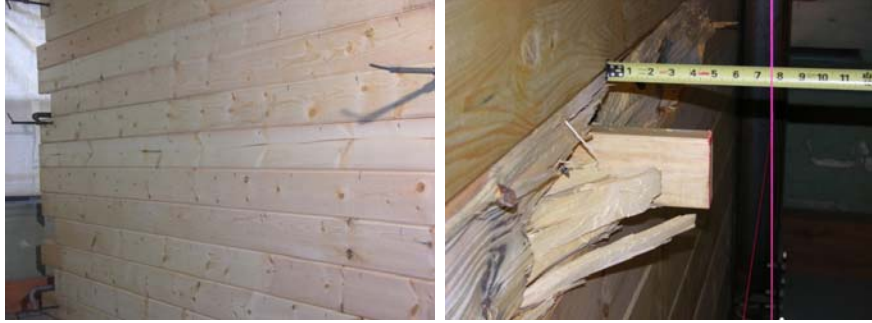
| Test No. | Panel description | Wall/support frame | Panel location | Missile speed (mph) | Damage description |
|---|---|---|---|---|---|
| 1 | No panel<br>(The first missile was launched at the wall only.) | Wall only | Front | 104 | Full perforation, with 5-in. protrusion out of the back of the wall section. Wood shards airborne on impact. |

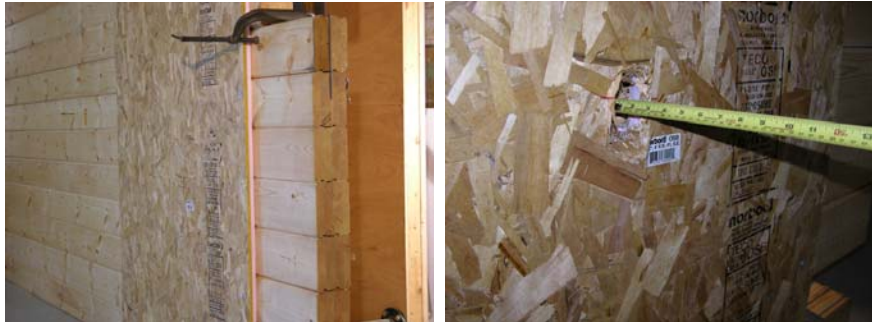
| Test No. | Panel description | Wall/support frame | Panel location | Missile speed (mph) | Damage description |
|---|---|---|---|---|---|
| 2 | Layer 1: ½-in. oriented strandboard (OSB)<br>Layer 2: 1-in. foam insulation<br>Mounted to the wall with nails every 6 in. on the perimeter. | Wall only | Front | 102 | 2-in. indentation in OSB, insulation, and face of the wall. The rear of the wall cracked and showed about 2-in. deformation. Wood shards airborne on impact. |

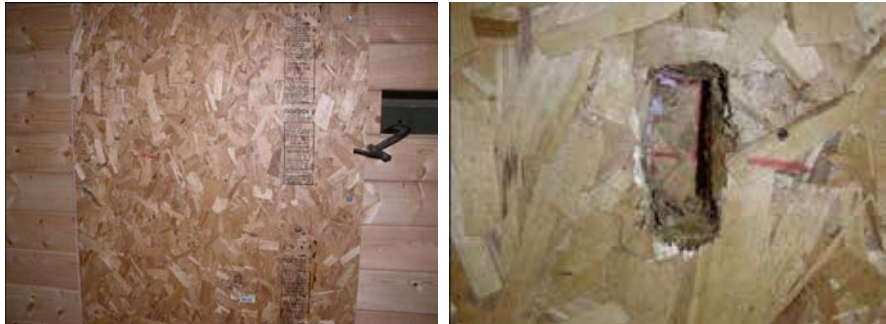
| Test No. | Panel description | Wall/support frame | Panel location | Missile speed (mph) | Damage description |
|---|---|---|---|---|---|
| 3 | Layer 1: ½-in. OSB<br>Layer 2: 1-in. foam insulation<br>Layer 3: ½-in. wire mesh<br>Mounted to the wall with nails every 6 in. on the perimeter. | Wall only | Front | 104 | 2-in. indentation in OSB, insulation and face of the wall. The rear of the wall was cracked. |

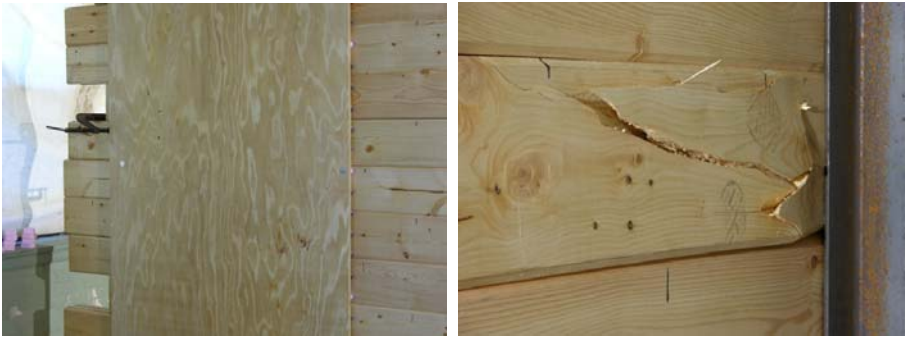
| Test No. | Panel description | Wall/support frame | Panel location | Missile speed (mph) | Damage description |
|---|---|---|---|---|---|
| 4 | Layer 1: ½-in. plywood panel<br>Layer 2: 1-in. foam insulation standoffs inside the squares of a chain link fence<br>Mounted to the wall with nails every 6 in. on the perimeter. | Wall only | Front | 87 | The missile pushed in the chain link and made a 2-in. indentation on the face of the wall. The rear of the wall was cracked and showed about a 2-in. deflection. Wood shards airborne on impact. |

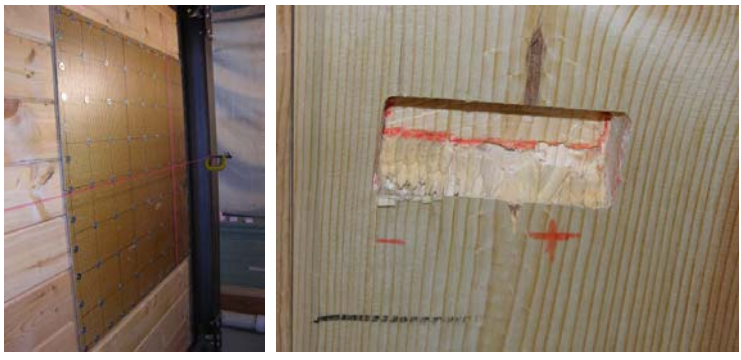
| Test No. | Panel description | Wall/support frame | Panel location | Missile speed (mph) | Damage description |
|---|---|---|---|---|---|
| 5 | 4-in. by 4-in. by ¼-in. ballistic fiber-coated hardboard.<br>Mounted to the wall with 2-1/2-in. deck screws and 1-in. fender washers spaced at 4 in. on the perimeter and 6 in. in the interior. | Wall only | Rear | 103 | The missile caused a 2-in. indentation in the front of the wall, but there was no deflection at the rear. The ballistic panel appeared undamaged. No debris; some screws loosened. |

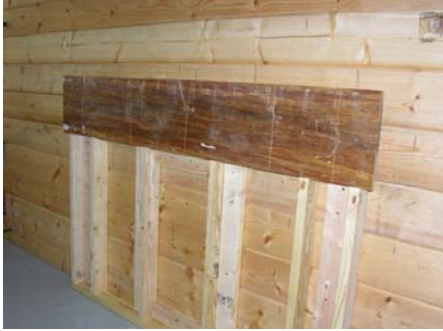
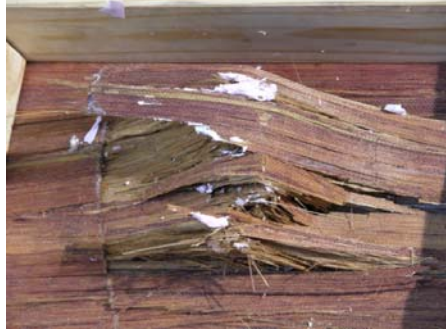
| Test no. | Panel description | Wall/support frame | Panel location | Missile speed (mph) | Damage description |
|---|---|---|---|---|---|
| 7 | 1-in. by 12-in. by 48-in. bamboo panel.<br>Mounted to the support frame with screws to all support studs. | 16-in. on-center (OC) wall frame with 2-1/2 in. of foam insulation in the void. | Front | 103 | The missile bounced off the panel but made an indentation in the face of the wall. No damage was seen on the rear of the wall. |

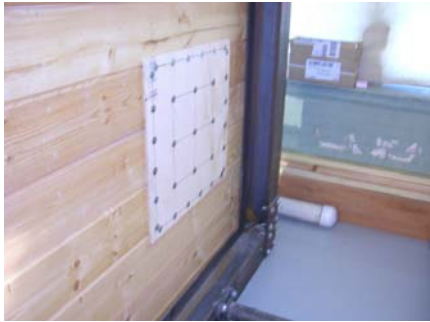
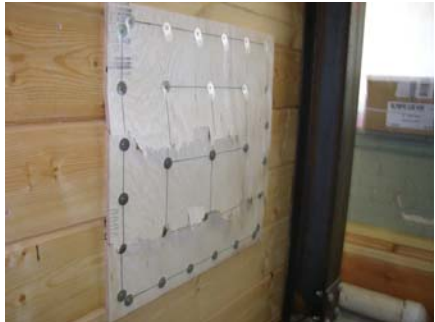
| Test no. | Panel description | Wall/support frame | Panel location | Missile speed (mph) | Damage description |
|---|---|---|---|---|---|
| 9 | 2-ft by 2 ft by 1/2-in. plywood panel.<br>Mounted to the wall with 2-1/2-in. deck screws and fender washers spaced at 4 in. on the perimeter and 6 in. in the interior. | Wall only | Rear | 104 | The missile caused a 2-in. indentation in the face of the wall. Cracks were present in the plywood panel. The rear of the wall had 1 in. or less deflection. No debris; some screws loosened. |

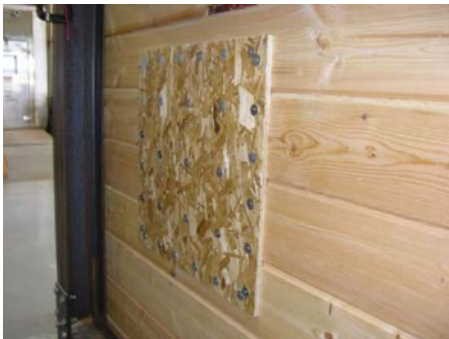
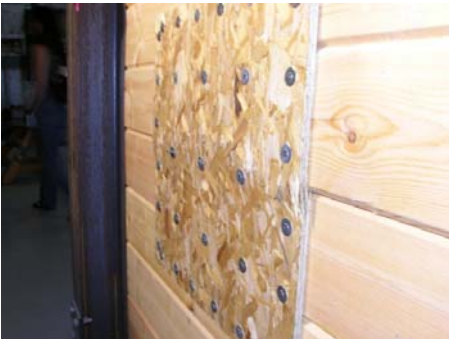
| Test no. | Panel description | Wall/support frame | Panel location | Missile speed (mph) | Damage description |
|---|---|---|---|---|---|
| 10 | 2-ft by 2-ft by ½-in. OSB panel. Mounted to the wall with 2-1/2-in. deck screws and fender washers spaced at 4 in on the perimeter and 6 in. in the interior. | Wall only | Rear | 105 | The missile caused a 2-in. indentation in the face of the wall. Cracks were present in the OSB panel. The rear of the wall had 1 in. or less deflection. No debris; some screws loosened. |

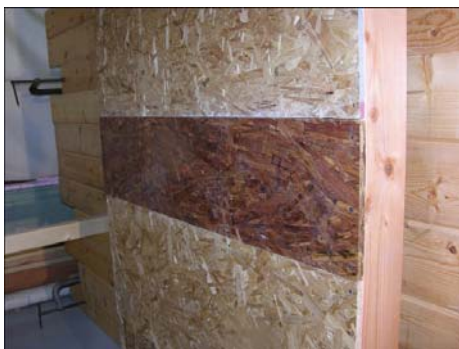
| Test no. | Panel description | Wall/support frame | Panel location | Missile speed (mph) | Damage description |
|---|---|---|---|---|---|
| 11 | ¾-in. by 12-in. by 48-in. bamboo panel. The panel was machine made with generally uniform thickness. Mounted to the support frame with three rows of screws, 16-in. spacing. | 4-ft by 8-ft frame of 2-in. by 6-in. studs, 16-in. OC. The frame was mounted to the wall with 4-in. by 4-in. blocks at the top and bottom. The frame had OSB sheathing above and below the target panel. | Front | 105 | The missile penetrated the panel and made an indentation in the face of the wall. No visible damage was done to the back side of the wall. |

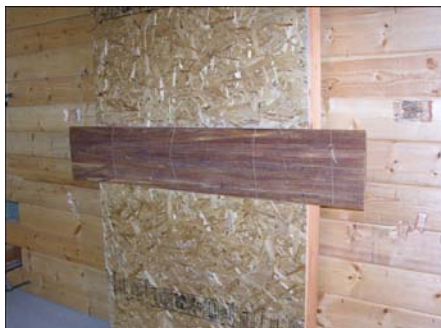
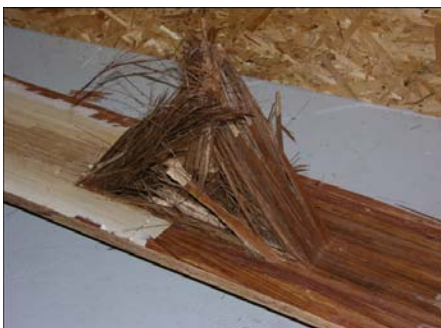
| Test no. | Panel description | Wall/support frame | Panel location | Missile speed (mph) | Damage description |
|---|---|---|---|---|---|
| 12 | ¾-in. by 12-in. by 64-in. bamboo panel. The bamboo panel was humanmade with longer fibers and had a varied thickness. Mounted to the support frame with three rows of screws, 16-in. spacing. | 4-ft by 8-ft frame of 2-in. by 6-in. studs, 16-in. OC. The frame was mounted to the wall with 4-in. by 4-in. blocks at the top and bottom. The frame had OSB sheathing above and below the target panel. | Front | 105 | The missile perforated the panel and impacted the wall in the same area as Missile #14. There was damage to the back side of the wall in the form of a large crack. |

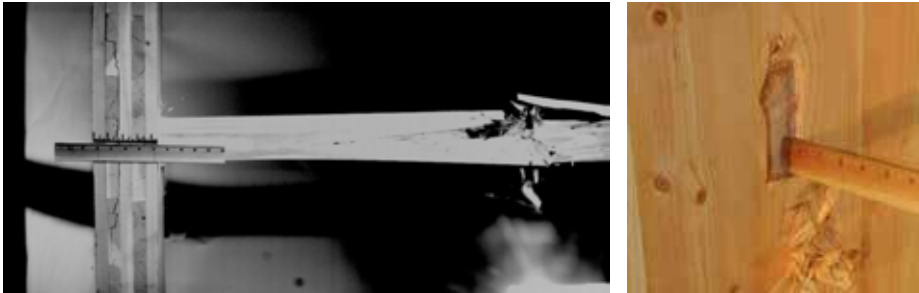
| Test no. | Panel description | Wall/support frame | Panel location | Missile speed (mph) | Damage description |
|---|---|---|---|---|---|
| 30 | Five ply Douglas-fir cross-laminated timber panel. Each lamination was 1-in. thick. | 2-ft by 8-ft panel attached to steel frame | Front | 103.4 | The 15.6-lb., 2 by 4 missile caused a 15/16-in. indentation in the front of the panel. The fourth lamination failed perpendicular to grain. There was limited deflection at the rear but it was not permanent and no debris flew from the back of the panel. Missile shattered. |
