## Non-Destructive Analysis Reveals Effect of Installation Details on Plywood Siding Performance

This study evaluated the influence of a variety of construction techniques on the performance of plywood siding and the applied paint, using both ultrasound and conventional visual inspection techniques. The impact of bottom edge contact, flashing vs. caulking board ends, priming the bottom edge, location (Wisconsin vs. Mississippi) and a gap behind the siding to facilitate drainage were tested. Test fences were constructed to provide outdoor exposure of 2 replicates of each permutation using full factorial design. Yellow poplar (*Liriodendron tulipifera*), a decay prone wood species was used for the plywood to accelerate the results. After four years of outdoor exposure, mushrooms were observed on the surface of some boards and all were removed for lab evaluation. Extensive water staining was seen on the backs of the boards caused by water travelling upward from the bottom edge. Sound velocities were measured to determine the degree of decay. Herein we will present an analysis of the relative merits of ultrasound vs. visual inspection. We also analyze factors impacting performance, in

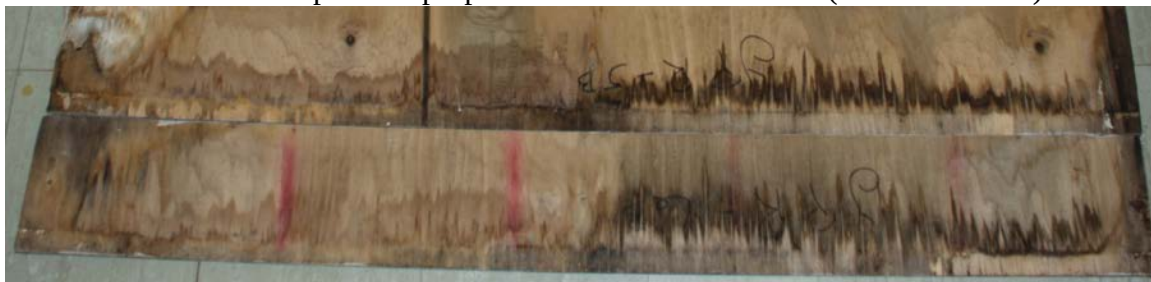
**Fig 3:** Back side of 2 panels after exposure, with caulked edges and no bottom gap showing water staining, more severe with the Venturi effect and gap behind boards (right) while end decay is more pronounced without gap behind boards (left).

A secondary drainage plane or gap is made by adding furring strips between the vapor barrier and siding. This is typically referred to as a “rain screen”, or if vented at the top, “ventilated siding”, and is generally recommended. In this study, the bottom of the siding was open and no foundation was present, allowing the wind to pass under the wall. There was no significant effect of the gap but Figure 3 shows that siding on the side with a gap (right) had more water stain, further up the backside of the board, than the side with no gap (left). This is clearly not the intent nor the typical performance of a rain screen. We believe the open space below the siding created a Venturi effect and a

low pressure zone behind the siding, which would drive water up behind the siding. This highlights the need for careful attention to installation details. We refer the reader to Rousseau for a description of proper rain screen construction (Rousseau 1990).
