# Comparison of the corrosion of fasteners embedded in wood measured in outdoor exposure with the predictions from a combined hygrothermal-corrosion model

This paper examines the accuracy of a recently developed hygrothermal-corrosion model which predicts the corrosion of fasteners embedded in wood by comparing the results of the model to a one year field test. Steel and galvanized steel fasteners were embedded into untreated and preservative treated wood and exposed outdoors while weather data were collected. Qualitatively, the distribution of corrosion products along the length of the fastener were in agreement with the simulation results. Quantitatively, the combined hygrothermal-corrosion model predicted 20% less corrosion than measured in the exposure test for galvanized steel fasteners due to a lower simulated moisture content.

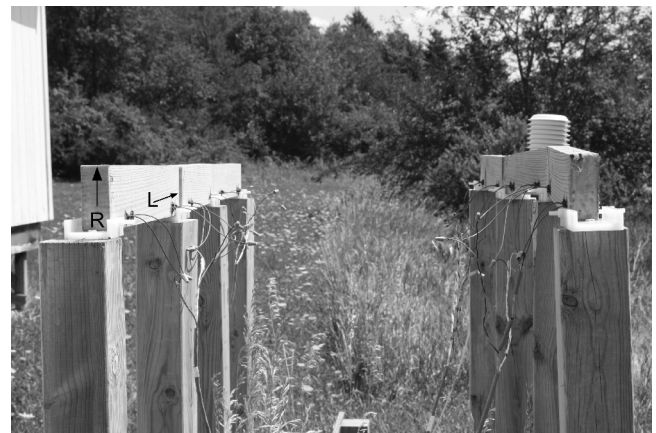
**Fig. 1.** Photograph of the untreated (left) and treated (right) specimens at the beginning of the 1-year exposure test. The “R” and “L” arrows denote the radial and longitudinal directions, respectively; the tangential direction is perpendicular to the radial direction on the front face. The tangential surface is on the top of the board and cannot be seen in these images.

The wood specimens used in the field tests were cut from a single large beam from the southern pine species group. Although the exact species could not be determined, it was harvested from a plantation where over 90% of the trees were slash pine (*Pinus elliotii*). Southern pine was chosen as over 70% of the southern pine harvested is treated with waterborne preservatives [40]. Specimens were cut along the anatomical directions of the wood to 40 mm (tangential) by 90 mm (radial), approximately the size of a nominal US “2 × 4”. The length of the boards of 610 mm (longitudinal), to match the geometry of the ASTM G198 test specimen [41]. The end-grain was sealed with paraffin wax so that transport along the longitudinal direction could be ignored. Nails were driven into the 38 mm by 610 mm face, which was the tangential surface (see Fig. 1). This face was exposed outdoors pointing up, parallel to the

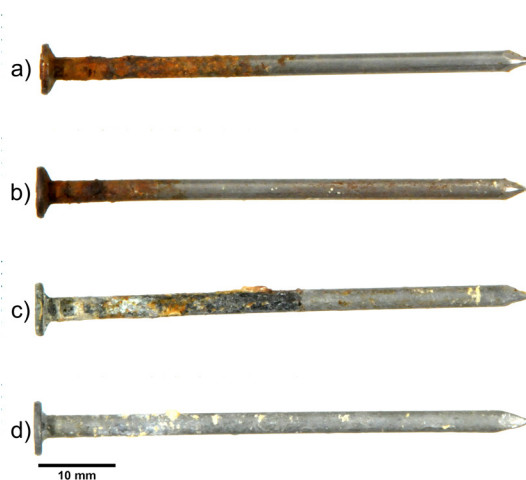
**Fig. 4.** Images of the fasteners after being removed from the 1-year field exposure test. (a) steel fastener in treated wood, (b) steel fastener in untreated wood, (c) galvanized fastener in treated wood, (d) galvanized fastener in untreated wood.

The severity of the corrosion attack was also measured by examining the amount of the fastener that exhibited visible corrosion products (Fig. 4). The corrosion was unevenly distributed along the length of fasteners because the top of the block of wood was exposed to rain, so the nail head had more rust than the nail tip, which had no visible corrosion products. The amount of visible corrosion products were recorded by measuring the fasteners along their length from the head until the last visible corrosion product, and we refer to this as the corrosion length. The corrosion length was measured from calibrated images using *ImageJ*, a freely available software developed by the US National Institutes of Health [50]. The average corrosion length for the steel and galvanized fasteners was 32 and 35 mm, respectively, in the treated wood. For the untreated wood, the steel fasteners had an average corrosion length of 25 mm; the corrosion length could not easily be determined for the galvanized fasteners (Fig. 4d).
