# Mass Timber Rocking Panel Retrofit of a Four-Story Soft-Story Building with Full-Scale Shake Table Validation

**Abstract:** Soft-story wood-frame buildings have been recognized as a disaster preparedness problem for decades. There are tens of thousands of these multi-family three- and four-story structures throughout California and other cities in the United States. The majority were constructed between 1920 and 1970, with many being prevalent in the San Francisco Bay Area in California. The NEES-Soft project was a five-university multi-industry effort that culminated in a series of full-scale soft-story wood-frame building tests to validate retrofit philosophies proposed by (1) the Federal Emergency Management Agency (FEMA) P-807 guidelines and (2) a performance-based seismic retrofit (PBSR) approach developed within the project. Four different retrofit designs were developed and validated at full-scale, each with specified performance objectives, which were typically not the same. This paper focuses on the retrofit design using cross laminated timber (CLT) rocking panels and presents the experimental results of the full-scale shake table test of a four-story 370 m<sup>2</sup>

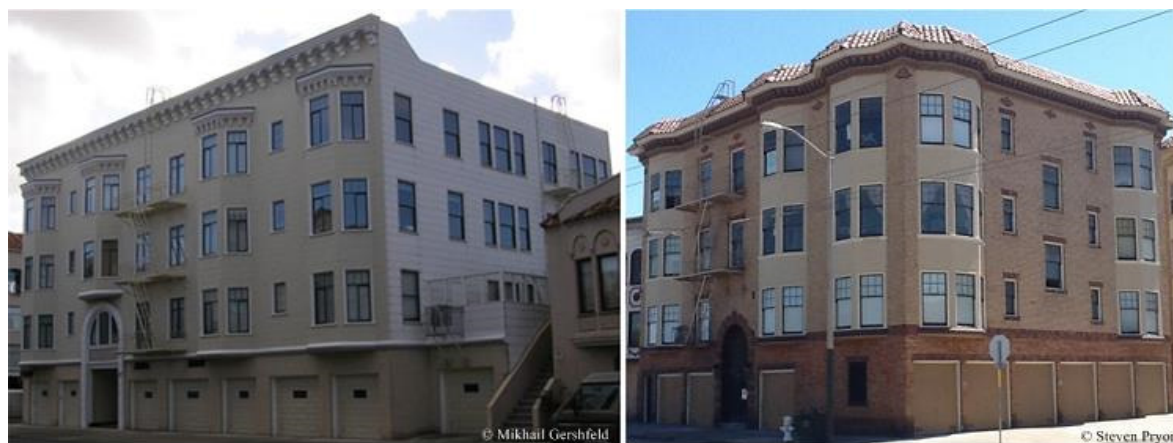
**Figure 2.** Soft-story wood buildings in the San Francisco Bay Area (Photos by Mikhail Gershfeld and Steven Pryor).

As with all test programs, the design of a system-level specimen presents unique challenges since it is, by definition, specific, but the test objectives necessitate a generalized representation of the building space being studied, i.e. how does one validate a method with one data point? A number of site visits were conducted to identify the architecture of the test building, with the focus placed on the San Francisco Bay Area in California. Figure 2 shows photos of typical Bay Area soft-story wood-frame buildings; note the garage doors at the first story of each building in Figure 2, which can often be on more than one side.

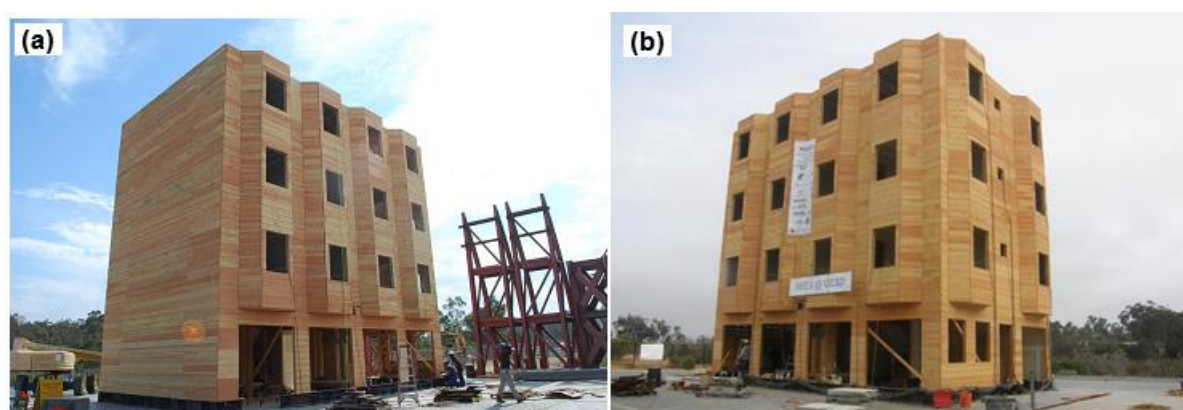
**Figure 3.** The test building designed as part of the NEES-Soft project: (a) Southwest view; and (b) Southeast view.

In order to investigate the performance of soft-story buildings subjected to seismic ground motion, a four-story building with a soft-story as its first story was designed and constructed on the top of the shake table at the University of California-San Diego's outdoor shake table laboratory (Figure 3). The building represented a corner building with two adjacent buildings on the North and West sides. The test building had four garage doors at the first story on its south side and two windows and a storage and an entrance door on its east side. The upper stories each had two two-bedroom units with bay-windows on the south and east sides. It can be seen that the large openings due to garage and storage doors reduce the available space for lateral load resisting systems, i.e. shear walls; thus, the building is soft and weak at the first floor. The details of the structural and architectural drawings of the building, existing vertical and lateral load resisting systems, and types of fasteners are presented in Bahmani et al. [14] and van de Lindt et al. [13] and hence are omitted here for brevity. Figure 3 shows photos of the NEES-Soft four-story test building built at the NEES@UCSD laboratory just prior to the installation of the CLT rocking walls. The shake table is a 7.6 m (25 ft)  $\times$  12.2 m (40 ft) outdoor uni-axial shake table with a maximum gravity payload of 20,000 kN (4496 kips); full details on the shake table performance and capabilities can be found in Ozcelik et al. [25].

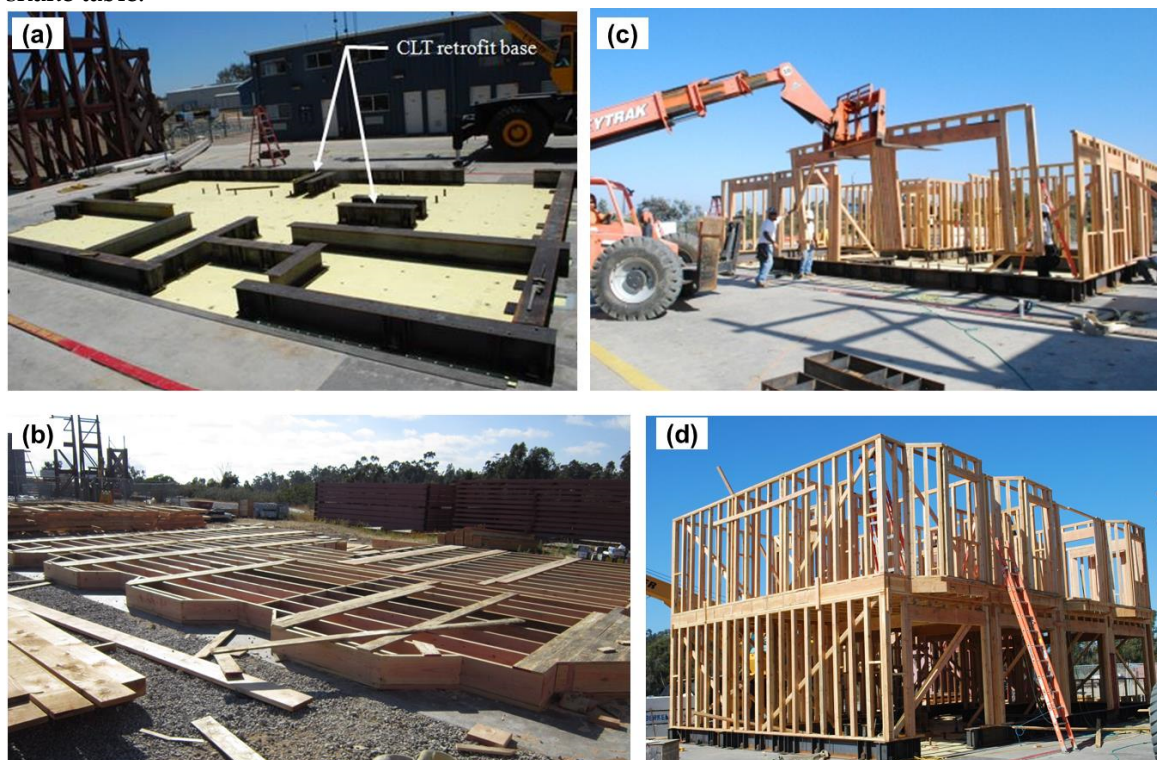
**Figure 6.** Construction of four-story building: (a) Installation of steel interface beams; (b) Prefabrication of floors and walls; (c) Erection of the first story with large openings; (d) Erection of the second story (stories 3 and 4 had the same floor plan as story 2).

Steel interface beams were designed and installed at the top of the shake table in order to anchor the four-story test building to the shake table and accommodate the installation of anchor bolts for each wall at the first story. W16  $\times$  61 interface beams were attached to the shake table prior to the construction of the building and the installation of retrofitting elements. It should be noted that, since the building was tested in four different testing phases, the interface beam segments were designed such that they could support all the retrofitting elements used in the four phases of testing in this study. Figure 6 presents photos of the construction of the four-story building on top of the shake table.

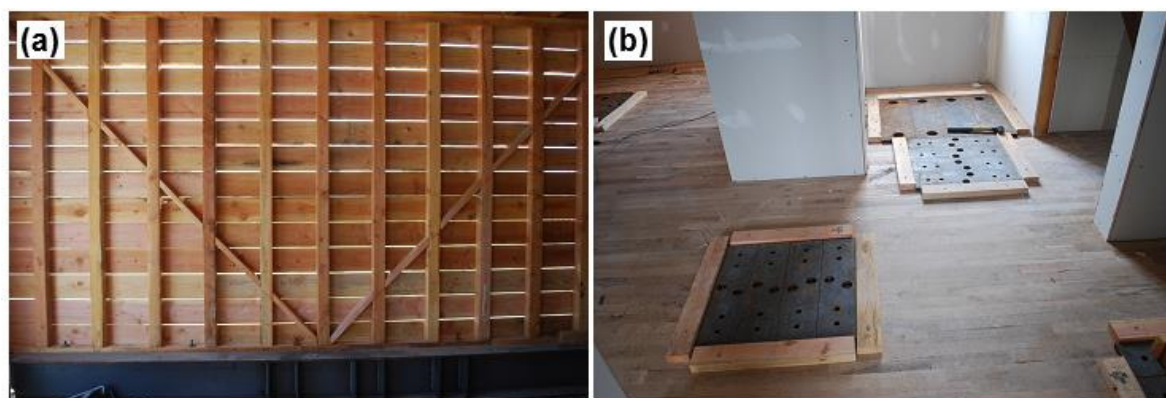
**Figure 7.** (a) Diagonal bracing at the west wall of the building at the first story; (b) steel plates attached to floor.

It should be noted that diagonal bracing was installed along the exterior walls of the west side of the building at the first story, which was a common construction practice during the construction of these types of buildings (Figure 7a). Additional mass was added to each floor of the building to represent the mass of the material not used in construction of the building such as tile flooring (Figure 7b). Horizontal wood siding was used for all the exterior walls of the building. Figure 8a presents one of the garage openings at the first floor, and Figure 8b shows the north-west view of the finished four-story building with horizontal wood siding installed on the exterior walls.
