Research  
Paper  
FPL 381

# Strength and Stiffness of Small Glued-Laminated Beams with Different Qualities of Tension Laminations

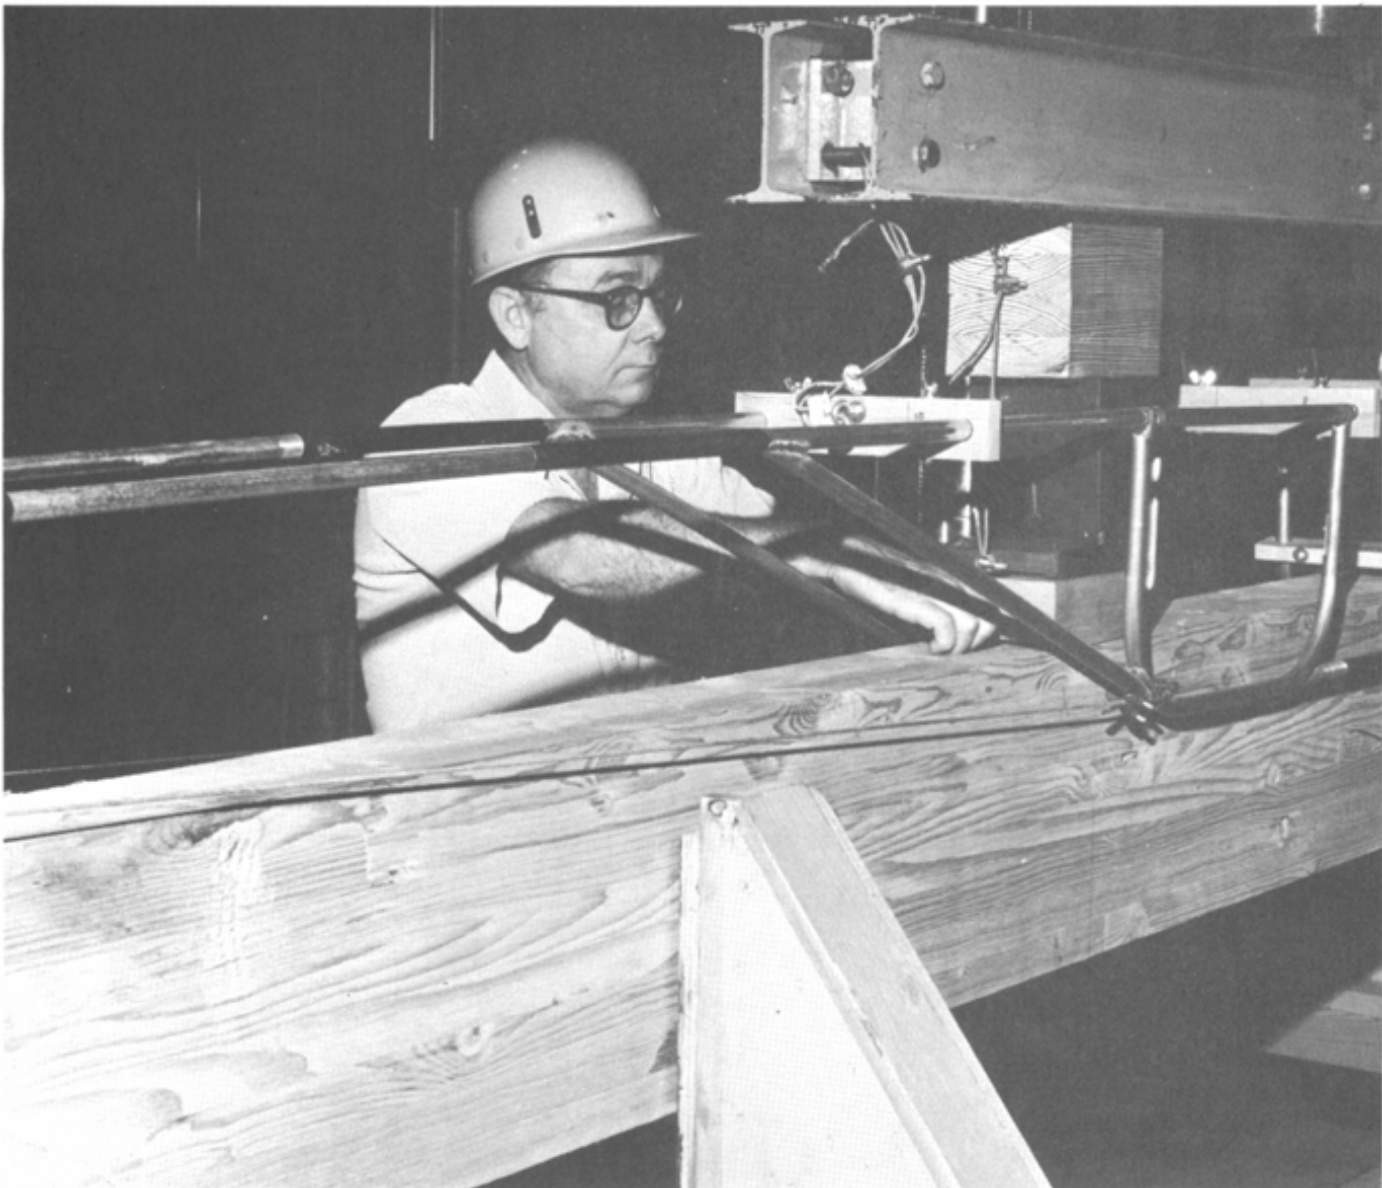
Figure 1.— Test-beam combinations. The DF-L combinations with L1 tension laminations are referred to as L1 DF-L in this report. Similarly, the SP combinations with No. 1D tension laminations are referred to as No. 1D SP. Beam combinations with 302-24 tension laminations are referred to as either 302-24 DF-L or 302-24 SP. (M 148 967)

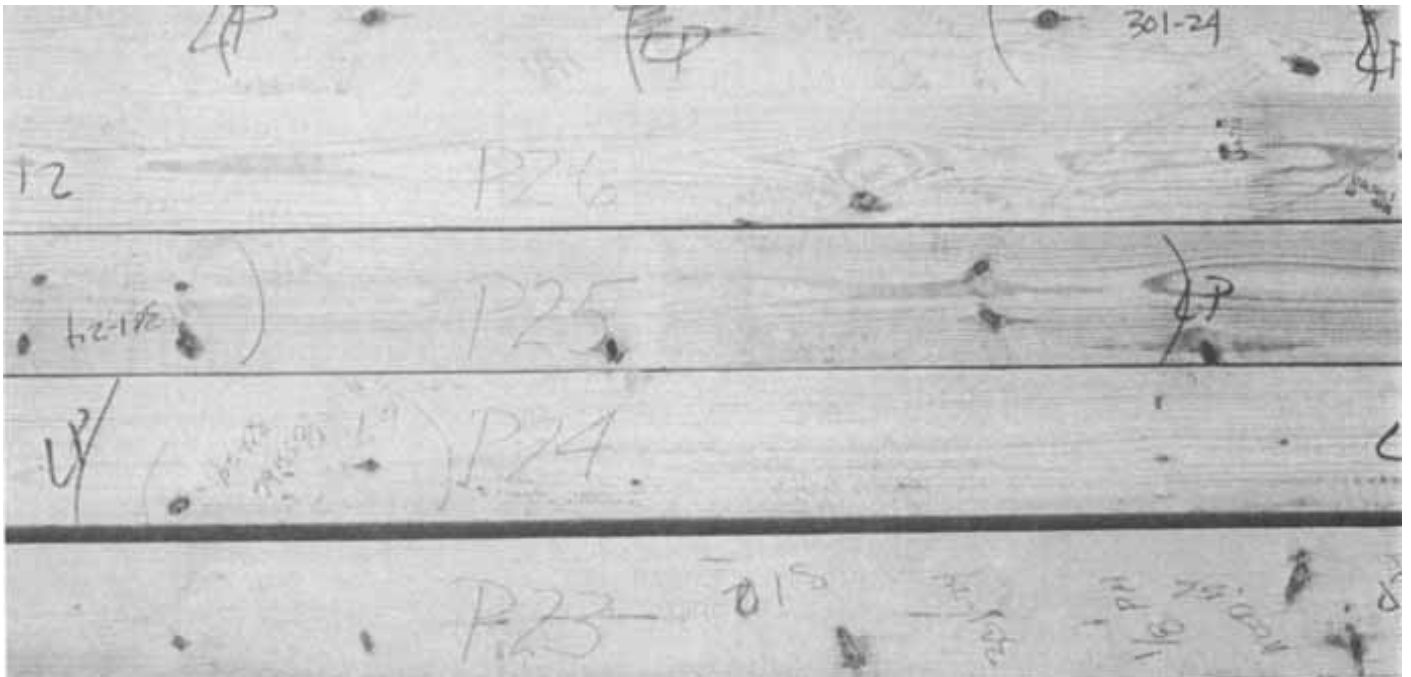
Figure 2.—Some 302-24 SP boards that illustrate the quality of 302-24 tension laminations selected for this study.

Figures 2 and 3 illustrate the typical, near-minimum quality of the selected 302-24 and No. 1D SP tension laminations, respectively. The near-minimum quality of the selected 302-24 and L1 DF-L tension laminations is illustrated in appendix A by figures A- 8 and A- 9, respectively, which show some of the beam failures.

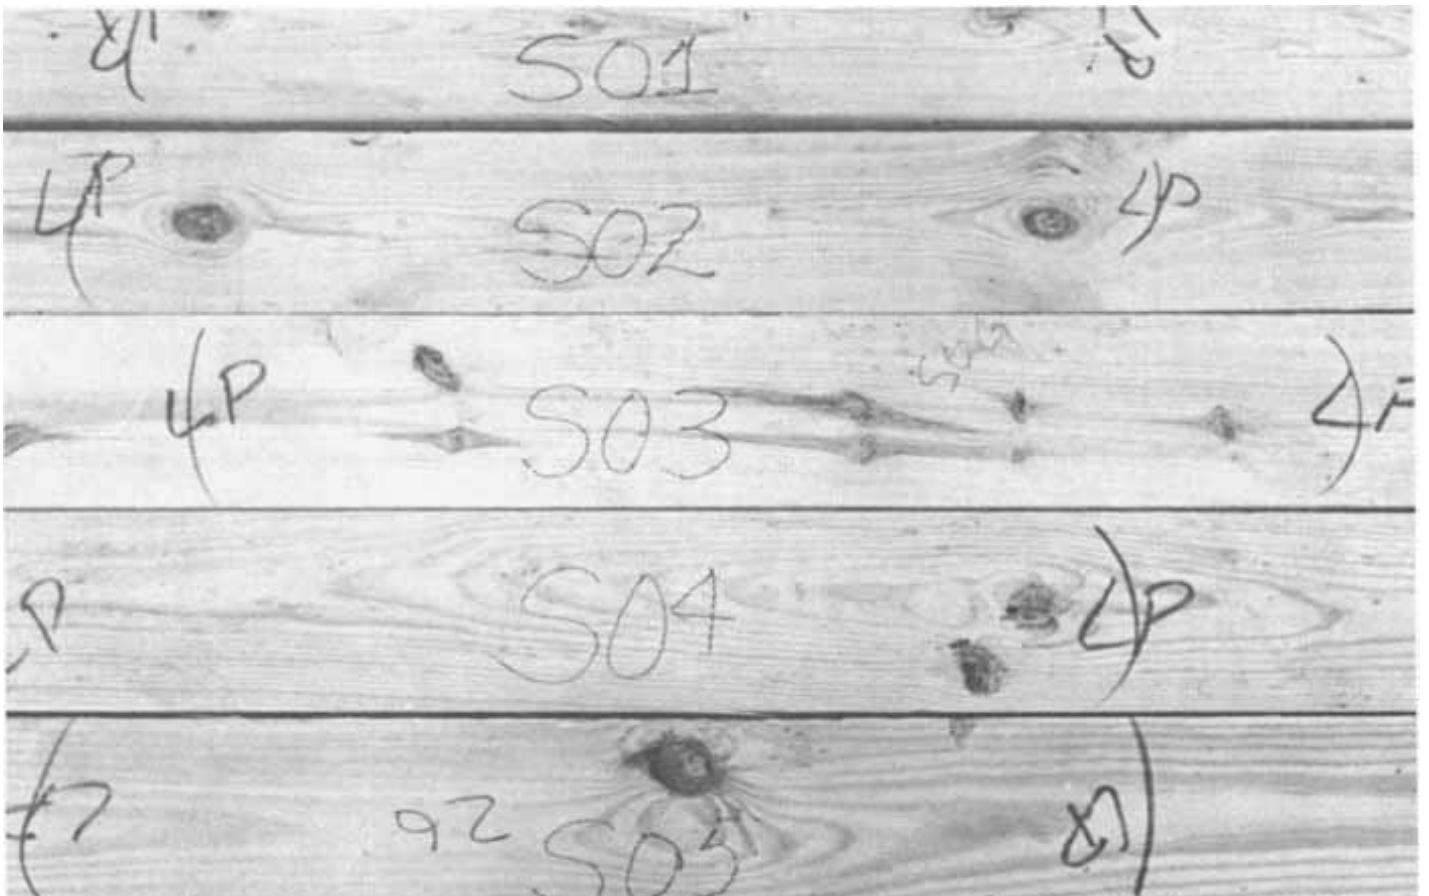
Figure 3.—Some No. 1D SP boards that illustrate the quality of No. 1D tension laminations selected for this study.

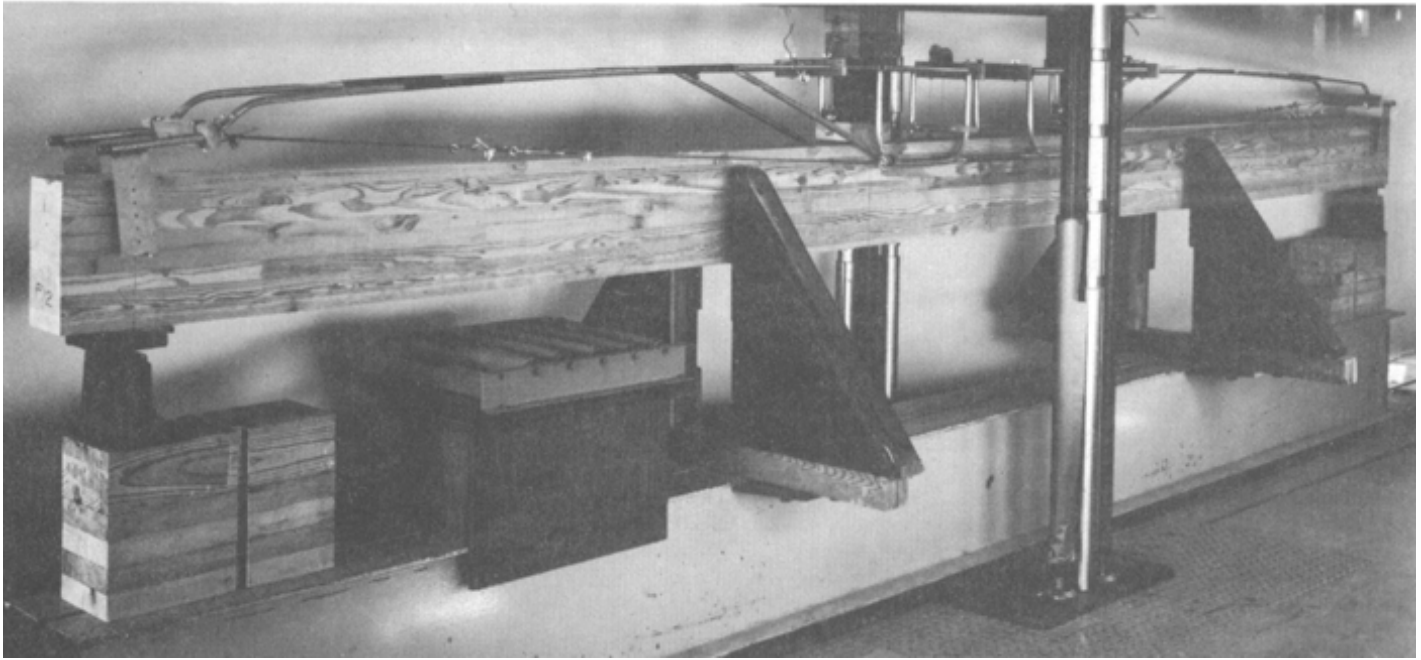
Figure 4.—Floor-level view of the 8-lamination beam test setup. The 4- and 10-lamination beam test setups were similar.

with the span between the reactions varying from 9.5 to 19.0 to 24.0 feet for the 4-, 8-, and 10-lamination beams, respectively. Similarly, the distance between the load heads varied from 2.0 to 4.0 to 5.0 feet. These dimensions provided a shear span-to-depth ratio of about 15:1 in order to maximize bending-type failures and minimize the chance of horizontal shear failures.

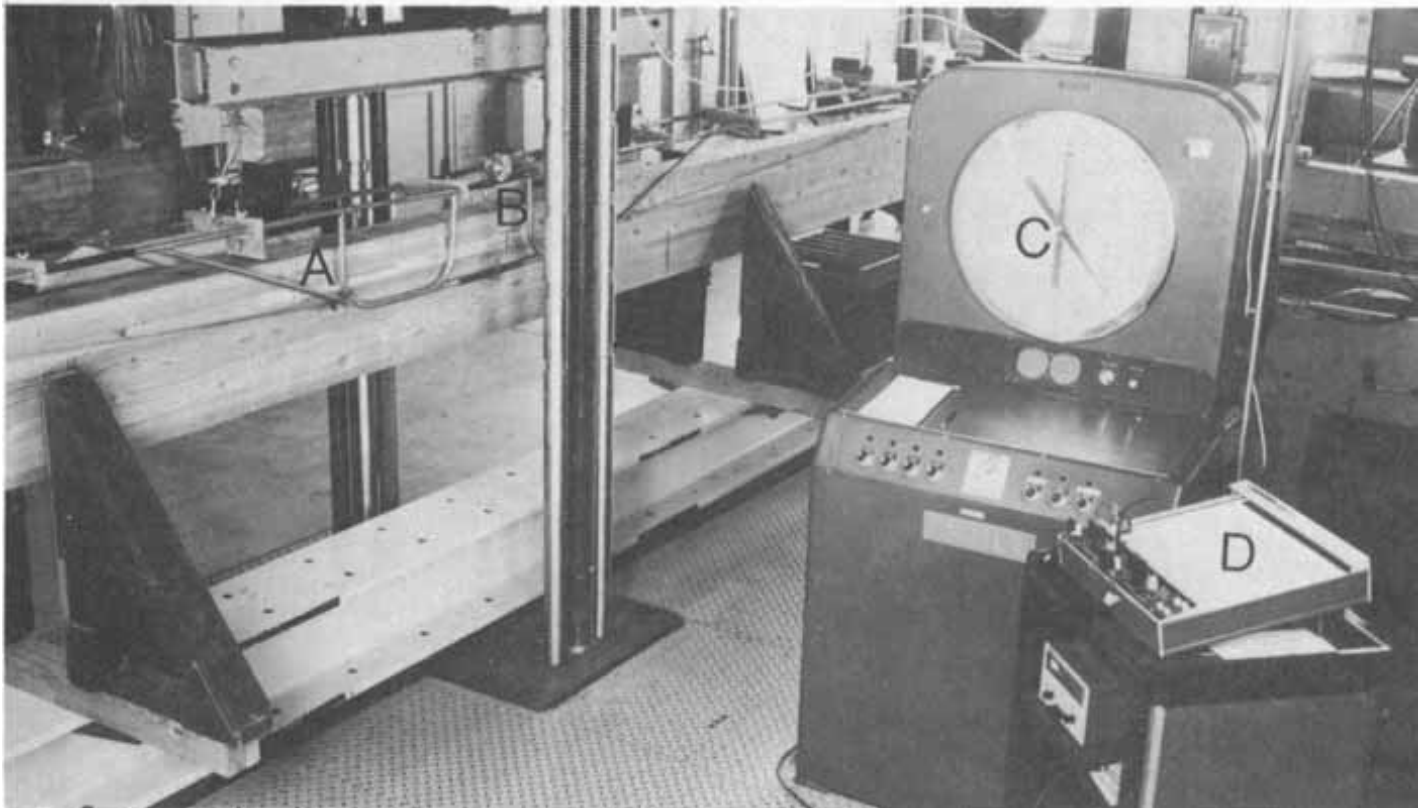
Figure 5.—Close-up view of the equipment used to obtain the required data: A. deflection yoke; B. linear potentiometer; C. Riehle 160,000-pound testing machine; D. x-y recorder.

vided a continuous record of the machine test load versus the full-span deflection (fig. 5). Following failure the moisture content of each lamination was measured near the failure area with a resistance-type meter having 1-1/2-inch-long prongs. The failure area was cut from each beam, photographed, and saved for further inspection.

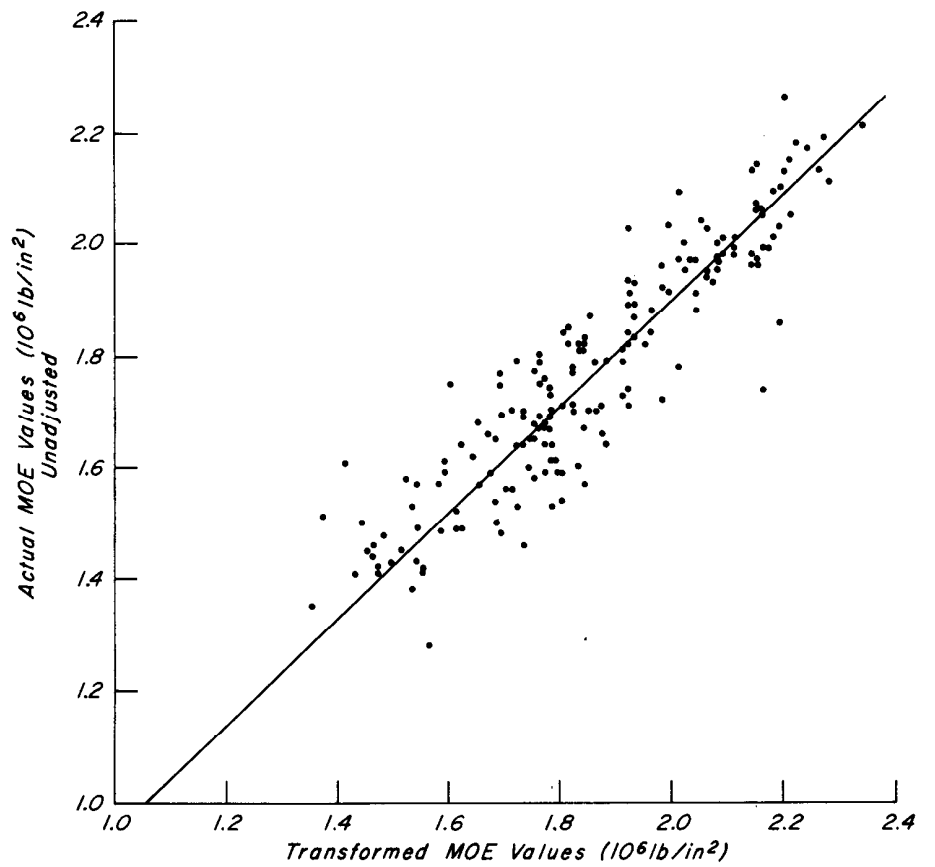
Figure 6.—Comparison of actual and transformed MOE values. Calculations for transformed values were based on actual stiffness of individual pieces of lumber used in the beams.

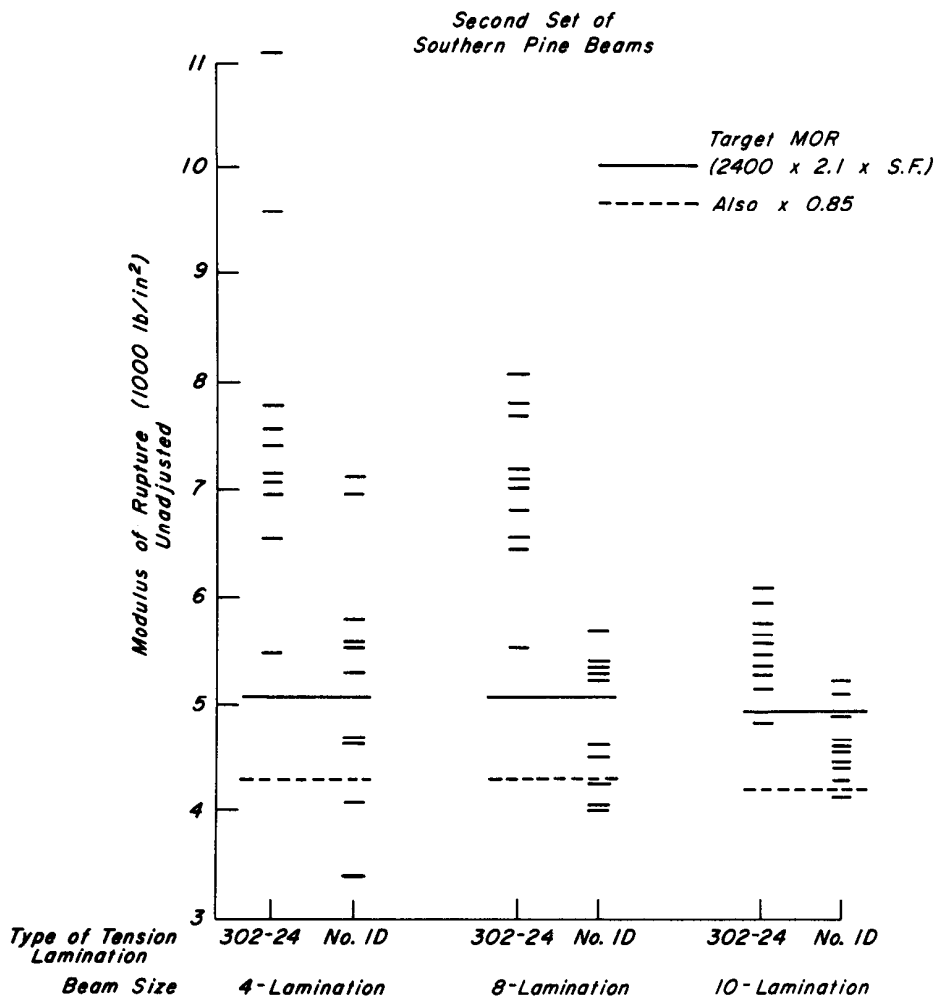
Figure 7.—Comparison of the second set of SP test MOR values with the appropriate target MOR value.

3. Figures 7 and 8 and table 8 show that only two out of 60 302-24 test beams (3 pct) failed below the target MOR level. This is a lower frequency than allowed by the criteria currently used in determining an appropriate design level; that is, one out of 20 beams (5 pct) is allowed to fail below the design stress times 2.1.

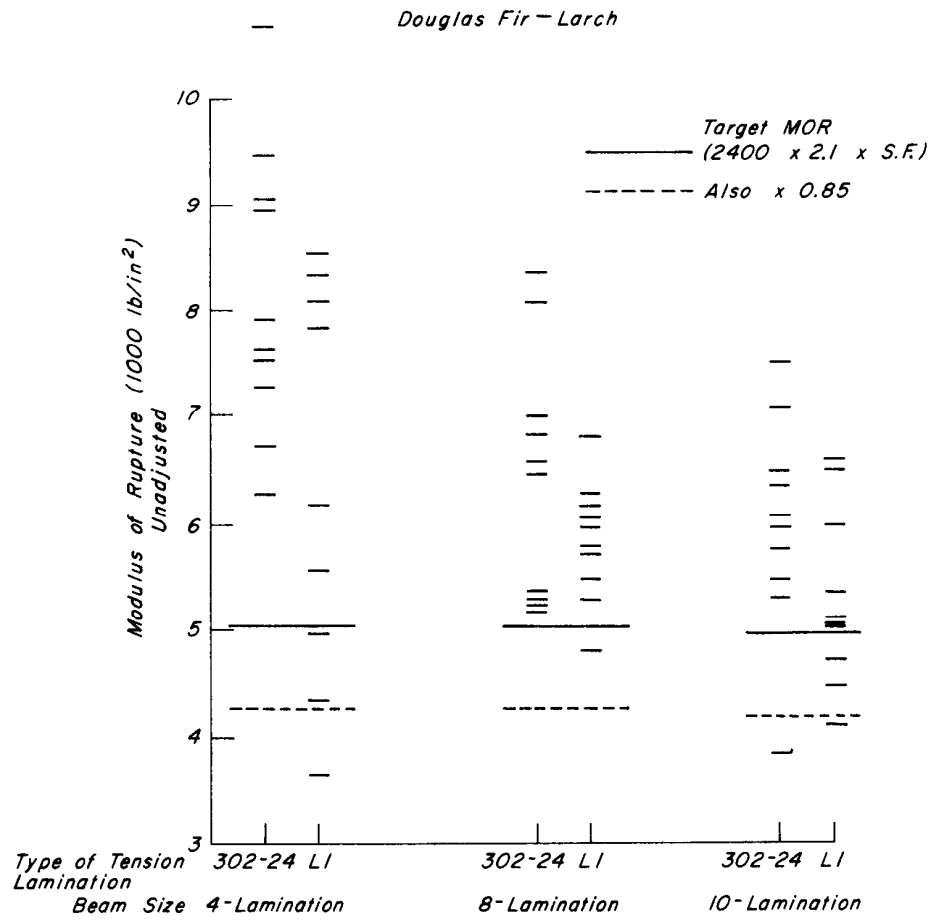
Figure 8.—Comparison of the DF-L test MOR values with the appropriate target MOR value.

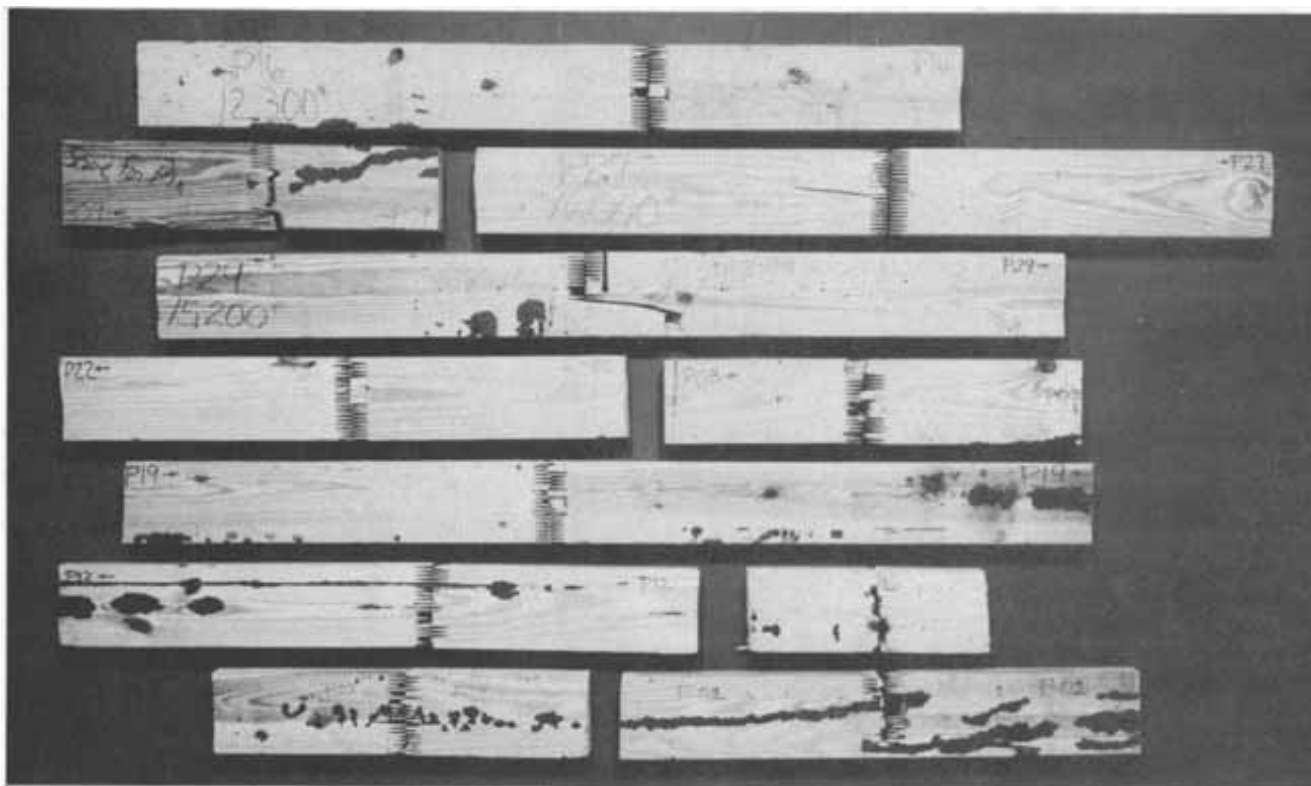
Figure A-1.—Failure sections of the initial set of 302-24 SP beams that failed below the target MOR level. (P18 is missing from the photograph.) Also illustrated is the typical appearance of the initial 302-24 SP finger-joint failures.

finger joint. Most of those beams had finger joints subjected to 75 percent or more of the maximum moment, but two of the beams failed at finger joints subjected to between 50 and 75 percent of the maximum moment. About half of the No. 1D beam failures involved a finger joint; all of those beams failed at finger joints subjected to 75 percent or more of the maximum moment. Typical finger-joint failures for the initial set of SP beams are shown in figures A-1 and A-2 in appendix A.

Figure A-1 shows all of the below-target MOR beam failures with the exception of P18. Beam P30 was the only beam in that below target MOR group that did not fail at a finger

joint. It failed at one of the selected knots (center-line knot and grain deviation occupying 17 pct of the cross section) and at what was likely an undetected timber break at the same cross section. Close inspection of the failure revealed some compression wrinkles in the tension lamination within a few inches of the abrupt break.

Beams P02, P03, P09, P12, P16, P18, P19, P22, P27, P28, and P29 all failed at a finger joint. Beam P29 failed at a finger joint in combination with the selected knot (centerline knot and grain deviation occupying 21 pct of the cross section). Pith-associated wood was present in the failed finger joints of P02, P09, P12, and P28. The other listed beams failed solely at a finger joint.

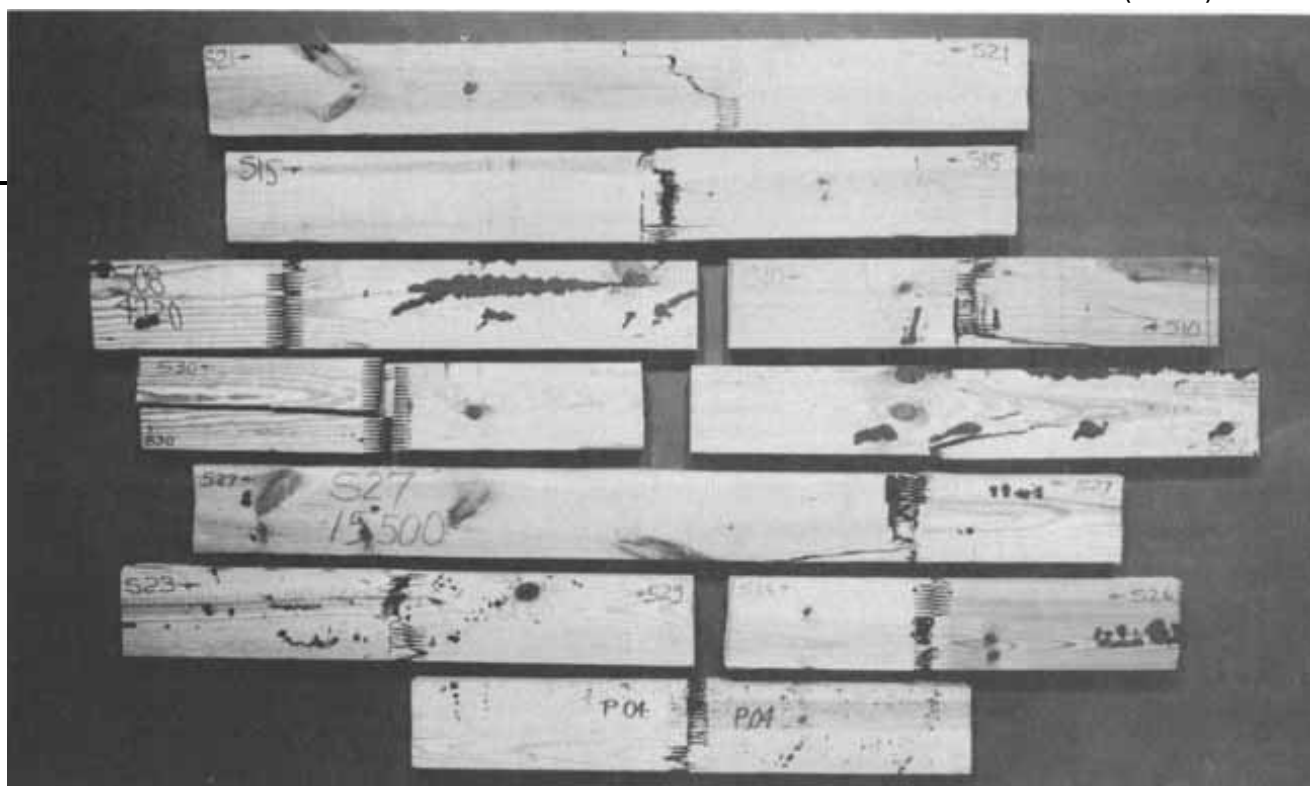
Figure A-2.—Failure sections of the initial set of No. 1D SP beams that failed below the target MOR level. (S20 is missing from the photograph.) Also illustrated is the typical appearance of the initial No. 1D finger-joint failures.

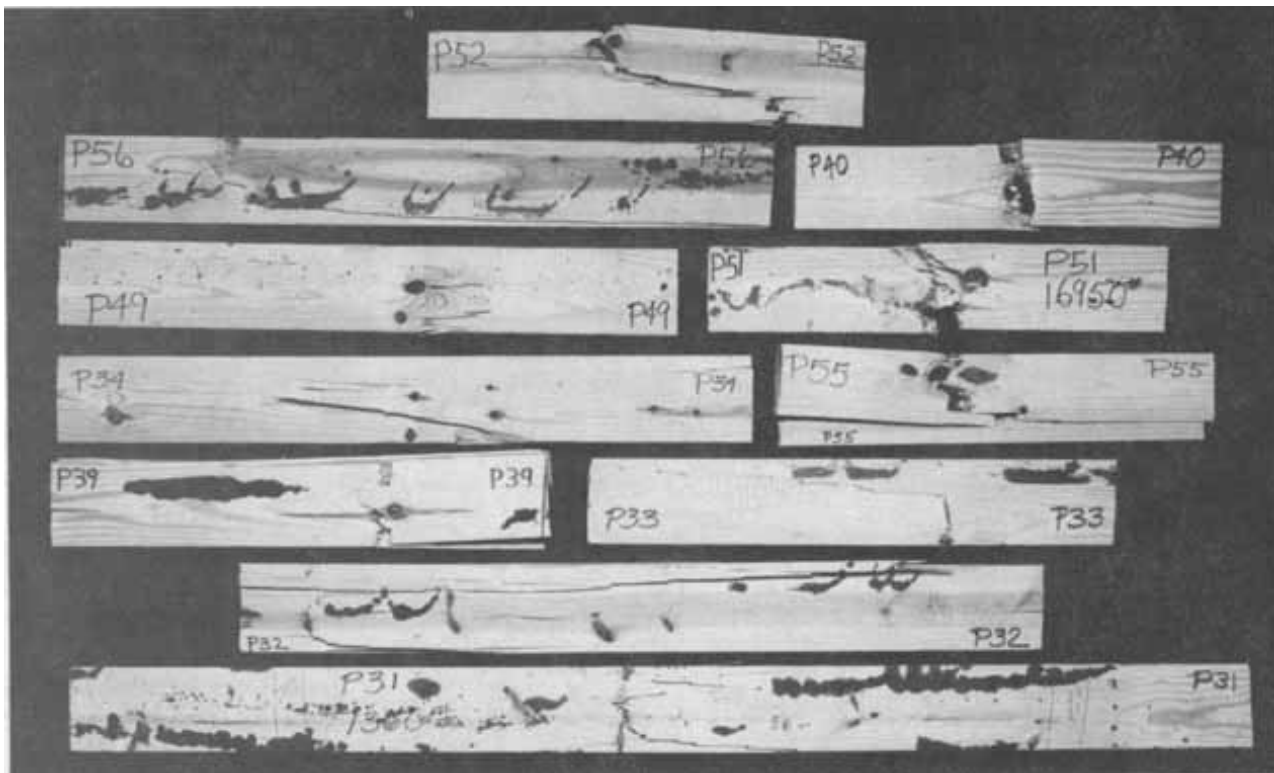
Figure A-3.—Selected failures from the second set of 302-24 SP beams. P52 (top) was the Only beam that failed below the target MOR level. (M 147311)

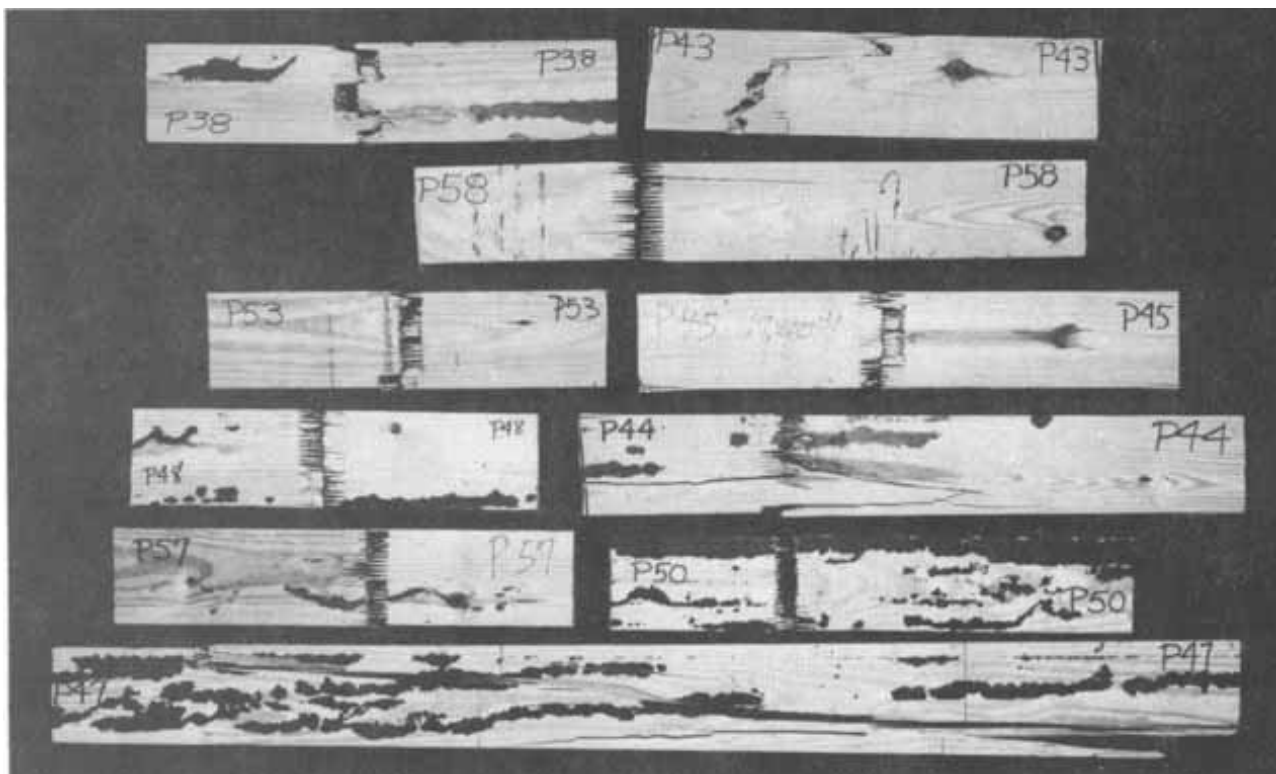
Figure A-4.—Failure sections of the beams from the second set of 302-24 SP beams that had a finger joint involved in the failure, Also illustrated is the typical appearance of the second set of SP finger-joint failures. (M 147 312)

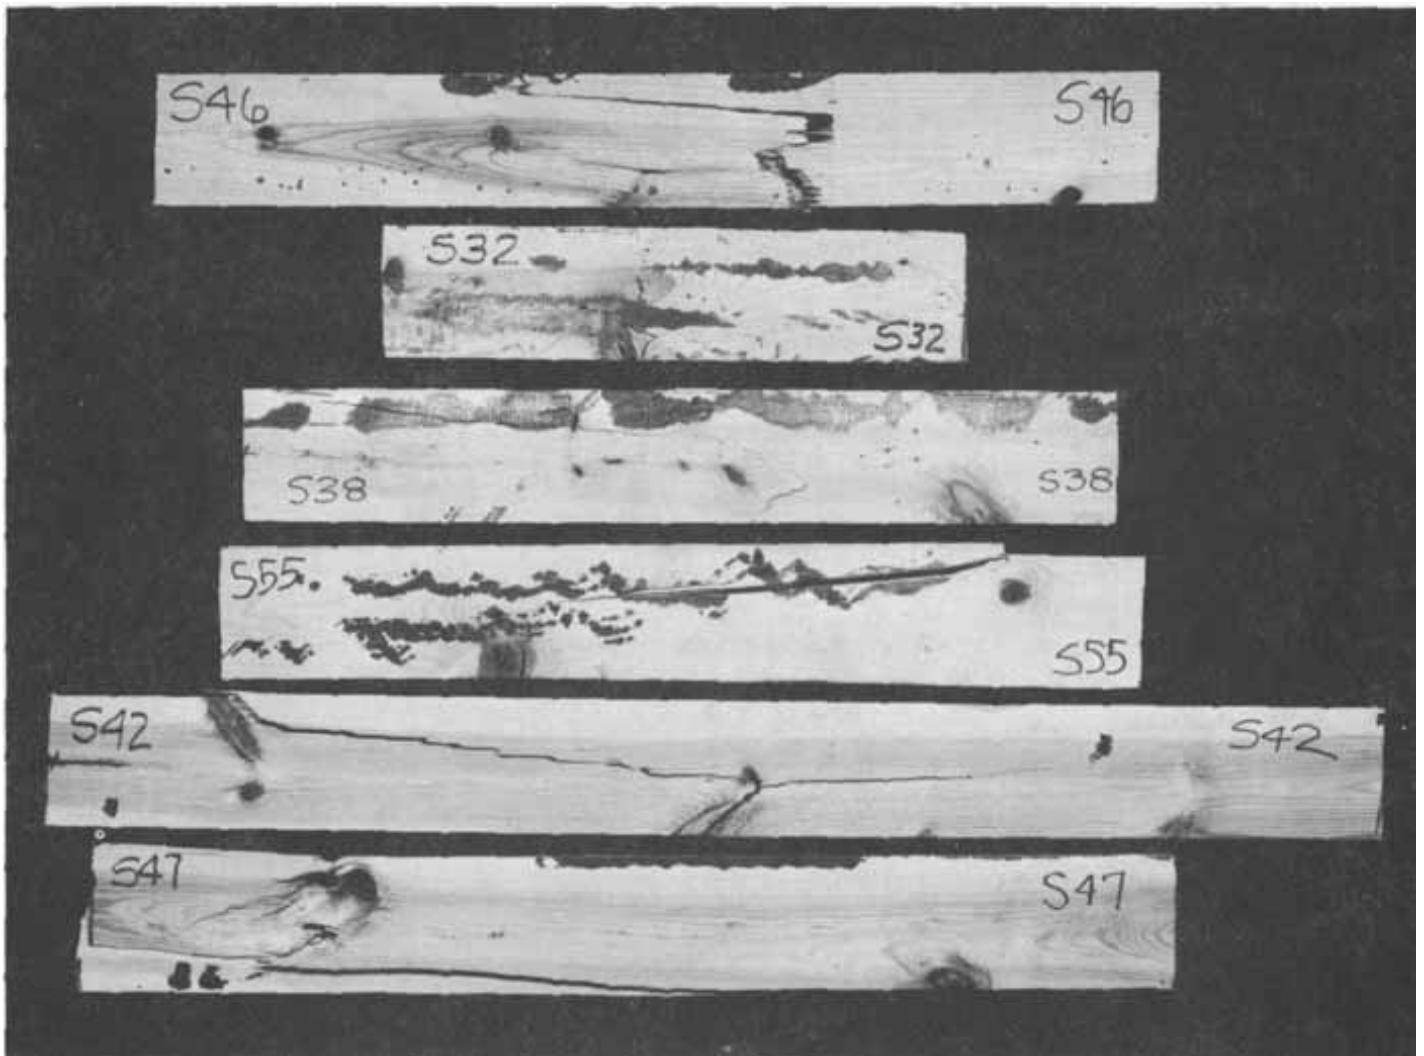
Figure A-5.—Failure sections of the beams from the second set of No. 1D SP beams that failed more than 15 percent below the target MOR level.  
(M 147 310)

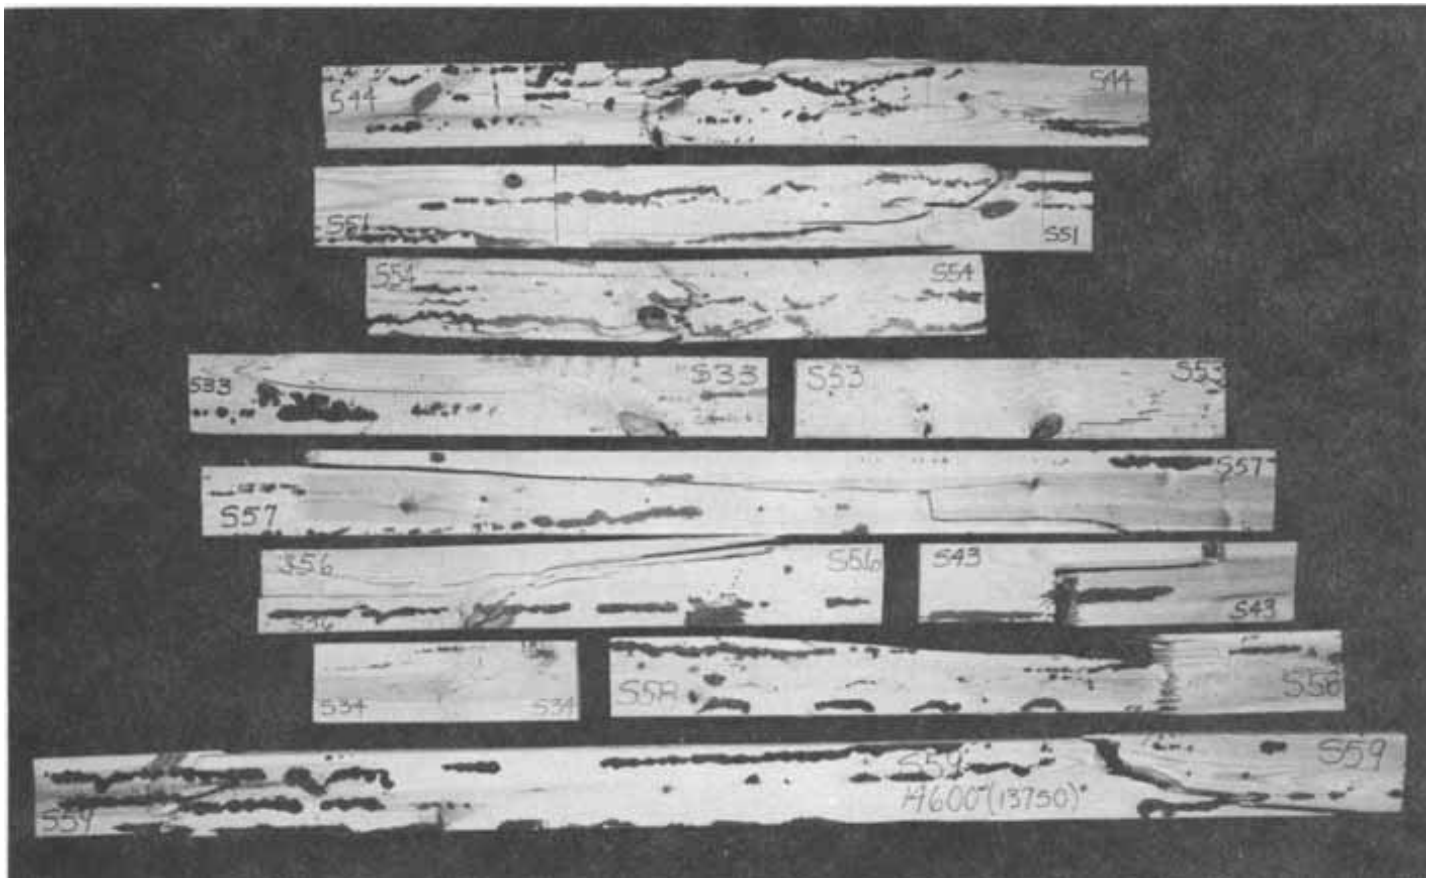
Figure A-6.—Failure sections of the beams from the second set of No. 1D SP beams that failed below the target MOR level, but by less than 15 percent.

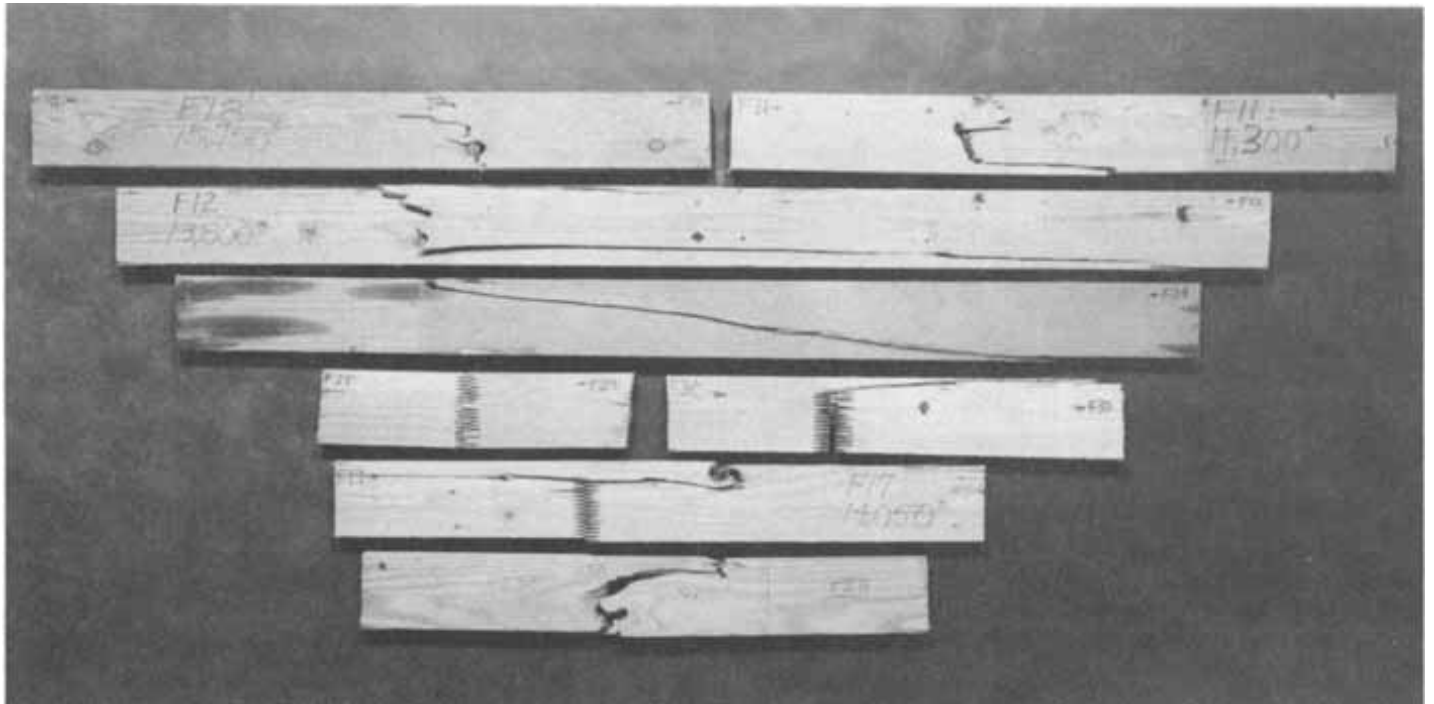
Figure A-7.—Most of these 302-24 DF-L beam failures occurred at a level slightly above the target level.  
Beam F23 failed below the target level.  
(M 147 126)

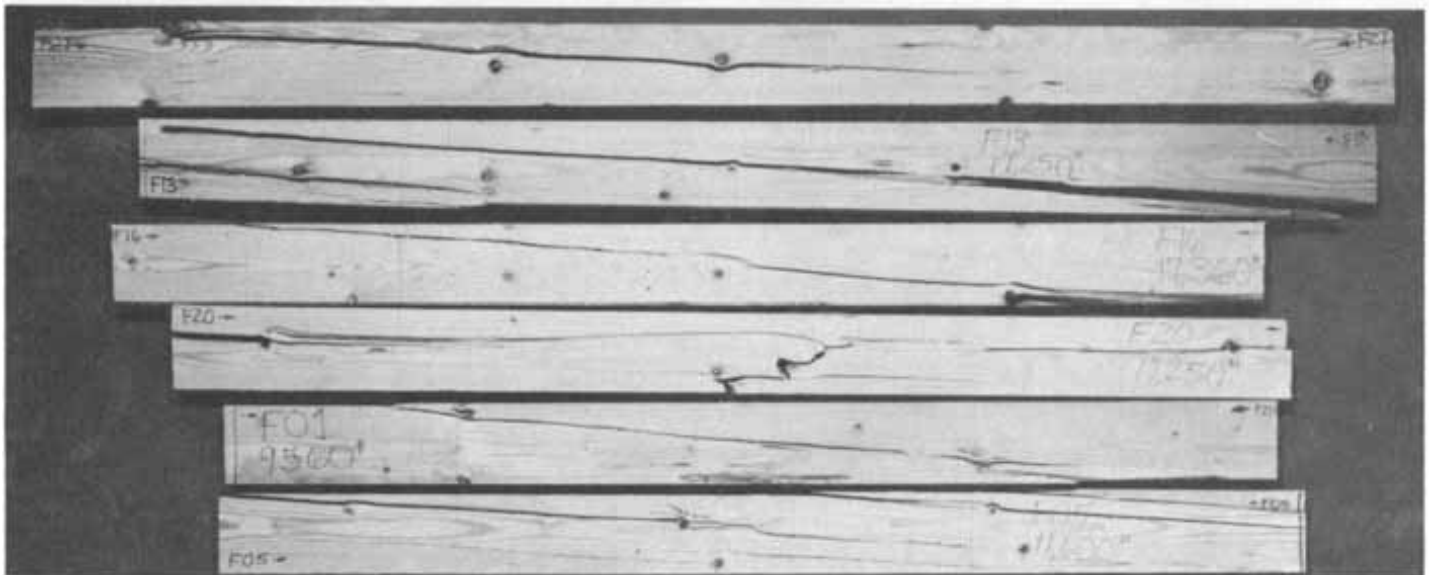
Figure A-B.—These 302-24 DF-L failures illustrate the typical, near-minimum quality of 302-24 tension lamina-  
tions selected.  
(M 147 136)

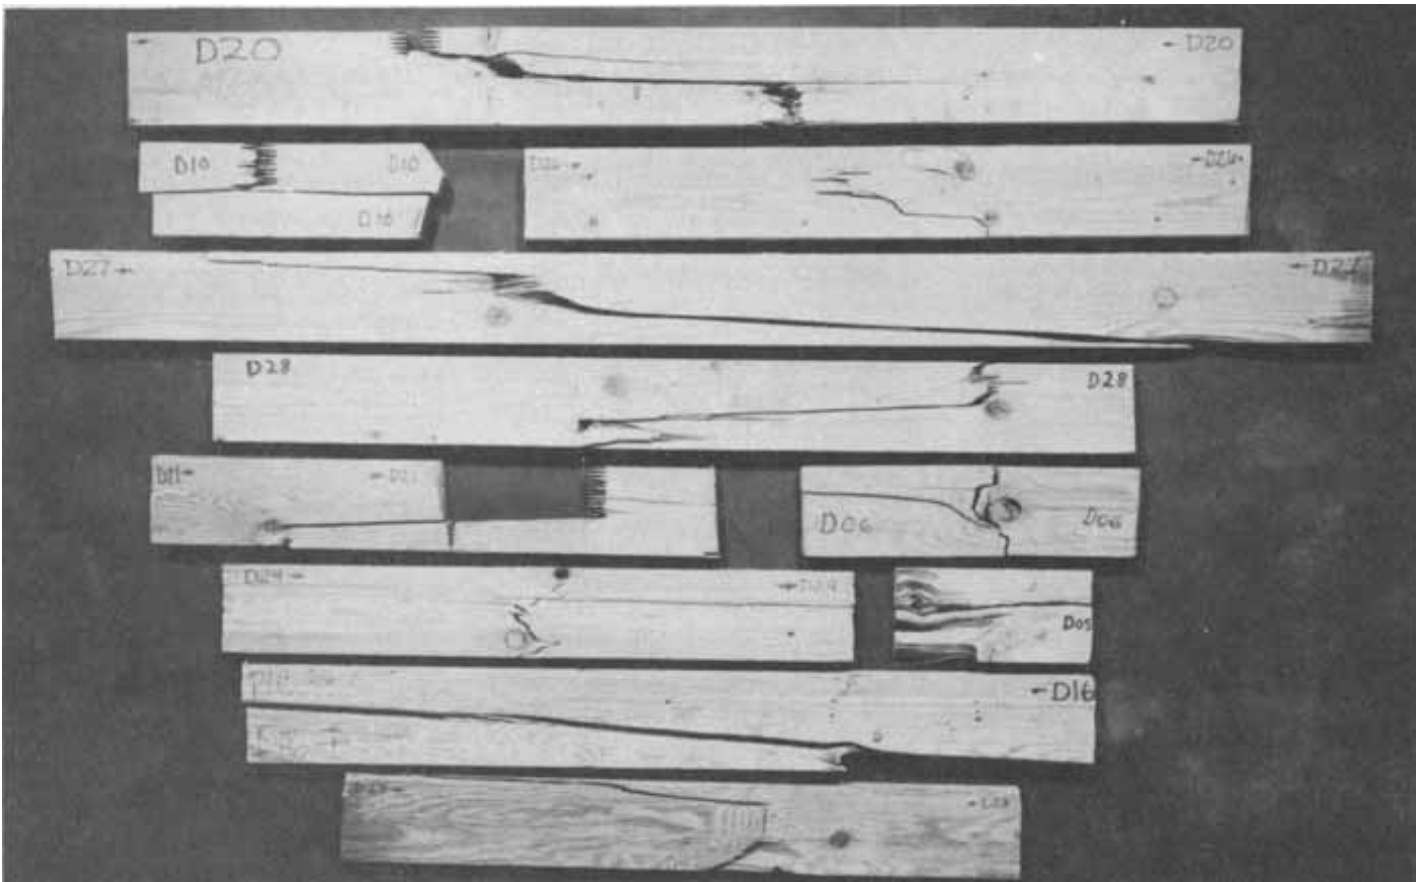
Figure A-9.—All of the below-target L1 DF-L beam failures are shown here along with some selected failures just above the target level. The photograph also illustrates the typical, near-minimum quality of L1 tension laminations selected. (M 147 138)

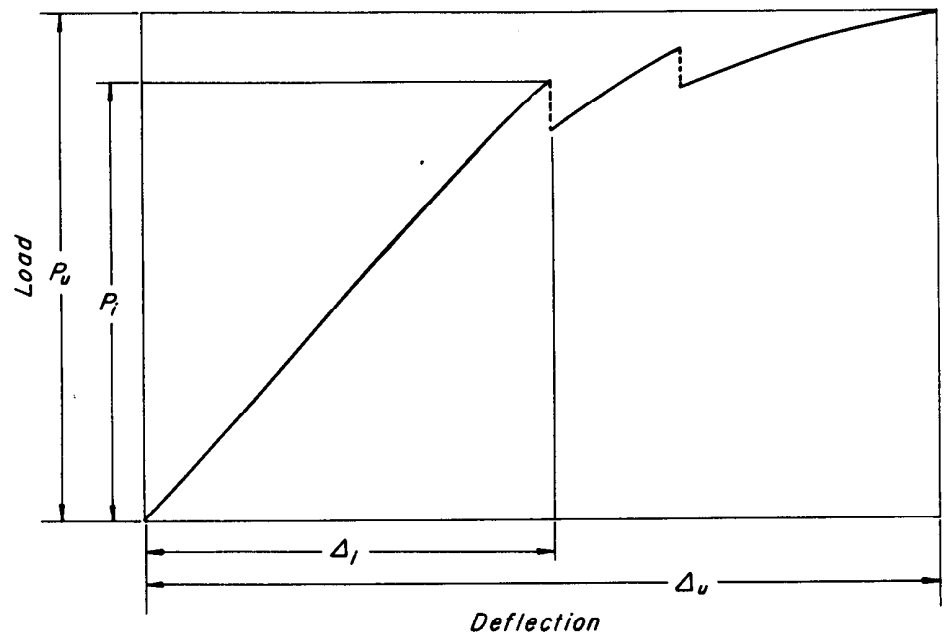
Figure A-10.—A typical example of a load versus deflection curve for a beam that failed gradually. Load ( $P_i$ ) and deflection ( $\Delta_i$ ) at first failure are shown along with ultimate load ( $P_u$ ) and deflection ( $\Delta_u$ ). The slope of the initial P-A curve is the basis for calculating the modulus of elasticity (MOE). (M 148953)

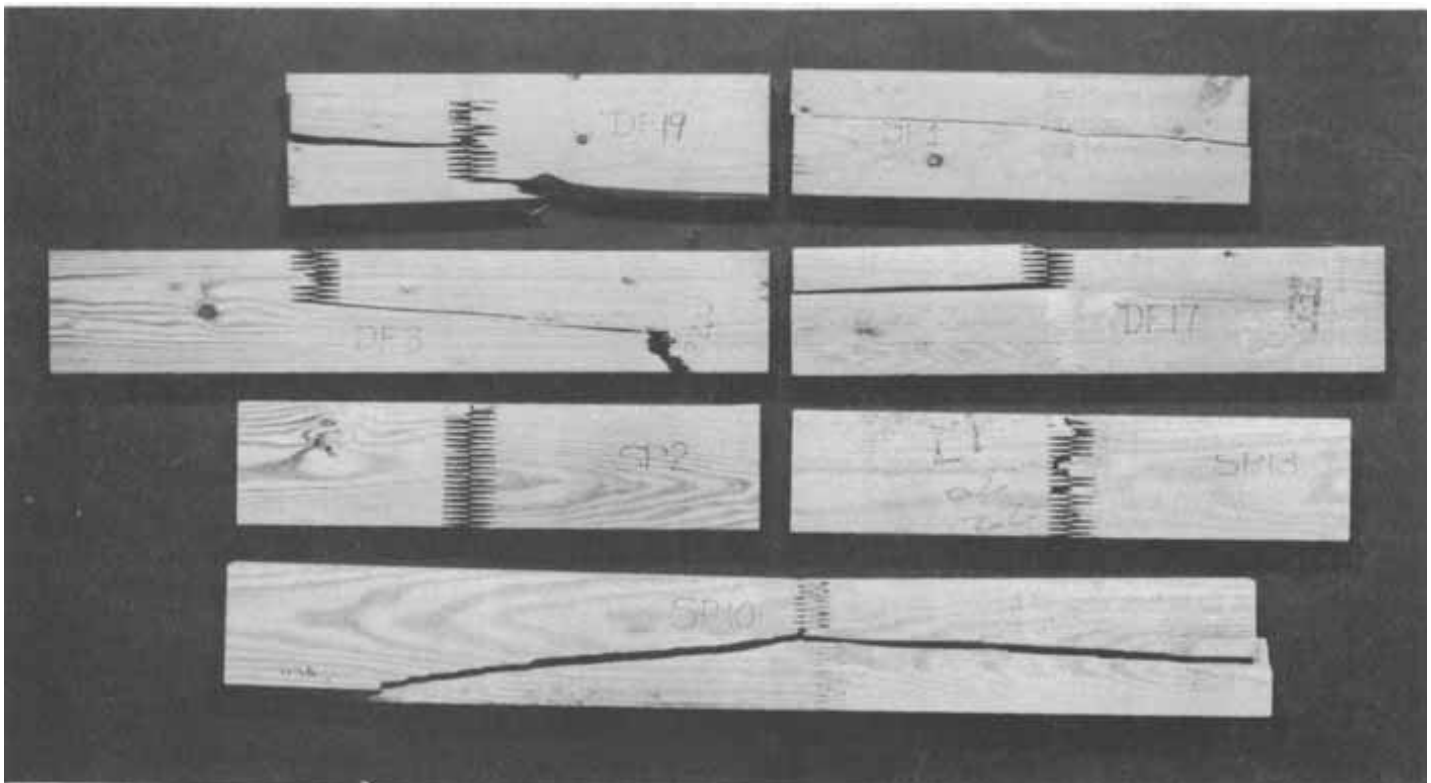
Figure D-1.—Failure sections of seven 302-24 grade tension test specimens.
