Resource Bulletin PNW-84  
May 1979

# MASS MOVEMENT RESPONSE TO FOREST MANAGEMENT IN THE CENTRAL OREGON COAST RANGES

Pacific Northwest Forest and Range Experiment Station  
U.S. Department of Agriculture • Forest Service

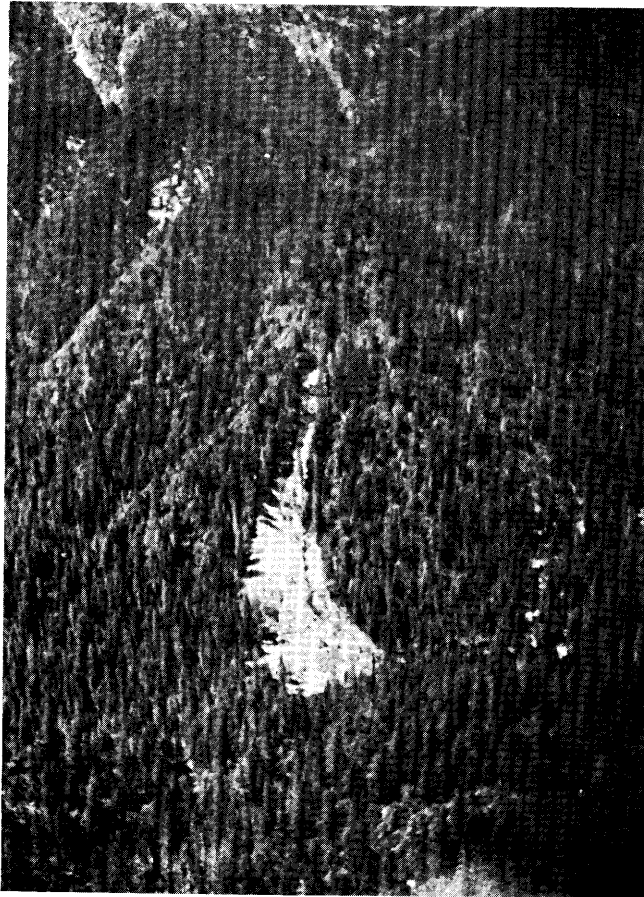
Figure 3.--Debris  
avalanche on an  
undisturbed  
slope.

Information on an event was recorded on a standard data sheet (fig. 2). Slides were first placed in one of three major categories: natural, road-related, or in-unit. Natural slides were those events which had no apparent relation to management activity (fig. 3). Road-related failures were those failures which occurred within the road prism or had an obvious connection to the road (fig. 4). Typically, those were from a concentration of drainage water by ditchline and culvert outfalls or by ditchline obstruction. Slides occurring at the edge of landings were considered road related. Those which occurred within the boundaries of clearcut units and had no apparent relation to roads or landings were in-unit slides (fig. 5).

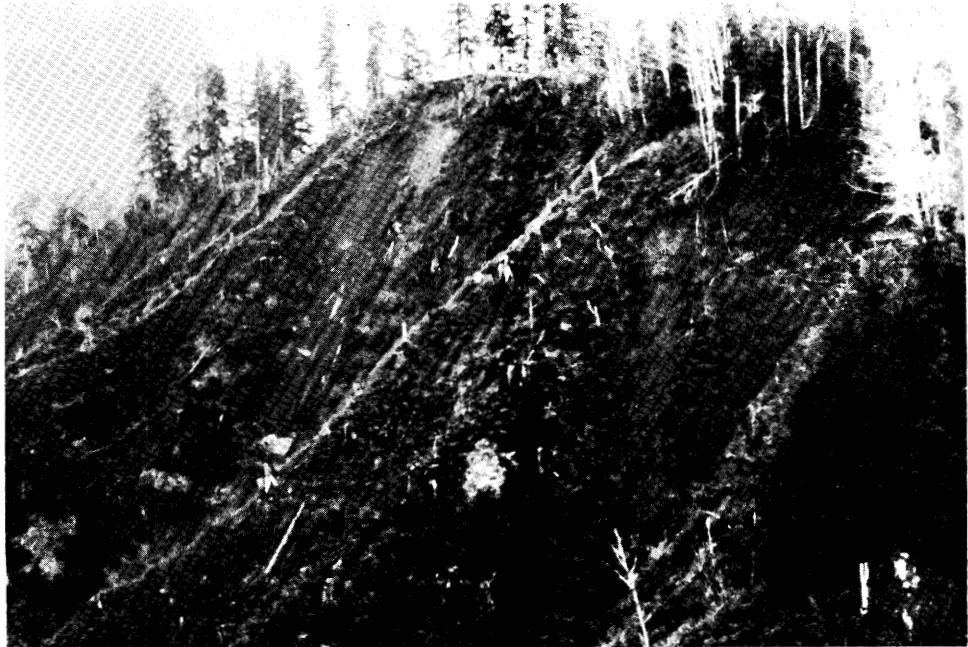
Figure 5.--Debris avalanche developed in clearcut units.

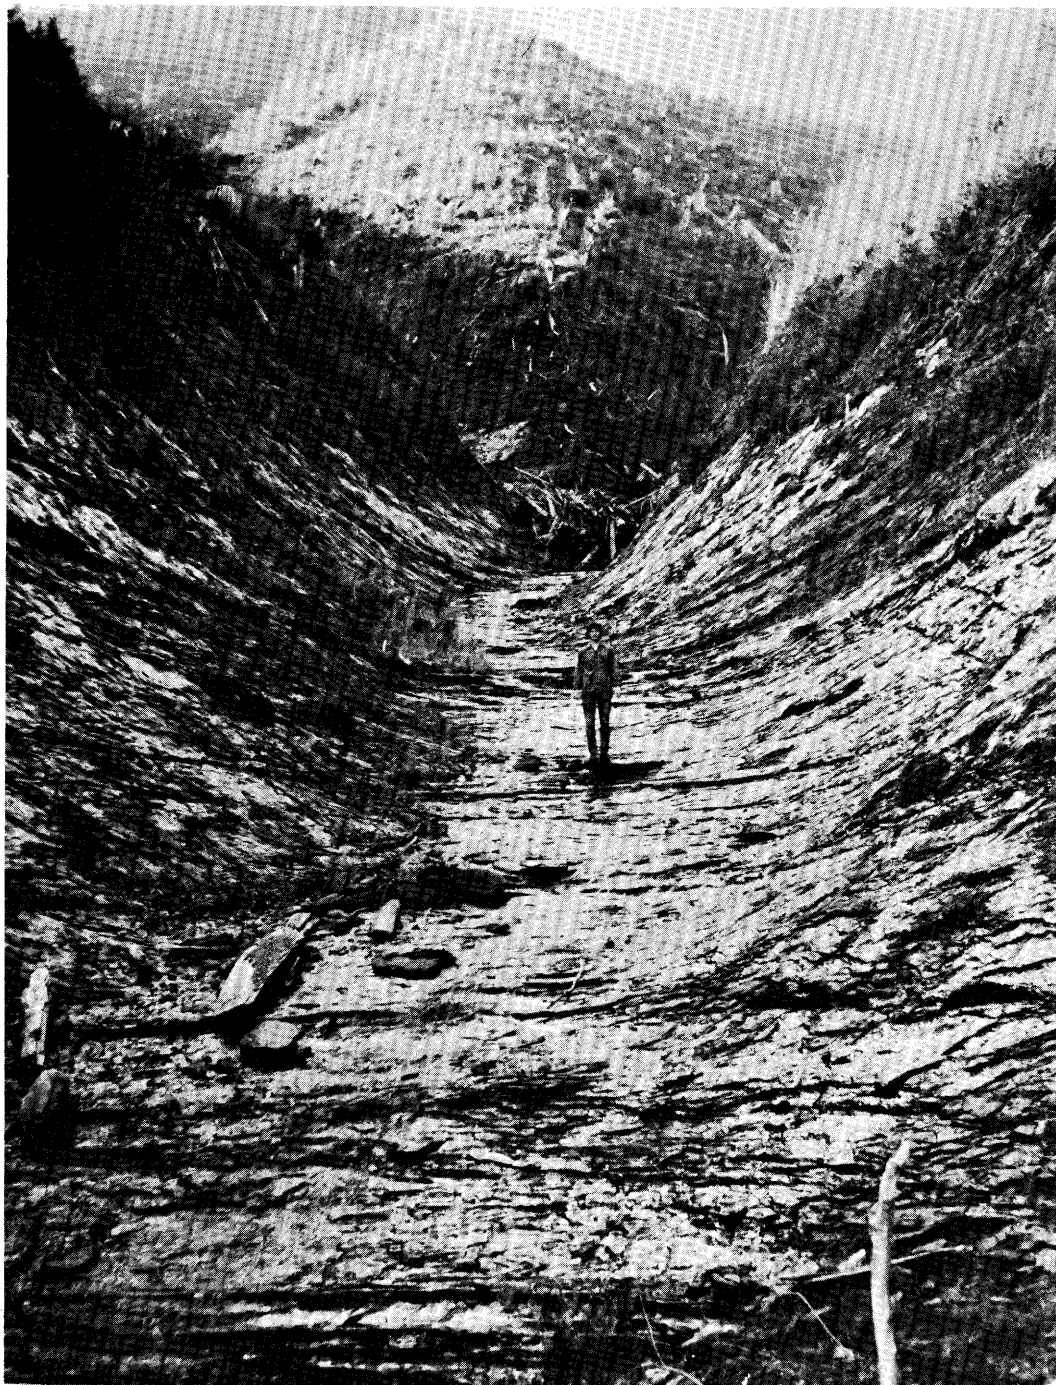
Figure 7.--Channel scour in a class I stream result from a debris torrent.

Mechanical scouring was the clearest impact to identify and define during the inventory (figure 7). It was possible to correlate scour directly with failure category. Thus, of the total length of channel scour observed (91,236 feet or 17.28 miles), 52 percent (47,395 feet or 8.98 miles) occurred as the result of in-unit failures. Road related failures accounted for 29 percent of about 26,140 feet (4.95 miles) of scour. Natural failures produced 19 percent or 17,700 feet (3.35 miles) of scour. All of these channel scour estimates are conservative.
