# Revegetation of Reconstructed Reaches of the Provo River, Heber Valley, Utah

**Abstract:** In 1999, the Utah Reclamation Mitigation and Conservation Commission began the Provo River Restoration Project to create a more naturally functioning riverine ecosystem between Jordanelle Dam and Deer Creek Reservoir. The purpose of the project was to mitigate for past impacts to riverine, wetland, and riparian habitats caused by the Central Utah Project and other Federal reclamation projects in Utah. Project implementation followed a management model where a great deal of planning and study preceded construction, which was closely followed by monitoring. Lessons applied to habitat restoration include: avoiding compaction; working with the natural disturbance regime of the river; and choosing the right plants for the site, including selecting the right size plant materials and outplanting at the appropriate density. Lessons learned include coordinating plant installation with plant availability and planting site availability, and irrigating during drought.

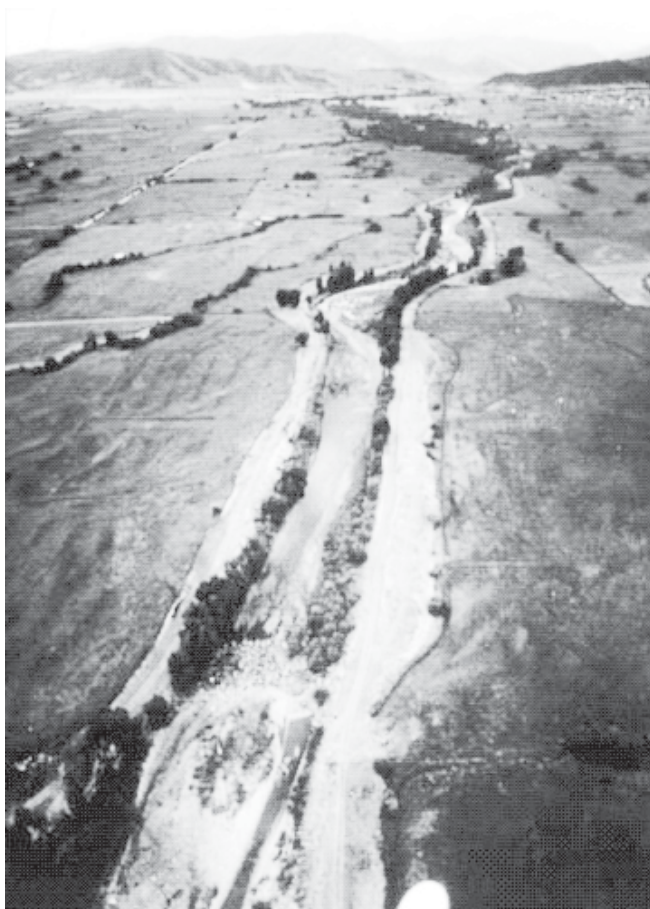
**Figure 1**—Provo River in Heber Valley before restoration.

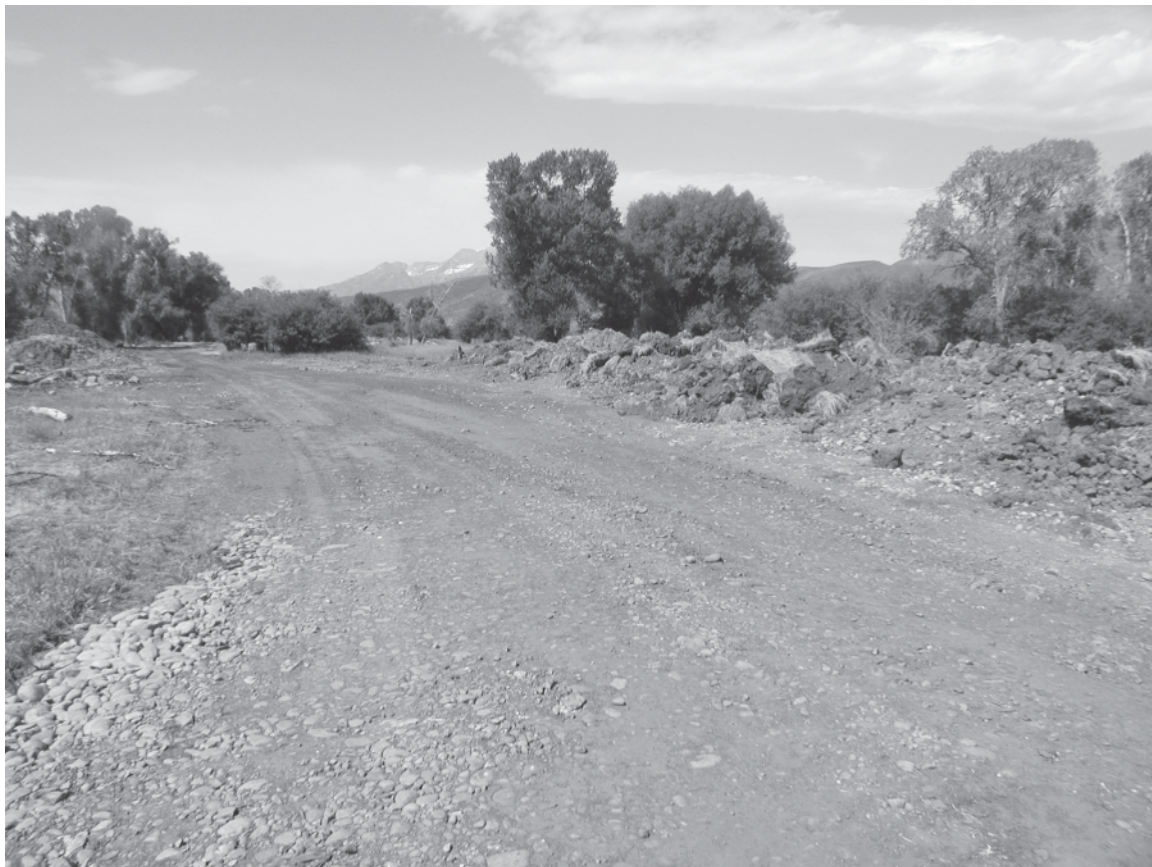
**Figure 2**—PRRP haul route. Note that the top foot of soil, which contains plant roots and seeds, has been stockpiled to the right of the road. This minimizes handling of the topsoil. Decommissioning of the route would follow the sequence of removing any road fill, grading to establish proper contour, ripping (if necessary), and replacement of topsoil.

Haul routes were minimized, and, to the maximum extent practicable, did not cross wetlands, wet areas, or constructed features. If crossing a constructed feature became necessary, compacted areas were ripped prior to topsoiling. No crossing was permissible on topsoiled areas (figure 2).

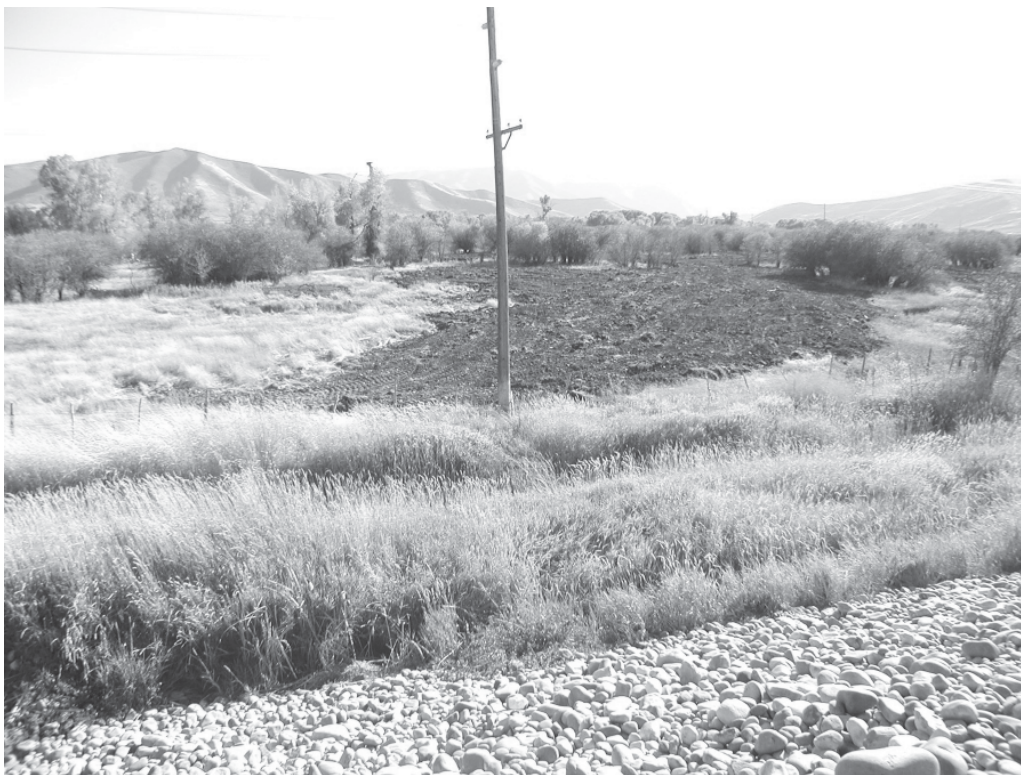
**Figure 3**—Small mammal refuge created by onsite disposal of excess material.

Onsite disposal of excess material can cause site impacts by disturbing additional area and possibly covering productive habitat. However, careful dispersal of excess material onsite will not only avoid transportation costs, but can reclaim disturbed habitats. For example, PRRP small mammal studies indicated that upland habitat for small mammals might be in short supply during high water events associated with periodic floods. For this reason, excess material has been used to raise the elevation of uplands in several areas in order to provide a refuge during high water events (figure 3).

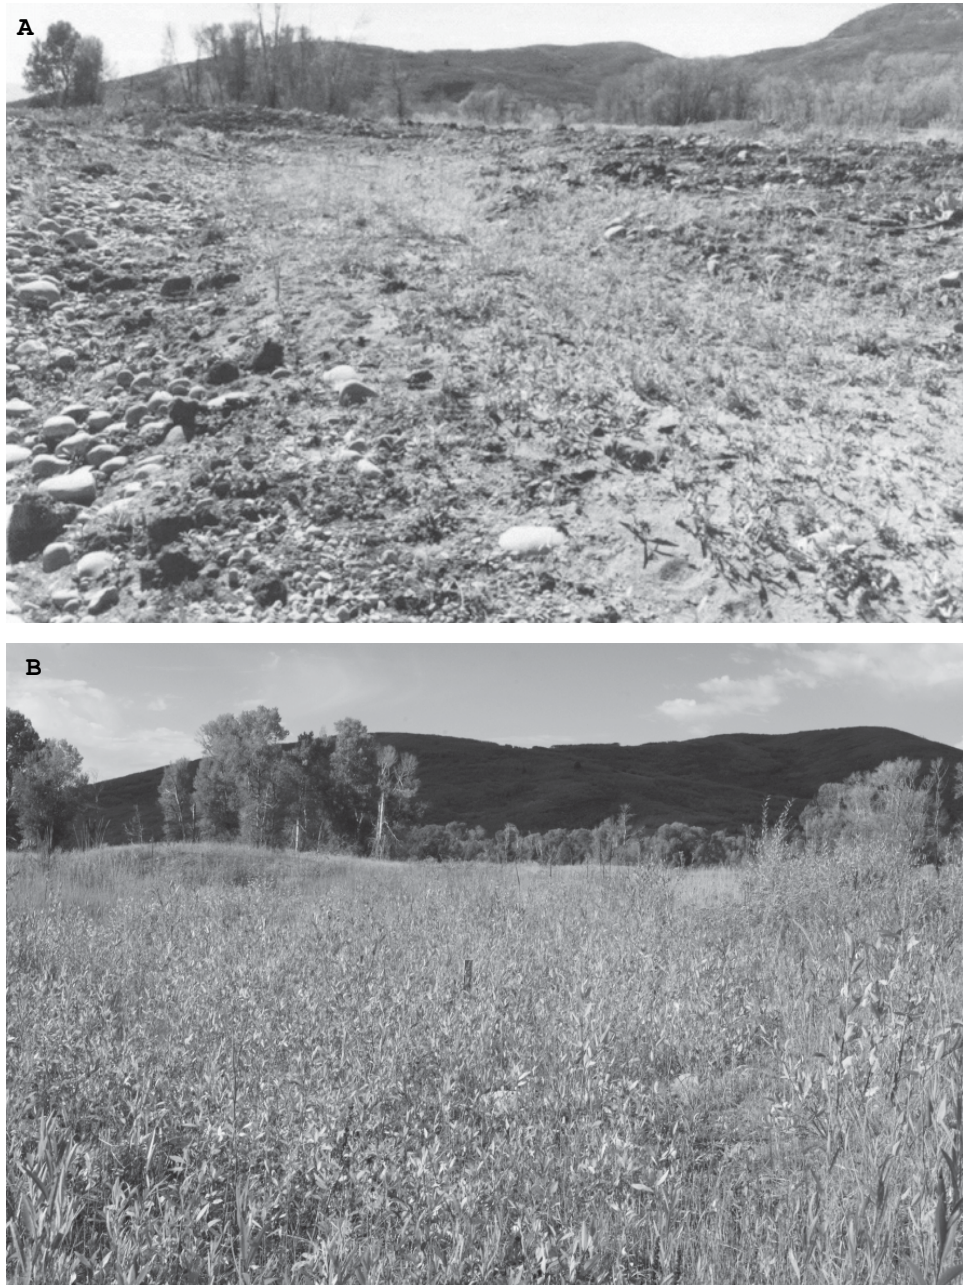
**Figure 4**—High flow channel one flood event after construction (A) and three flood events following construction (B). Note that no trees or shrubs have been installed at this location. Natural recruitment accounts for the many hundreds of seedlings.

Wherever possible, it was important to work with the natural disturbance regime of the river. Figure 4a shows the natural recruitment of hundreds of seedlings within a high flow channel following a single flood event, and figure 4b the natural recruitment of hundreds, if not thousands, of seedlings following three flood events. No trees or shrubs were

installed at this location, yet several cohorts of willow and cottonwood have successfully established because the natural disturbance regime of the river has been reestablished.
