# INTERPRETING PHYSIOLOGICAL DATA FROM RIPARIAN VEGETATION: CAUTIONS AND COMPLICATIONS<sup>1</sup>

John G. Williams<sup>2</sup>

*Abstract: Water potential and stomatal conductance are important indicators of the response of vegetation to manipulations of riparian systems. However, interpretation of measurements of these variables is not always straightforward. An extensive monitoring program along the Carmel River in central California, carried out by the Monterey Peninsula Water Management District, provides examples of the complications that can arise in practice.*

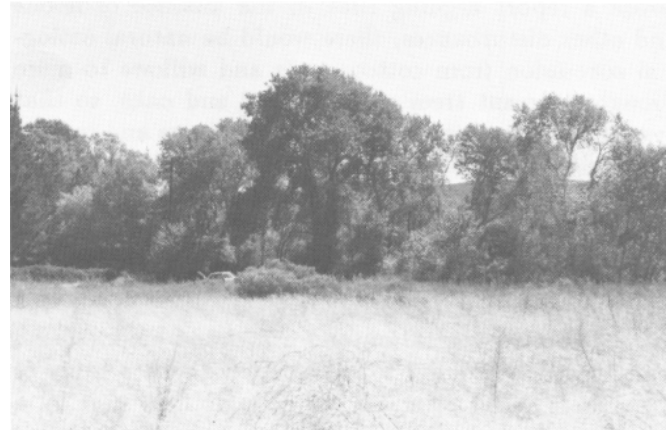
**Figure 1** – Relatively undisturbed riparian forest along the Carmel River; trees to the left in the picture grow over a layer of clay that buffers the effect of groundwater extractions.

The undisturbed riparian forest along the lower Carmel River is dominated by Black Cottonwood (*Populus trichocarpa*), together with abundant Arroyo Willow (*Salix lasiolepis*) and Red Willow (*S. laevigata*); White Alders (*Alnus rhombifolia*), Bay (*Myrica californica*), and Sycamore (*Plantanus racemosa*) and minor constituents. Large areas of riparian forest were cleared for agricultural and suburban development, but a nearly continuous stretch of forest existed along the lower river until recent decades (fig. 1).

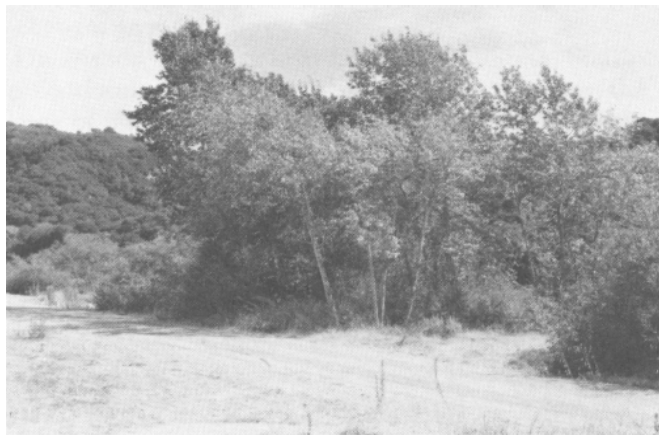
One group of trees monitored in 1985 are a stunted remnant of a closed canopy riparian forest that occupied the river terrace in this area until about 1970 (fig. 5). The cottonwoods here are probably root sprouts from larger trees that have died, fallen over, and decayed. A few large trees survive on this terrace around a well where they are watered by blow-off.

**Figure 5** – Remnant, stunted trees in an area long affected by groundwater extraction.

The 1985 data shows that DWP in these stunted trees declined steadily after the river stopped running in June, and the trees also steadily lost leaves. There was nothing unusual about the few conductance data taken here, although leaves on these trees appear to be smaller and thicker than on trees in areas not subject to large drops in the water table. Smith (1984) noted similar changes in leaf morphology along dewatered Sierran streams.
