# COYOTE CREEK (SANTA CLARA COUNTY) PILOT REVEGETATION PROJECT<sup>1</sup>

John T. Stanley, L. R. Silva, H. C. Appleton, M. S. Marangio, W. J. Lapaz and B. H. Goldner<sup>2</sup>

*Abstract: The Santa Clara Valley Water District, located in Northern California, is currently evaluating a pilot riparian revegetation project on a 1.6 ha (4 ac) site adjacent to Coyote Creek in the south San Francisco Bay Area. Specific techniques used during the design, site preparation and installation of 3640 plants (including seed planting locations) are described. This paper reports on the analysis of 1 year's data, comparing the survival of various types of plant materials for each of the 15 native plant species installed. Plant survival is evaluated for portions of the site irrigated by overhead sprinklers versus flood irrigation. Weed control techniques and plant protection measures are also discussed.*

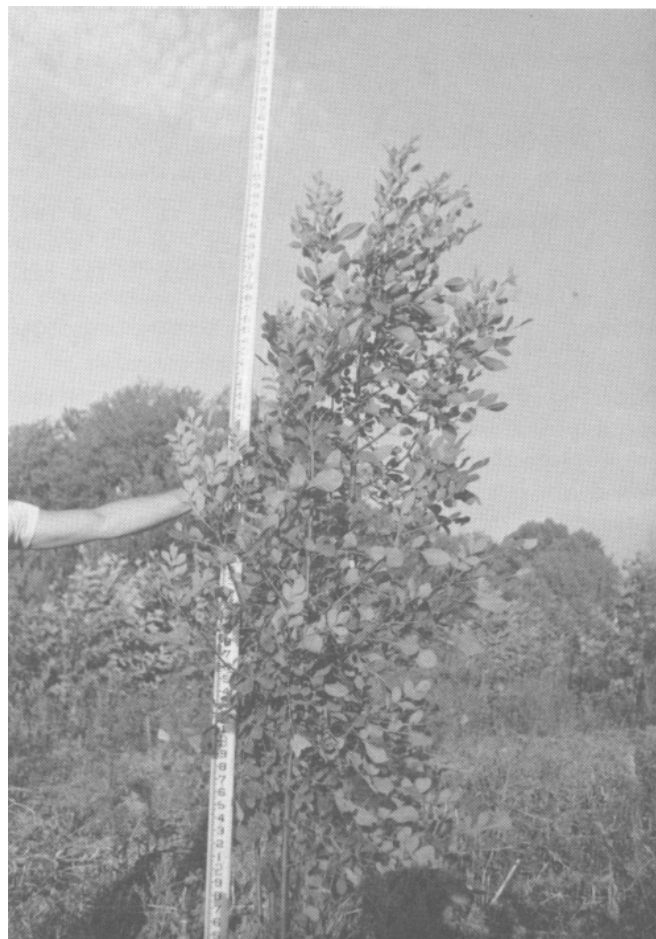
**Figure 4-** Flowering Ash from 1 gallon stock, 19 months after installation (2.6 m [8.5 ft], flood irrigation).

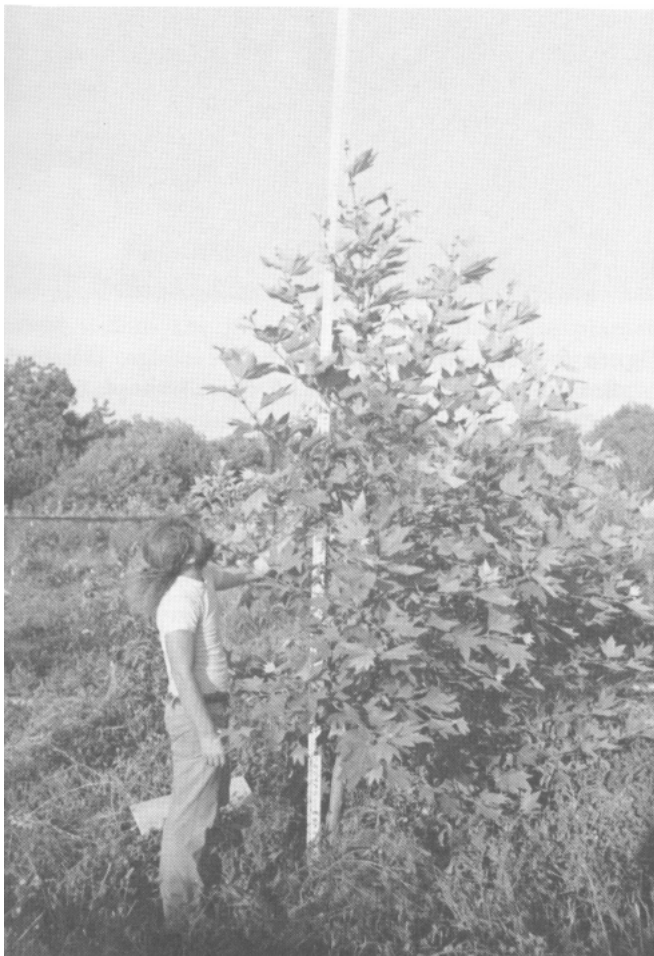
**Figure 5-** Western Sycamore from 1 gallon stock, 19 months after installation (3.3 m [11 ft], flood irrigation).

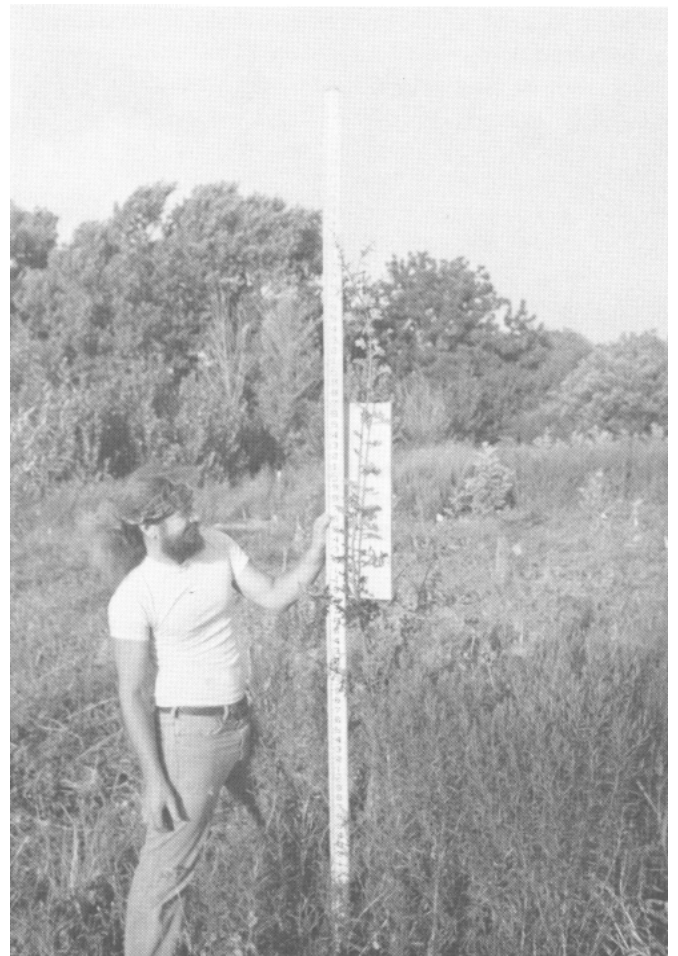
**Figure 6-** Valley Oak from 1 gallon stock, 19 months after installation (2.2 m [7.3 ft], flood irrigation).

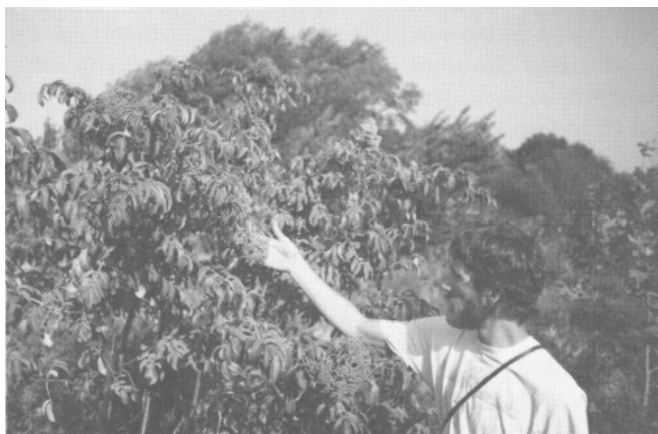
**Figure 7-** Blue Elderberry from 1 gallon stock, 19 months after installation (flood irrigation, note fruit).

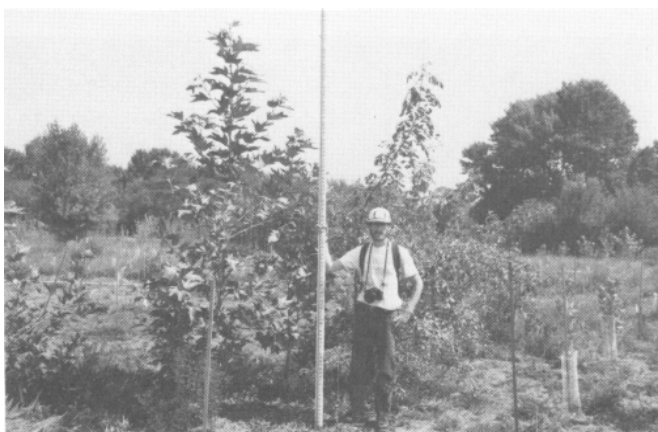
**Figure 8-** Western Sycamore and Blue Elderberry from 1 gallon stock, 19 months after installation (3.2 m [10.8 ft], overhead sprinkler irrigation).

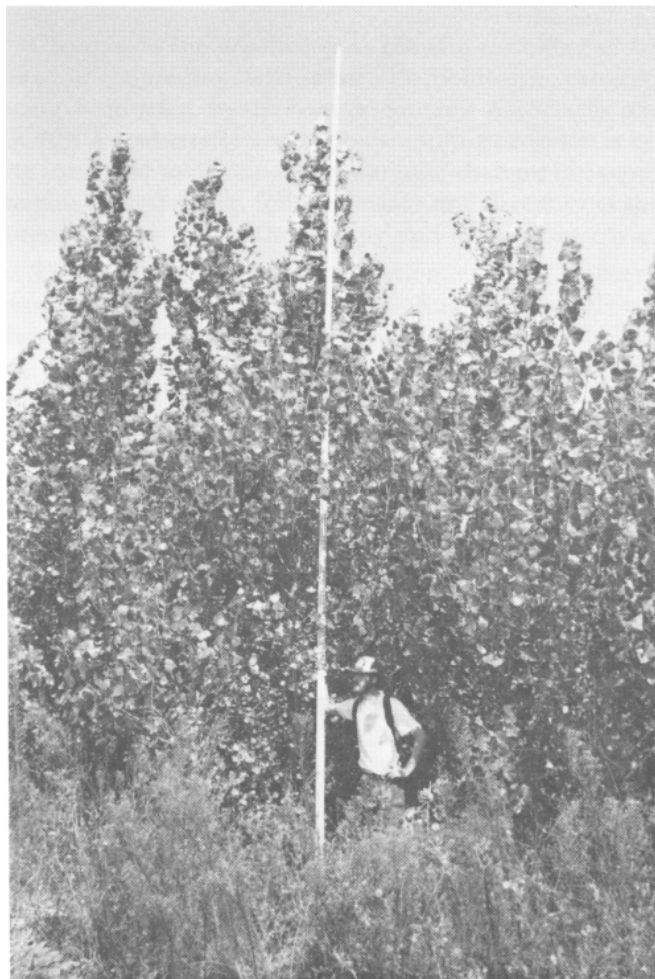
**Figure 9-** Fremont Cottonwood pole cuttings, 19 months after installation (7.1 m [23.5 ft], overhead sprinkler irrigation).

Three-meter (10-ft) long pole cuttings were taken from nearby Fremont cottonwoods. Poles were no larger than 4.4 cm (1 3/4 in) in diameter with the branches and succulent tops pruned off. The poles were inserted into augered 1.8 m (6 ft) deep, 20 cm (8 in) diameter, holes which were then back-filled with "tamped-in" native soil.

Initial growth in the flood irrigation area subjectively appeared to be more rapid than in the sprinkler section. Most of the cottonwood pole cuttings were 3.6-4.6 m (12-15 ft) tall at the end of one growing season. We will be analyzing the data on growth rates of the trees after we collect another year's data.
