# TIME DOMAIN ULTRASONIC SIGNAL CHARACTERIZATION FOR DEFECTS IN THIN UNSURFACED HARDWOOD LUMBER

*Mohammed F. Kabir* †

*Daniel L. Schmoldt*

*Mark E. Schafer*

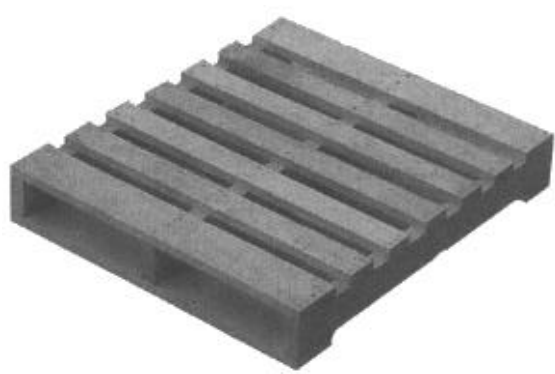
FIG. 1. A typical stringer pallet employed by the Grocery Manufacturers Association contains top and bottom deckboards and notched stringers.

wood pallet consists of two parts: (1) stringers, the structural center members that support the load, and (2) deckboards, the top and bottom members that provide dimensional stability and product placement (Fig. 1). Most pallet parts are produced from low-quality lumber or from the center cant material of logs. Because these cants originate from the defect-laden central core of logs, they have less market value for other solid wood products. Pallets are a major part of the world's transportation infra-

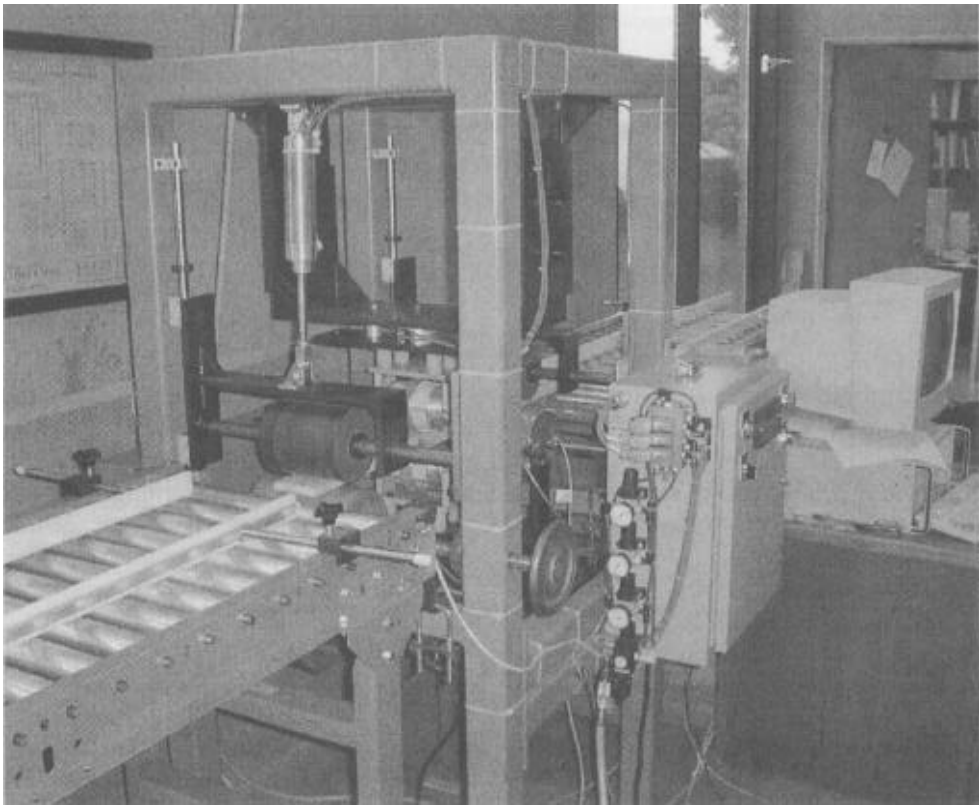
FIG. 2. Our ultrasonic scanning system includes materials handling, computer control of part movement and data collection, and ultrasound electronics.

in-fed and out-fed roll beds, two pinch rollers for parts movement, and two rolling transducers, which are mounted in an ultrasonic scanning ring (Fig. 2). Pallet parts are driven through the system longitudinally by the motorized pinch rollers. Perceptron provided the necessary electronics and software to control material movement, signal generation, and waveform capture and analysis. Data are collected, stored, and processed by LabView™ software. The desired scanning resolution can be achieved by controlling roller speed and the number of pulses generated per second. Both transducer rollers are 9 cm in diameter and 8.9 cm in width. A plastic tier 1.9 cm in width is mounted on each of the transducer rollers to provide good contact with the sample. The transducers can be operated at a range of frequencies from 90 to 180 kHz.

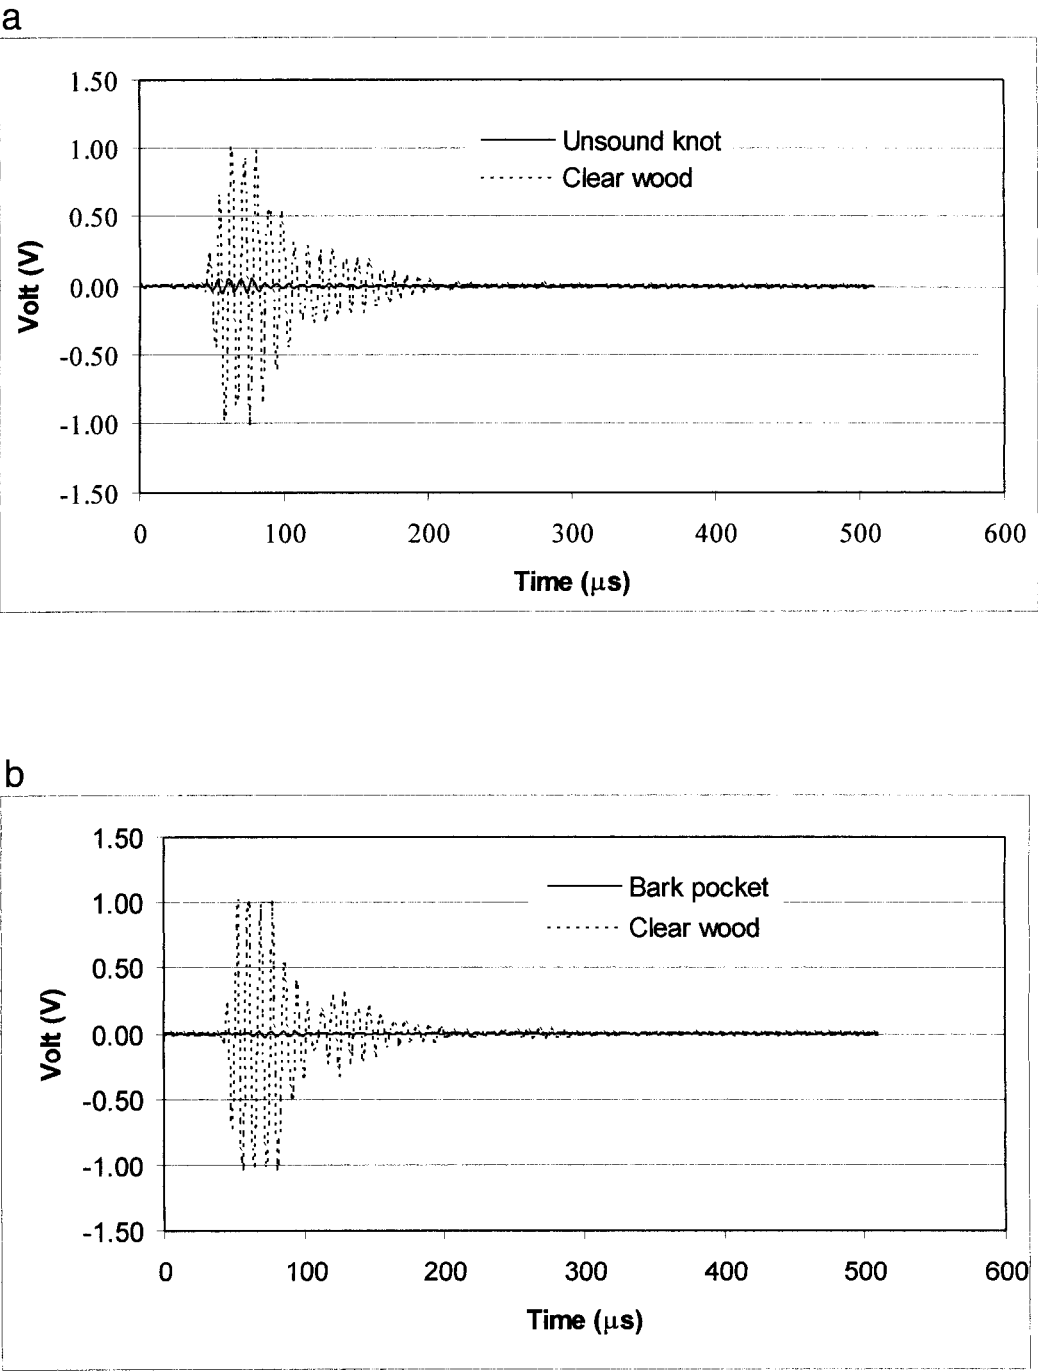
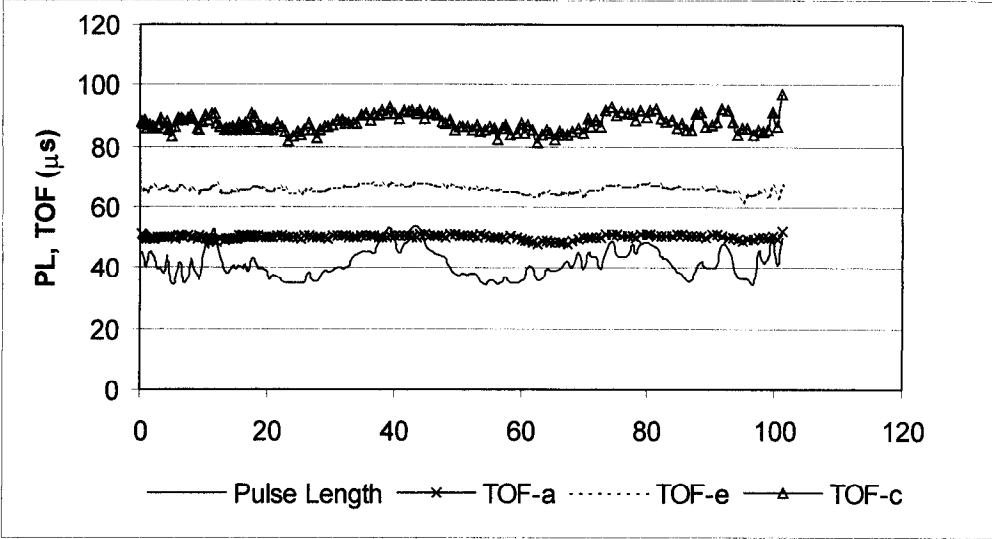
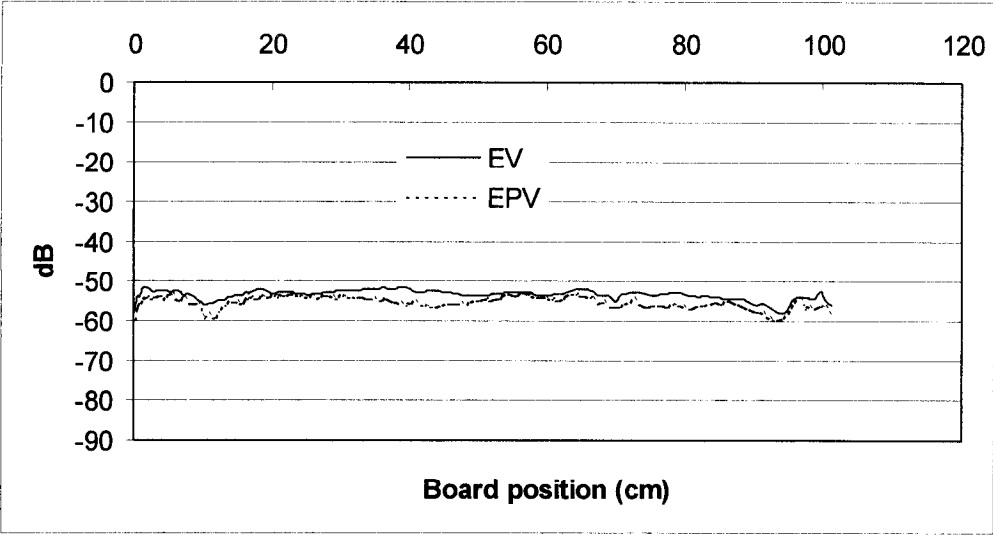
FIG. 3. Ultrasonic time-domain signals through clear and effected yellow-poplar show a dramatic loss in signal strength for unsound defects, (a) an unsound knot, (b) bark pocket.

Six variables—pulse length (PL), time-of-flight-centroid (TOF-c), time-of-flight-energy (TOF-e), time-of-flight-amplitude (TOF-a), energy value (EV), and energy/pulse value (EPV)—were calculated from each ultrasound waveform captured at each measurement point. Examples of received ultrasonic waveforms through clear wood and defected wood are shown in Fig. 3a and Fig. 3b. It can be seen in this figure that defected wood, i.e., unsound knot and bark pocket, reduce the amplitude of the signal substantially.

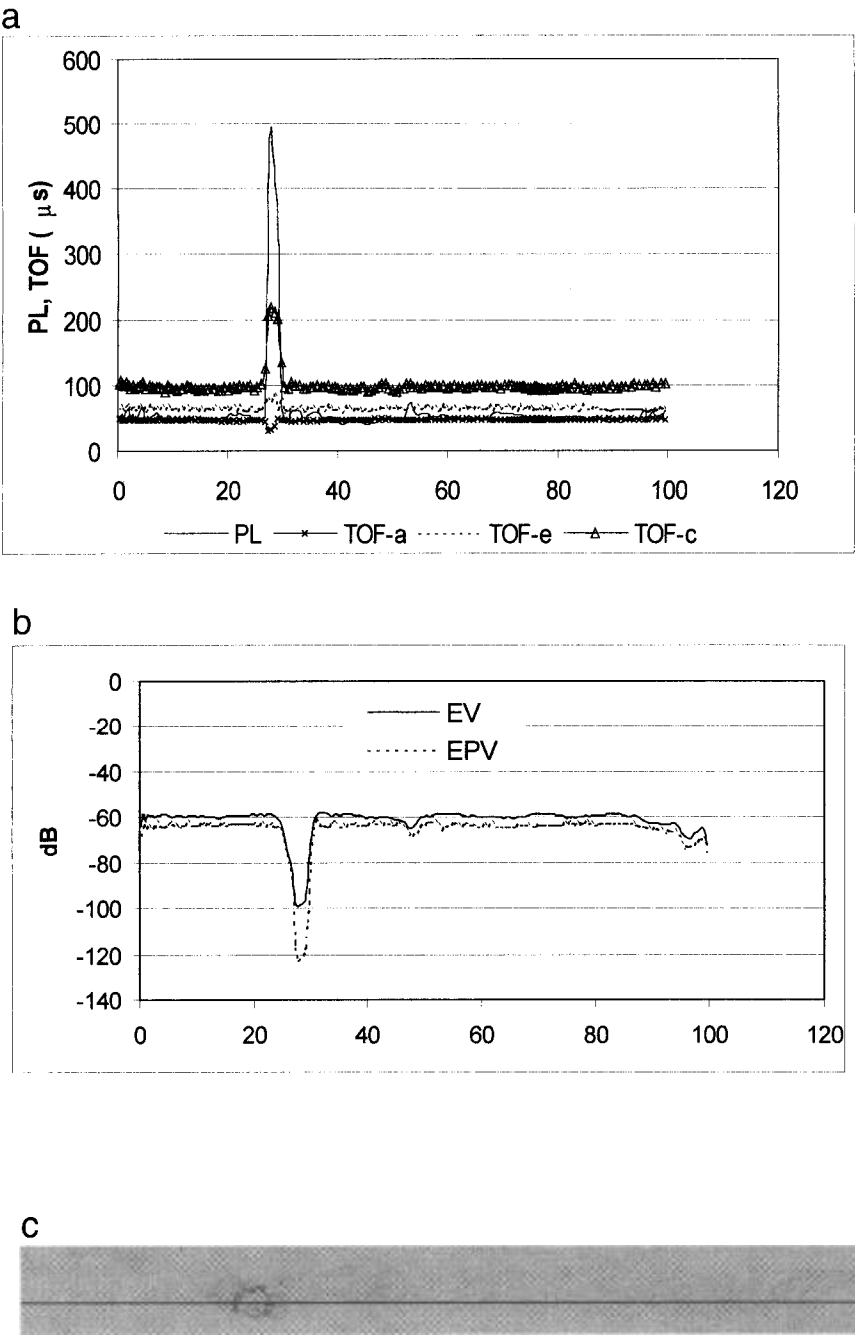
FIG. 5. Ultrasonic variables are graphed for a scan line through an unsound knot in red oak, (a) energy, PL, TOF-a, TOF-e, and TOF-c, (b) EV and EPV, and (c) board photo. The scan line is marked on the board image.

An unsound knot has a much greater effect on both TOF variables and energy loss variables (Fig. 5a, b). Almost all variables change abruptly in proximity to the unsound knot. Unsound knots come in two manifestations: knots that are not integrated with the surrounding wood (resulting in some wood disintegration at the knot-wood interface that produces a loose knot, or a hole, after drying) and knots that contain bark and/or decay at the center.

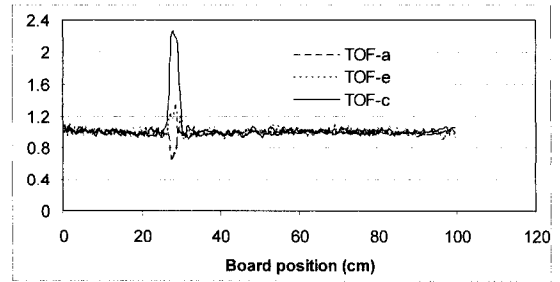
FIG. 6. Normalized TOF-a, TOF-e, and TOF-c, values are plotted for the deckboard in Fig. 5c.

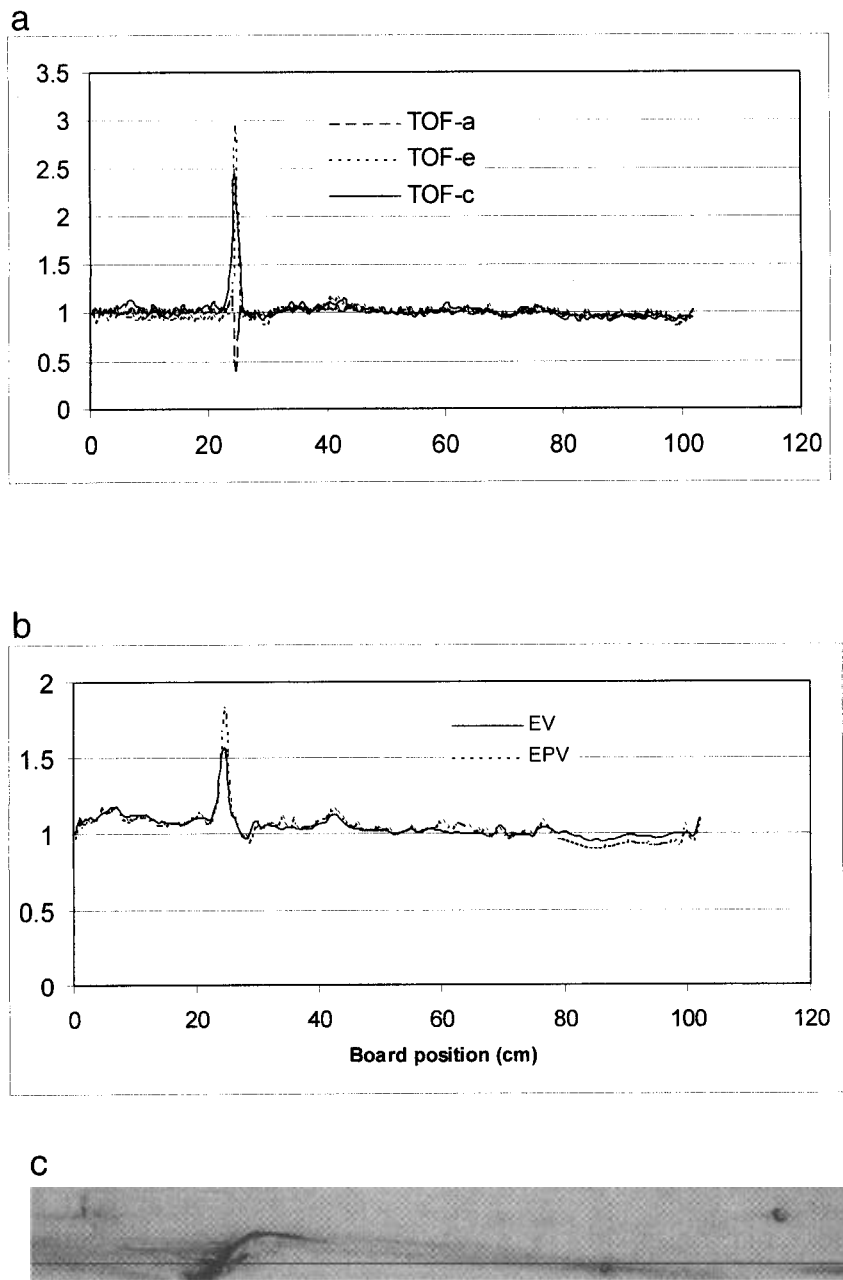
FIG. 7. Normalized ultrasonic variables are graphed for a scan line through a bark pocket in a yellow-poplar deckboard, (a) TOF-a, TOF-e, and TOF-c, (b) EV and EPV, and (c) board photo. The scan line is marked on the board image.

Ultrasonic responses to other unsound defects appear in Fig. 7 and Fig. 8. Figure 7 shows normalized ultrasonic variables from a scan line through a bark pocket on a yellow-poplar deckboard. Because bark is an unsound defect in wood, its ultrasonic signature is very similar to other unsound defects, e.g., unsound knots and decay. Figure 8 depicts the effect on ultrasonic signals. Both TOF and energy loss change sharply in the region of decay. Decay's effect on TOF-a and TOF-e is not as dramatic as TOF-c, and slightly different from either the bark pocket or the unsound knot.

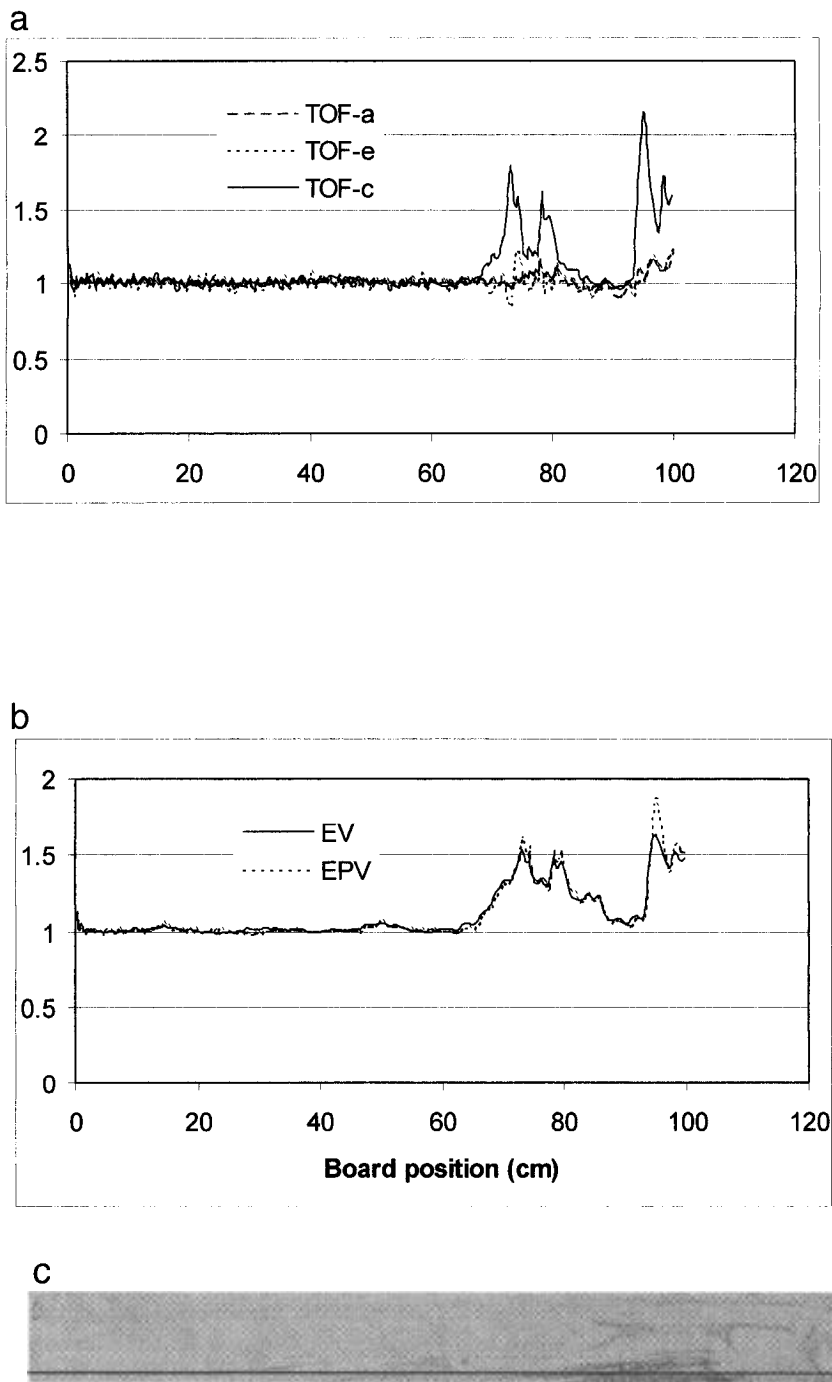
FIG. 8. Normalized ultrasonic variables are graphed for a scan line through decay in an oak deckboard, (a) TOF-a, TOF-e, and TOF-c, (b) EV and EPV. The scan line is marked on the board image.

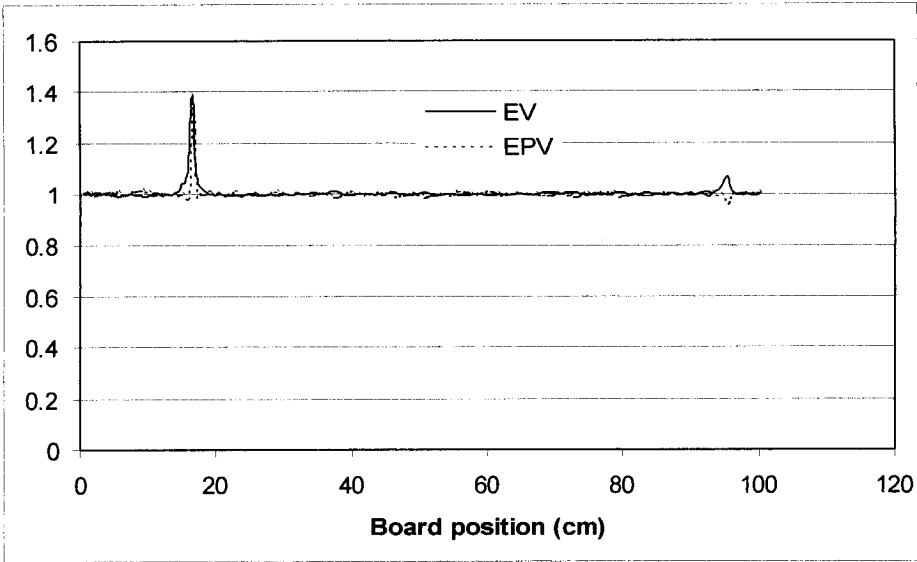
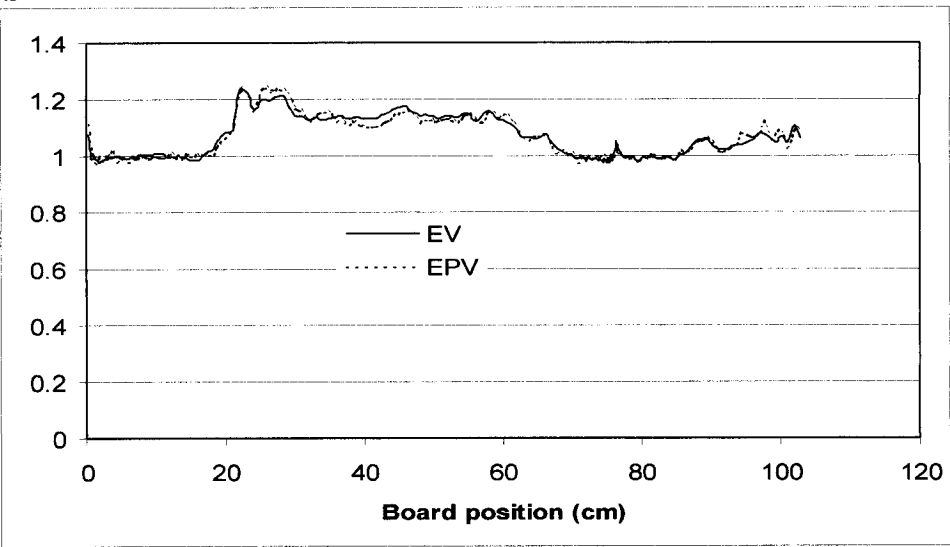
FIG. 9. Normalized energy values and energy/pulse values are graphed for a scan line through a hole (a) and wane (b) of an oak deckboard.

Figure 9 illustrates the response of ultrasound to holes and wane. These are defects associated with the absence of wood (voids). Both the hole and the wane areas exhibit increased EV and EPV losses relative to clear wood. In both cases, greater energy losses result from poor transducer to wood contact induced by the voids.

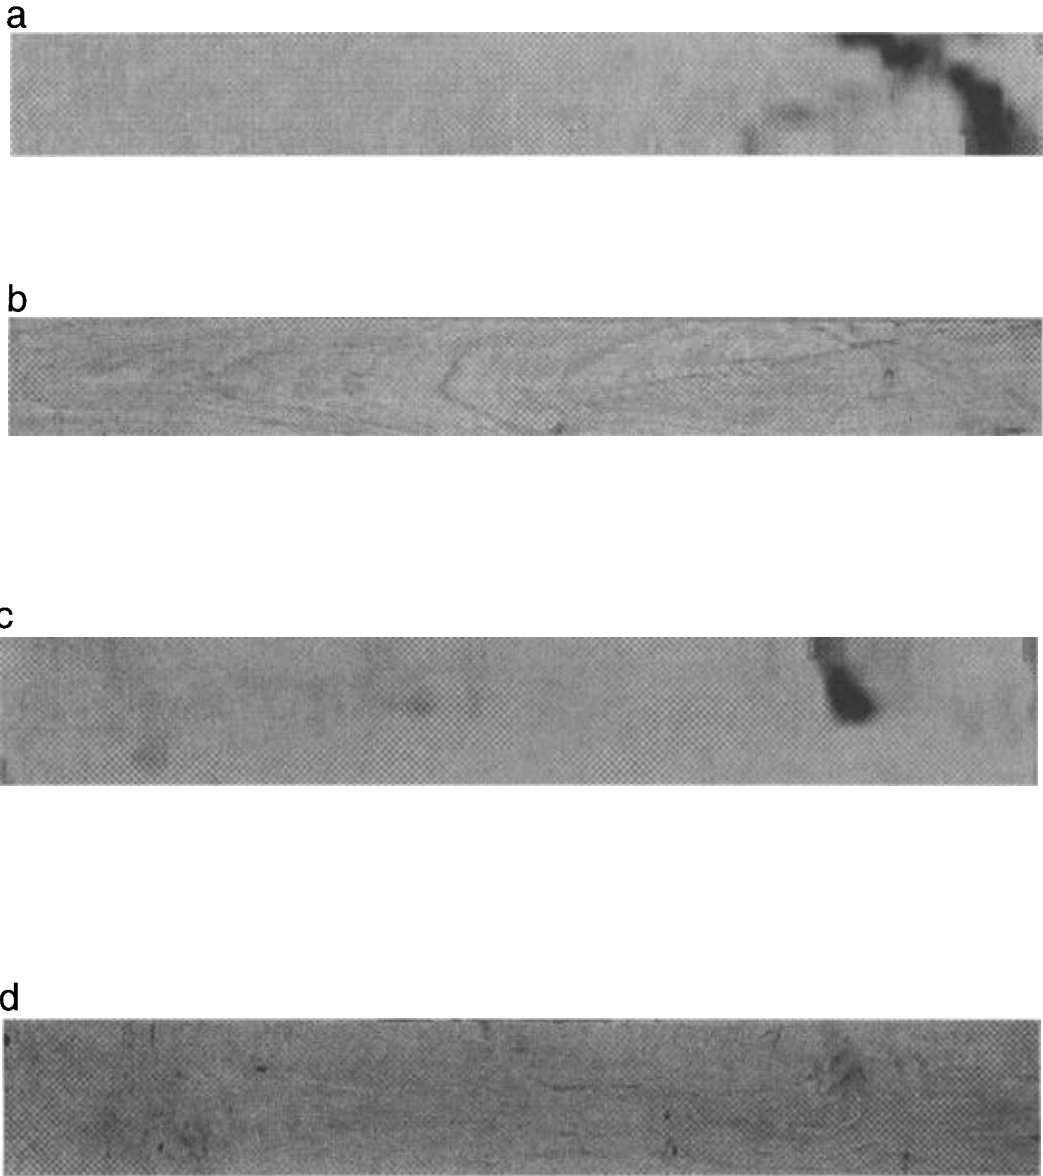
FIG. 10. Images were generated using multi-line scanning. EV values (a and c) and gray-scale photos (b and d) depict a split and a sound knot, respectively.

agery, or ultrasonic maps, where each scan will provide multiple images (one image for each ultrasonic variable). Simultaneous multiple-line scanning will be required to achieve this. For illustrative purposes, manual multi-line scanning data are presented in Fig. 10, where lines are separated by 1.27 cm. Defect-

ed areas (darker regions) can be seen quite readily.

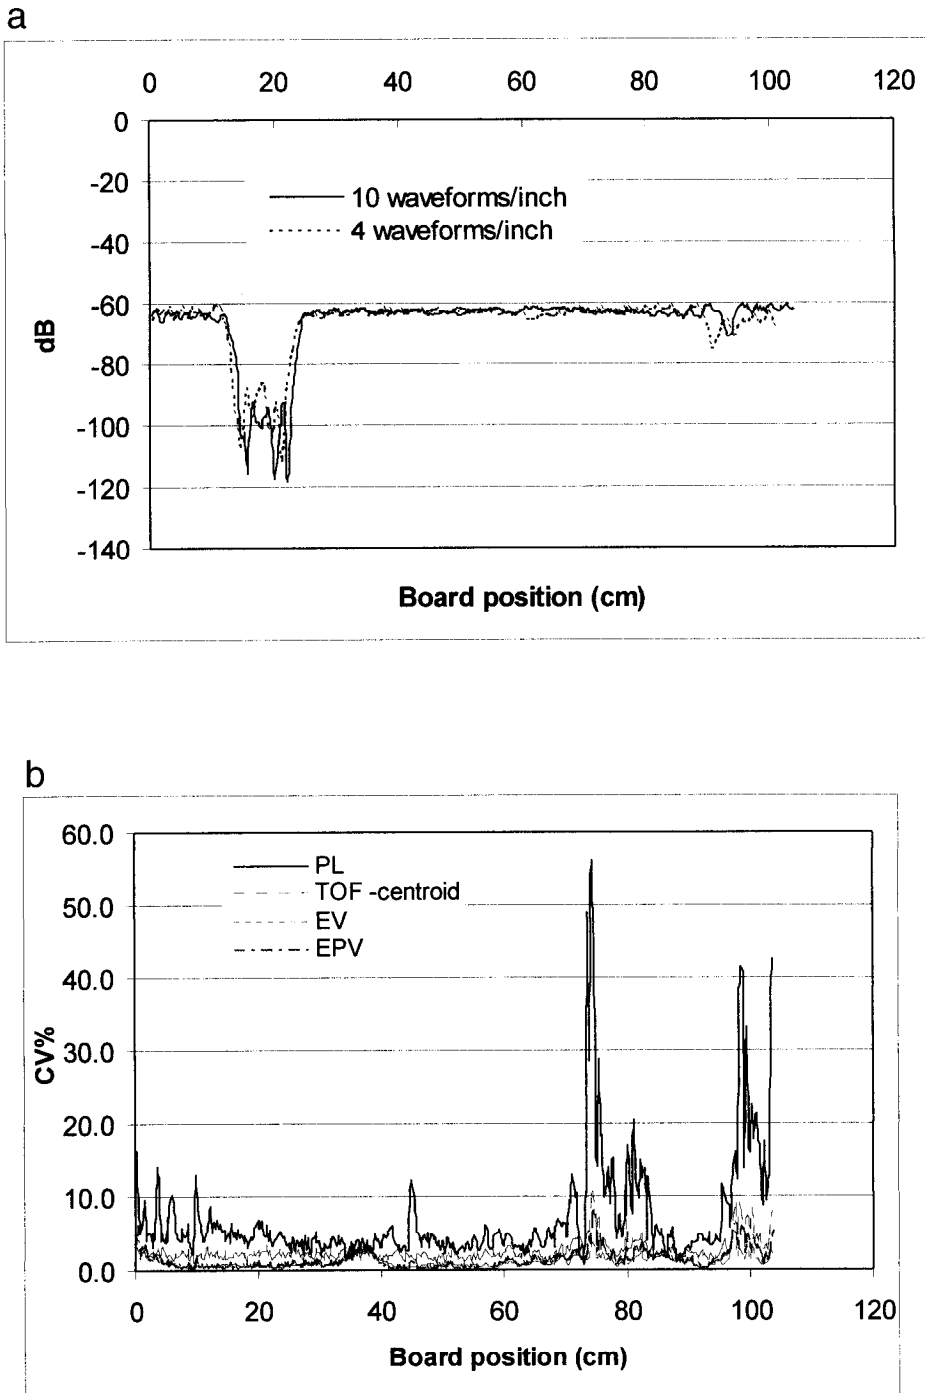
FIG. 11. Energy loss values are plotted for two different scanning rates along the same scan line on a red oak board (a). Percent coefficient of variation (CV%) is shown for several ultrasound variables using ten repeated measurements of the same scan line on a yellow-poplar board (b).

Repeated measurement plots appear in Fig. 11. Two scanning rates—4 waveforms/cm and 1.6 waveforms/cm—for the EPV measurements are shown in Fig. 11a for red oak. This illustration suggests that scanning rate does

not have much effect on energy/pulse value measurements. To examine the repeatability and reliability of data collection, a set of boards was scanned ten times on the same scan line, and coefficients of variation (CVs) were calculated. The percent CV (CV%) for a decay sample on yellow-poplar is presented in Fig. 11b. Low CV% values for most calculated variables suggest that data collection repeatability is acceptable, although a high CV% was obtained for PL. The higher CV% values for PL in relation to other defects were reported earlier (Kabir et al. 2000a). The higher CV% values are confined primarily to the defected regions. This suggests that PL may be more sensitive to a shifting data collection point, which can occur with multiple scans of the same line in which repeated data points are not perfectly registered spatially.
