## **Minimizing Corrosive Action in Timber Bridges Treated With Waterborne Preservatives**

Zelinka, Samuel L. ; Rammer, Douglas R. ; Wacker, James P. 2007. Minimizing corrosive action in timber bridges treated with waterborne preservatives. IN: Lyons, Robert, ed. Proceedings of the 2007 Structures Congress: New horizons and better practices; 2007 May 16-19; Long Beach, CA. Proceedings published on CD.

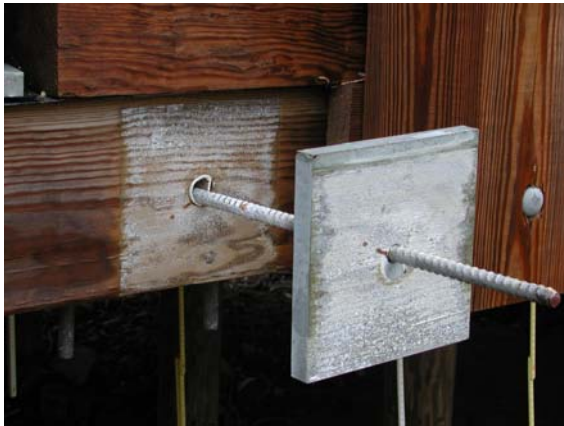
FIGURE 1  
PVC TUBING SEPARATING ACQ TREATMENT  
FROM GALVANIZED HIGH-STRENGTH STEEL  
BARS WITHIN A STRESS-LAMINATED DECK  
DECK. NOTICE THE WHITE CORROSION  
PRODUCTS.

Ceramic and organic coatings and barriers try to completely isolate the substrate from the corrosive environment (Figures 1 and 2). The effectiveness of these coatings depends on their ability to provide and maintain a defect-free, dry environment on the surface of the fastener. Organic coatings range from common alkyd paints to epoxy resins to various rubbers, although they all work upon the same principle of isolation. This wide range of materials allows for a certain degree of optimization of the coating to the environment and use. Ceramic linings, although more porous than their organic counterparts, have a higher hardness, which is important because any damage that occurs to the coating during insertion will give the corrosive environment a path to the substrate, and pitting and/or crevice corrosion may occur at these sites.

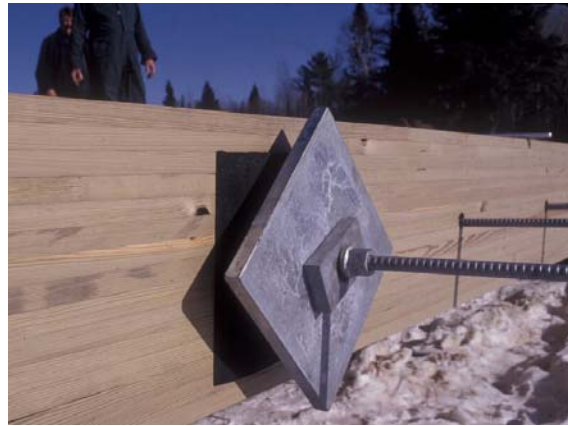
FIGURE 2  
ROOF SHINGLE MATERIAL SEPARATING A  
STEEL BEARING PLATE FROM CCA-  
TREATED WOOD DECK.
