# STREAM NOTES

January 2008

## Post-fire Erosion and the Effectiveness of Emergency Rehabilitation Treatments over Time

by Lee H. MacDonald and Peter R. Robichaud

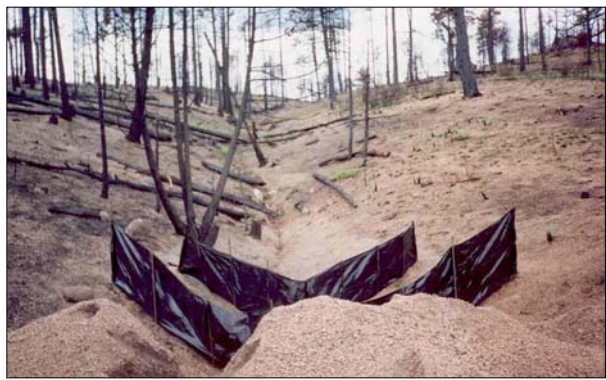
Figure 1. Photo from summer 2003 showing a pair of sediment fences, the piles of sediment excavated from the fences, and the relatively bare hillslopes after the June 2002 Hayman fire.

To evaluate the effectiveness of the different BAER treatments (straw mulching, hydromulching, scarification and seeding, and application of a polyacrylamide), we established 18 pairs of treated and control hillslopes plus four nearby hillslopes that had been treated with aerial hydromulching. Eroded sediment was captured and measured at each site with sediment fences (fig. 1). Most of the control sites were established within several weeks after burning in summer 2002, and the treatments were applied within 1-3 months after burning. All sites had burned at high severity, and they have been monitored through summer 2007. Rainfall simulations in the field and in the laboratory allowed more controlled studies of treatment effectiveness and the underlying runoff and erosion processes. A series of lab experiments also were conducted to test whether the polyacrylamide (PAM) preferentially binds with mineral soil and/or ash in aqueous solutions.

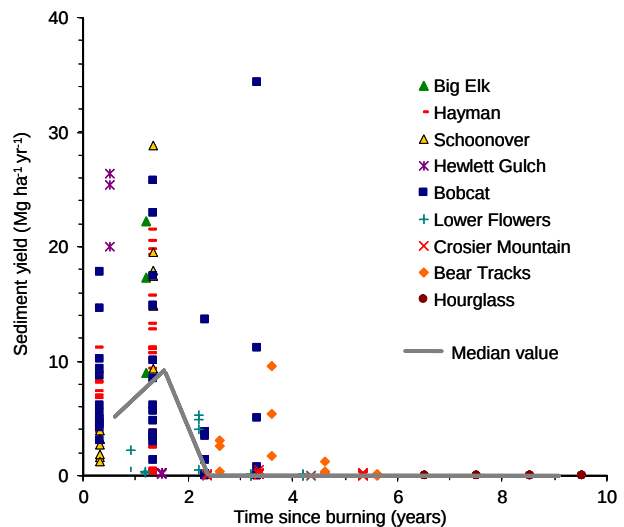
Figure 2. Annual sediment yields versus time since burning for plots at six wildfires burned at high severity and three prescribed fires in the Colorado Front Range.

Sediment production rates from sites burned at high-severity generally approach background rates by the third summer or roughly 24 months after burning (fig. 2) (Benavides-Solorio and

MacDonald, 2005; Pietraszek, 2006). Median sediment production rates are highest in the second summer after burning because summer rainfall is typically very low in the summer of burning. By the third or fourth summer after burning the median sediment production rate usually drops to near-background levels, but very high values can still occur as a result of severe storm events or those sites with particularly poor growing conditions. The range of values shows the extreme spatial and temporal variability, particularly in the first three years after burning. It is important to note that some of this variability cannot be readily explained by the observed differences in rainfall, ground cover, slope, or other site conditions.

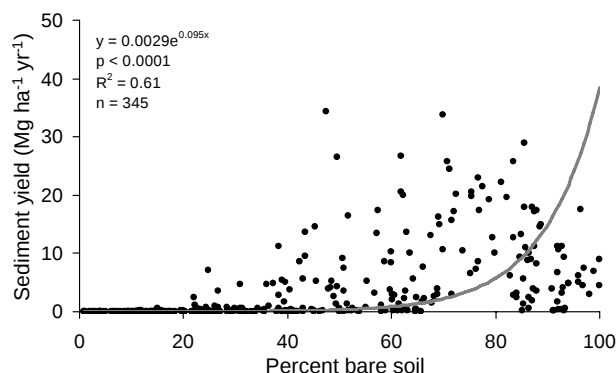
Figure 3. Relationship between percent bare soil and annual sediment yield. Data were collected from seven wildfires and three prescribed fires in the Colorado Front Range.

The large dataset collected under this and our other projects allowed us to evaluate the importance of different site characteristics on post-fire sediment production rates from both untreated and treated areas. The most significant finding is that post-fire sediment yields at the hillslope scale are most closely related to percent bare soil (fig. 3). The combined dataset shows that post-fire erosion rates are generally very low if there is less than 35-40% bare soil, highly variable when there is between 35 and 60% bare soil, and almost always high when there is more than 65% bare soil (Pietraszek, 2006). Rainfall simulation experiments indicate that percent ground cover is critical because this prevents the development of a structural seal at the soil surface that can greatly reduce infiltration rates. The ash cover present after a fire provides only a limited and very short-term protection against soil sealing. Surprisingly, removing the ground cover from an unburned site causes a similar erosion response as a high-severity wildfire (Larsen et al., in review).

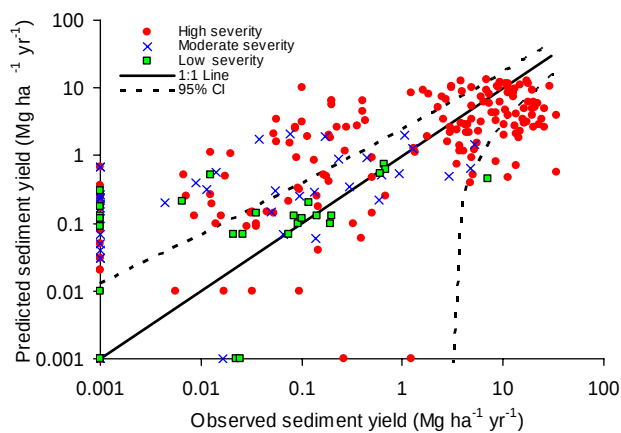
Figure 4. Mean of the predicted sediment yields using Disturbed WEPP for individual hillslopes.

sediment yields and underpredict high sediment yields (fig. 4). Neither RUSLE nor Disturbed WEPP were able to accurately predict post-fire sediment yields for individual hillslopes because of the high variability between sites and the inability to accurately represent all of the site characteristics that affect sediment yields. RUSLE and Disturbed WEPP were much more successful at predicting average sediment yields for a given fire and fire severity (Larsen and MacDonald, 2007).

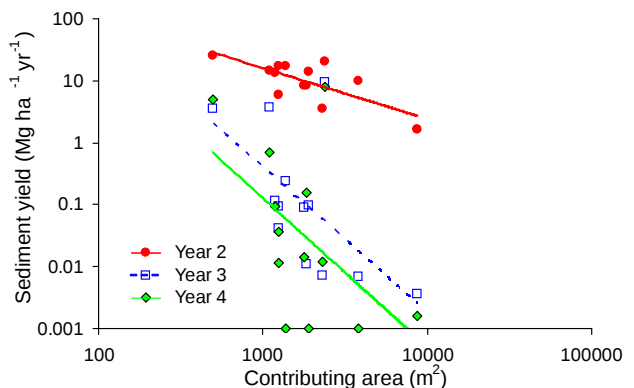
Figure 5. Sediment yield versus contributing area for convergent hillslopes, Bobcat wildfire.

The large dataset collected under this and our other projects is allowing us to determine whether sediment yields at the small plot or hillslope scale can be extrapolated to the small watershed scale. For the first two or three years after burning sediment yields for areas burned at high severity are relatively constant per unit area, but decline sharply with increasing area as burned areas recover (fig. 5) (Larsen et al., in prep.-b). Rainfall

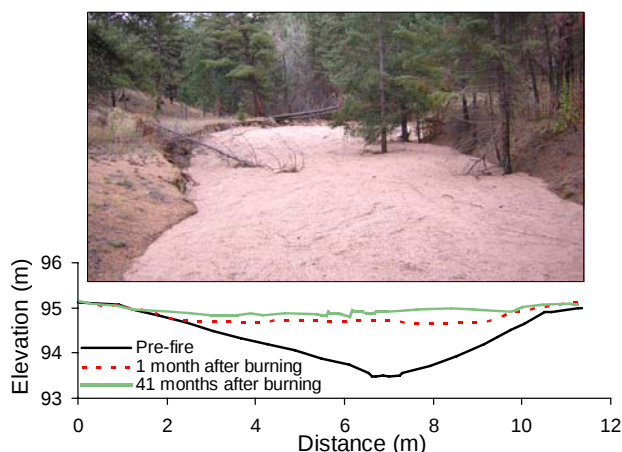
Figure 6. Post-fire sediment deposition and channel changes over time along a lower gradient channel segment; Saloon Gulch, Hayman wildfire.

The high runoff and erosion rates in headwater areas deliver large amounts of sediment to downstream channels. The predominant role of summer thunderstorms in the Colorado Front Range means that unit area peak flows decline rapidly with increasing scale. The decrease in unit area peak flows and the decline in gradient with distance downstream causes large accumulations of post-fire sediment in the lower gradient, downstream channels (fig. 6). Since hillslope runoff rates decline to near-background levels within 2-5 years, there is a rapid decline in peak flows and the corresponding ability of downstream channels to entrain and transport the accumulated sediment. This means that decades or even centuries may be necessary before the aggraded channels can recover to pre-fire conditions (Moody and Martin, 2001; Eccleston, in prep.). In some cases the aggraded sediment causes the streamflow to be primarily subsurface, and in these channels the recovery to pre-fire conditions may be extremely slow (Eccleston, in prep.).
