# Geomorphic response of a montane riparian habitat to interactions of ungulates, vegetation, and hydrology

Daniel G. Neary<sup>1</sup> and Alvin L. Medina<sup>2</sup>

**Abstract.**—Wildcat Creek, a tributary of the Black River on the Apache-Sitgreaves National Forest is being studied to determine the impacts of cattle and elk grazing on riparian wet meadows. An intensive survey of a selected stream reach revealed a unique channel development involving an aggradation/degradation process in a pool-riffle sequence of an E-6 stream channel. Grazing and trampling impacts of elk and cattle were found to affect the process in two ways: 1) overgrazing of stream banks resulted in exposure of the soil fabric and loss during high flows, sloughing of banks, channel widening, and a reduction in the ability of plants to trap sediments; and 2) trampling at animal crossings initiated a degradation of riffles by breaking down the armoring gravels which are held in place by native aquatic plants of the genera *Carex*, *Cyperus*, *Juncus*, *Glyceria*, *Scirpus* etc. The importance of the aggradation/degradation process is in the long-term maintenance of montane cienegas in a quasi-stable condition

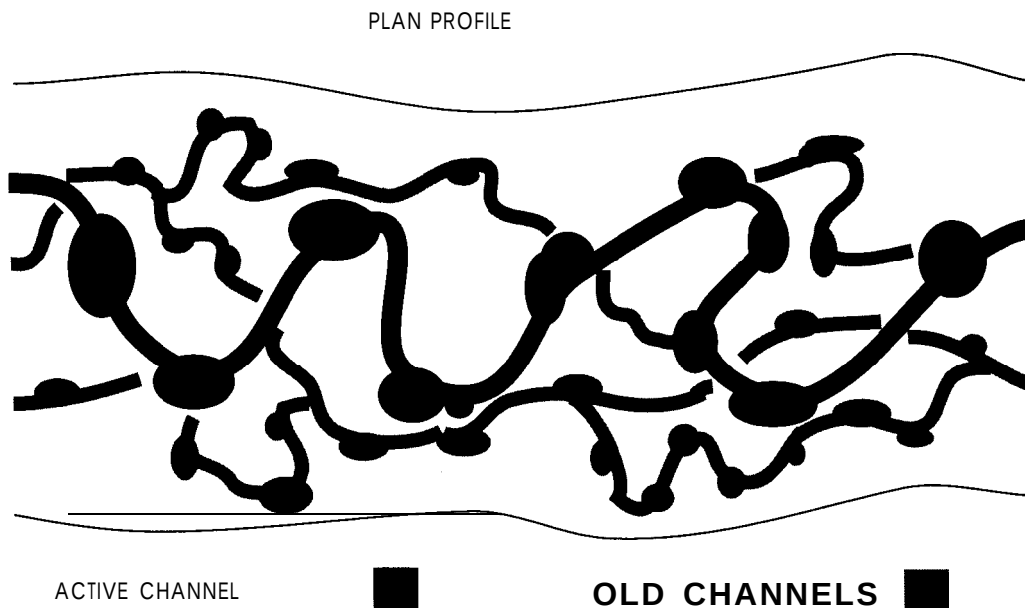
Figure 1. Plan profile of the active and old channels in the Wildcat Creek riparian meadow, Apache-Sitgreaves National Forest.

The Wildcat Creek drainage consists of steep upper and lower sections with a low gradient middle reach which contains a relatively narrow montane meadow. A planimetric survey of a 900 m portion of the mid-section of Wildcat Creek was conducted using a laser level. Longitudinal and valley profile measurements were taken to portray channel configurations. Additional measurements taken to characterize stream and channel geometry included: channel width, water depth, bank undercut dimensions, pool and riffle length, stream gradient, number and location of old channels, and streamside vegetation composition and cover. Data were analyzed to produce graphical depictions of site conditions. Photographs were taken to illustrate specific aspects of how vegetation influences streambank morphology. The soils of the site were examined and identified.

Valley dimensions in the study section ranged from 48 to 160 m wide. The stream channel was classified as an E-6 type (Rosgen 1994) with such characteristics as: 1.5% slope, sinuosity of 2.1, entrenchment ratio of 2.6, and width depth ratio of 9.6. Old channels are common (4-5) in wider reaches with at least 2 in the narrow sections (Figure 1).

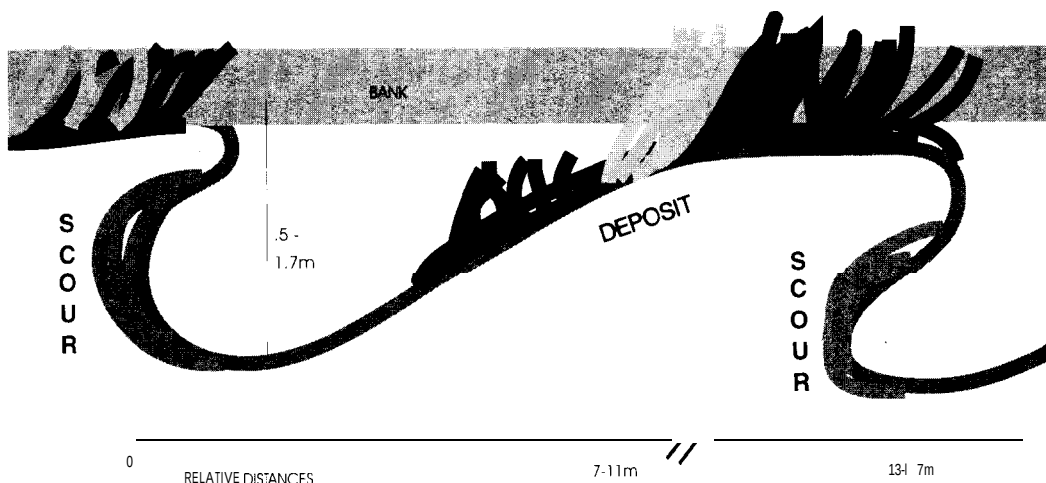
Figure 2. Longitudinal view of typical scour and deposit zones of pool-riffle sequences in the Wildcat Creek riparian meadow, Apache-Sitgreaves National Forest.

A longitudinal profile survey was conducted to determine the geometry of pools and riffles. The

average pool is 5.85 m long, with a minimum width of 86 cm and maximum width of 177 cm, a minimum pool depth of 19 cm and a maximum depth of 50 cm. Scour sections occur downstream of all riffle sections, and gravel deposits form on the inter-pool riffles (Figure 2). The scours occur mainly during snowmelt runoff high flows, but summer monsoon flows can occasionally reach scour velocities. Over time these two major physical processes interact with aquatic vegetation components to result in the aggradation of alluvial materials in these meadows. Five distinct geomorphic actions occur as a result of the aggradation. Scouring action results in upstream migration (1), and deepening of pools (2). The deposited material in combination with the vegetation causes riffle areas to aggrade (3) in three dimensions: longitudinal, horizontal and vertical. The aggradation process results in a deepening of the pool by elevation of the water surface (4), and a change in channel direction during peak flows to other older channels of lower elevation (5). This process is repeated in the new active channel. However, a change in the long term aggradation process can be reversed through the interaction of another biological component - animals.
