USDA Forest Service  
Research Paper RM-139  
1975

# WATERSHED MANAGEMENT PROBLEMS AND OPPORTUNITIES FOR THE COLORADO FRONT RANGE PONDEROSA PINE ZONE: The Status of Our Knowledge

Howard L. Gary

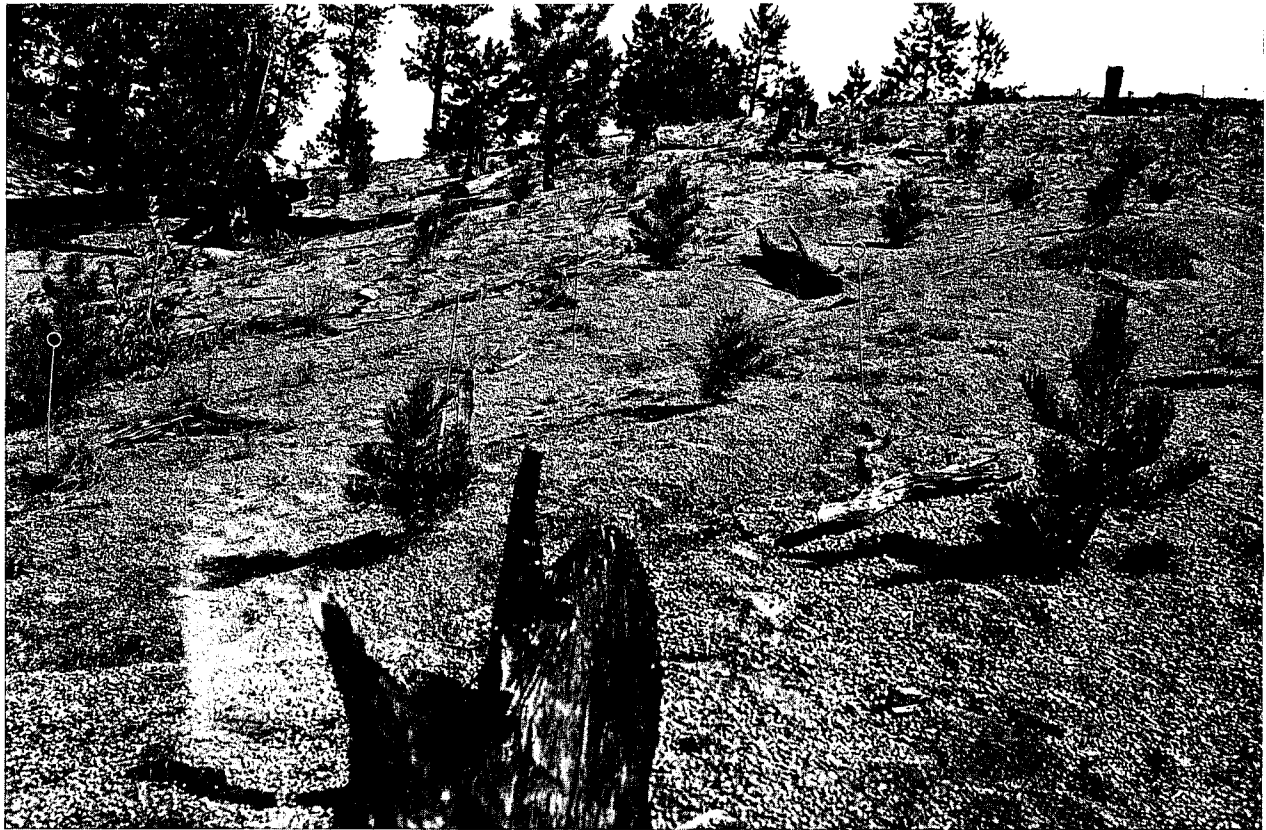
Figure 8.—Unprotected soil showing evidence of accelerated erosion.

Removal of protective plant cover and soil disturbance caused by road construction, logging, and fire, can accelerate natural erosion processes (fig. 8).

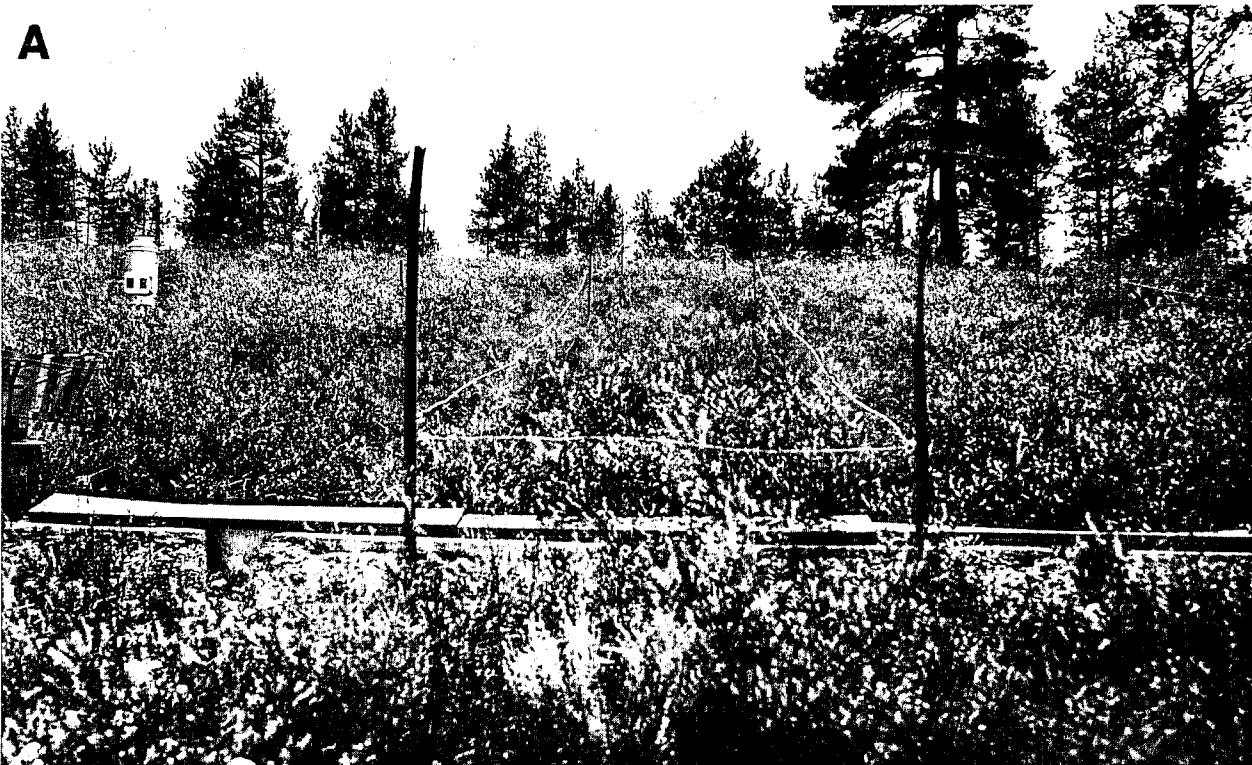
Figure 10.—Bunchgrass runoff plots: **A**, before grazing; **B**, after grazing by cattle (from left to right)—moderate, none, and heavy grazing.

tity of soil moved by erosion in the bunchgrass type (fig. 10). Grazing caused an increase in erosion, but not in direct proportion to intensity of use. Average annual erosion from summer storms (fig. 11) ranged from 111 to 163 pounds per acre. During the grazing treatments, 13 storms from 1941 to 1952 were of sufficient size to produce erosion. Average annual depositions were 134, 145, and 316 pounds per acre for no grazing, moderate, and heavy grazing, respectively. Only heavy grazing significantly increased erosion, but erosion was measurable in only 8 of the 16 years of study on any plot. Months of greatest soil movement were July and August. It was also noted that erosion tended to occur during periods when large storms followed one another at short intervals. From larger grazing studies at Manitou, Johnson (1953) reported that moderate grazing was most efficient from the standpoint of economic returns in beef production. An additional watershed benefit is that surface runoff and erosion are controlled under moderate grazing.

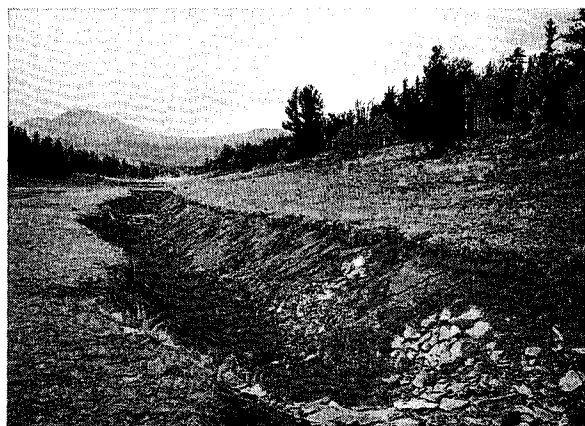
Figure 13.—Erosion channel through a heavily grazed meadow.

Throughout much of the Front Range pine zone, meadows and hillsides are typically lined with gullies (fig. 13). Accordingly, mechanical structures and treatments have long been used and are still needed in some areas to control runoff and soil erosion. Heede (1960) evaluated the gully-control structures installed some 30 to 35 years ago in the Pike and San Isabel National Forests, and made recommendations to guide future work in gully control.

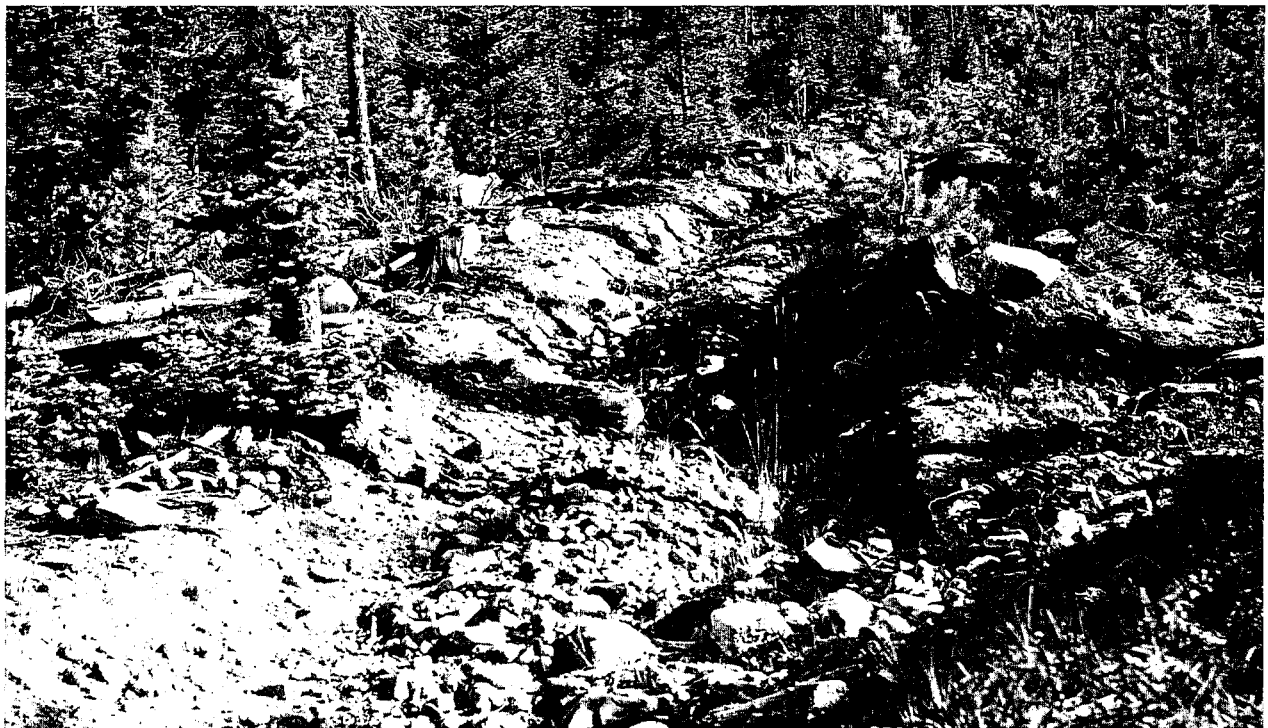
Figure 15.—A poorly planned skid trail established in the 1920's in the Front Range spruce-fir type. Elevation about 10,000 ft.

A survey of about 30 timber sales and old cutover areas on the Roosevelt and Pike National Forests gave some indications of the need for watershed condition criteria (USDA FS 1944). It was found that even the most severe timber cutting in the spruce-fir and lodgepole pine types had few bad effects on watershed conditions. Some damage has been caused by repeated perennial use of skid roads and trails, and by poor planning of logging roads (fig. 15).

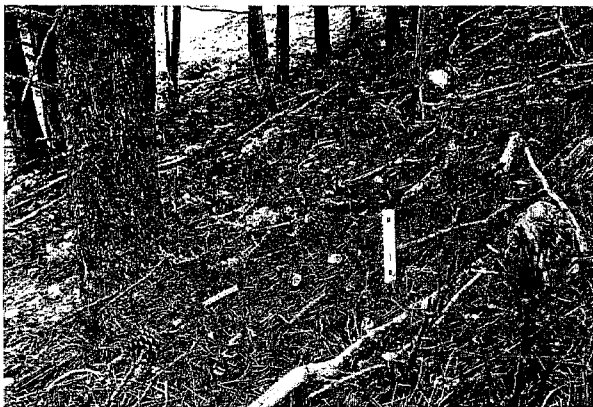
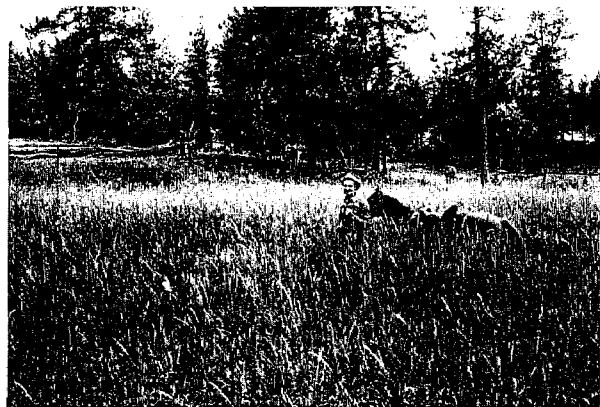
Figure 16.—Under good litter or grass cover, infiltration rates are usually sufficiently high to restrict surface runoff and erosion in the timber-grass types.

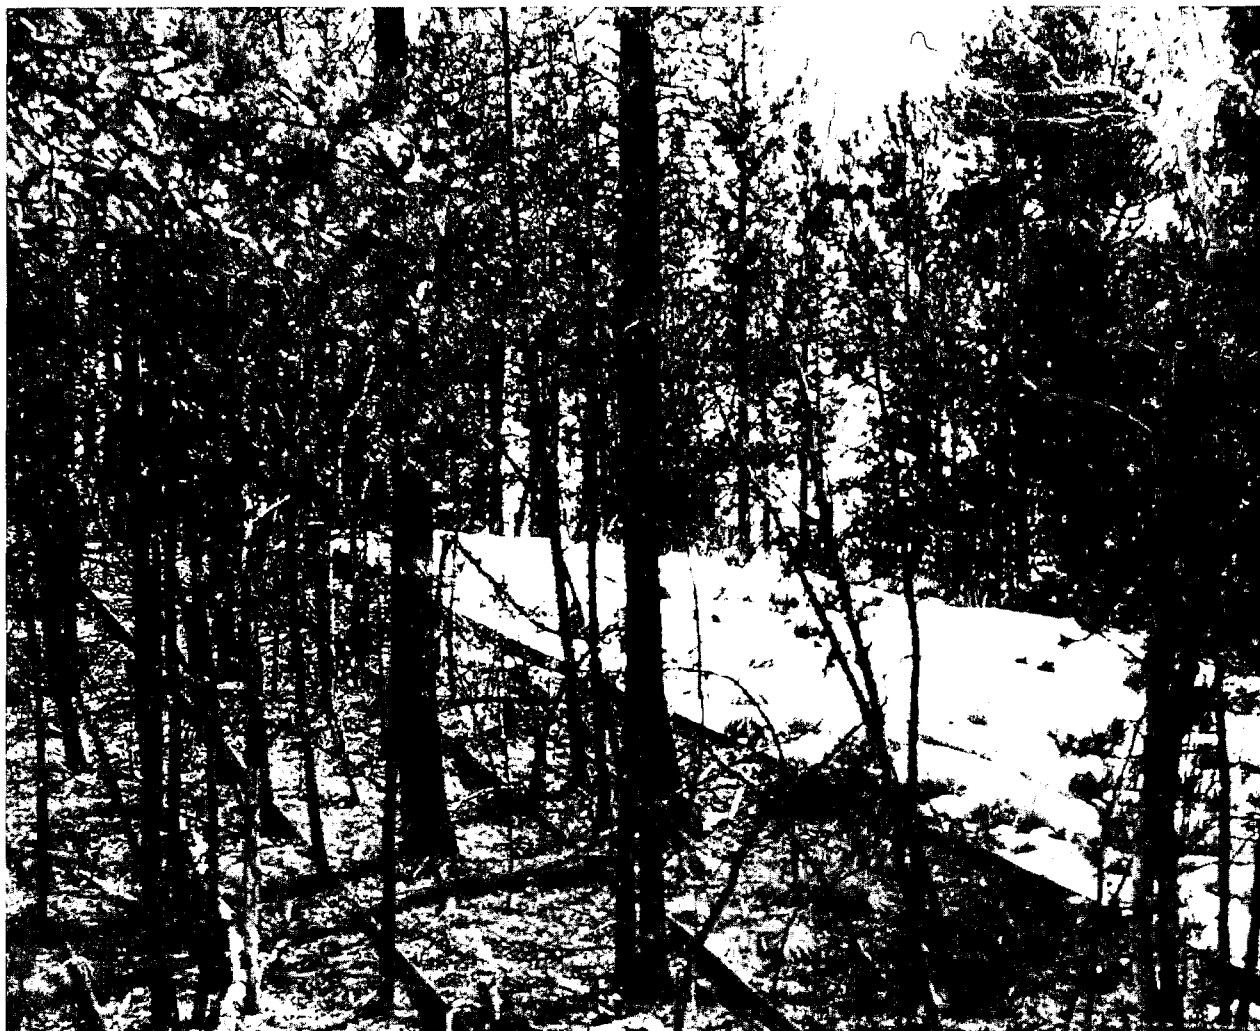
Figure 21.—Late-lying snow in a small rectangular clearing on a north-facing slope on the Manitou Experimental Forest.

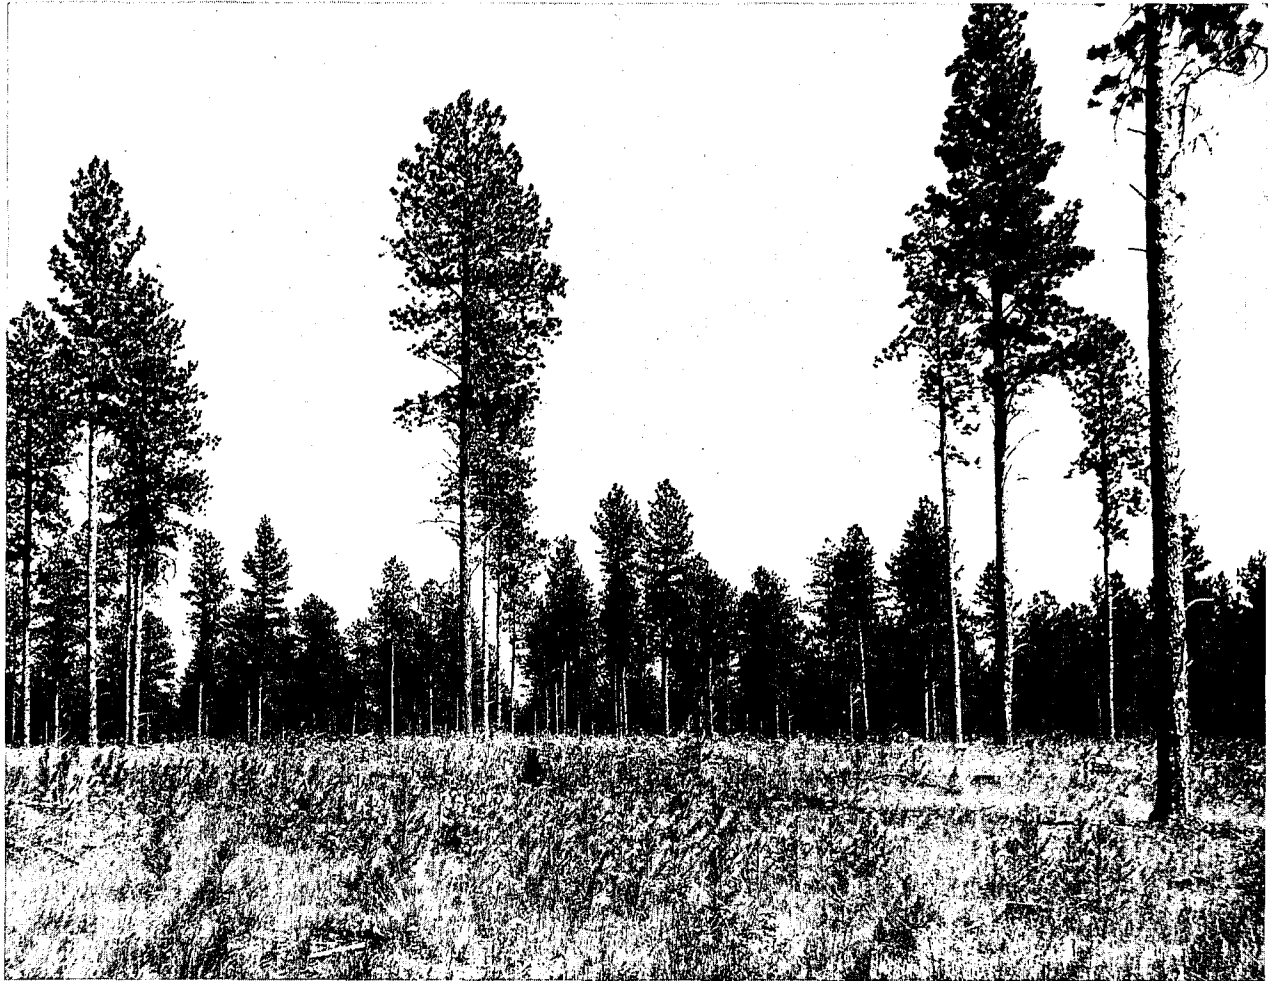
Figure 24.—A small clearcut patch in ponderosa pine after harvest by the seed-tree method. Small clearcut openings or drastically thinned forests are necessary to significantly increase water yields (Boldt and Van Deusen 1974).
