General  
Technical  
Report  
FPL-GTR-214

# Evaluation of the Lateral Performance of Roof Truss-to-Wall Connections in Light- Frame Wood Systems

Andrew DeRenzis  
Vladimir Kochkin  
Xiping Wang

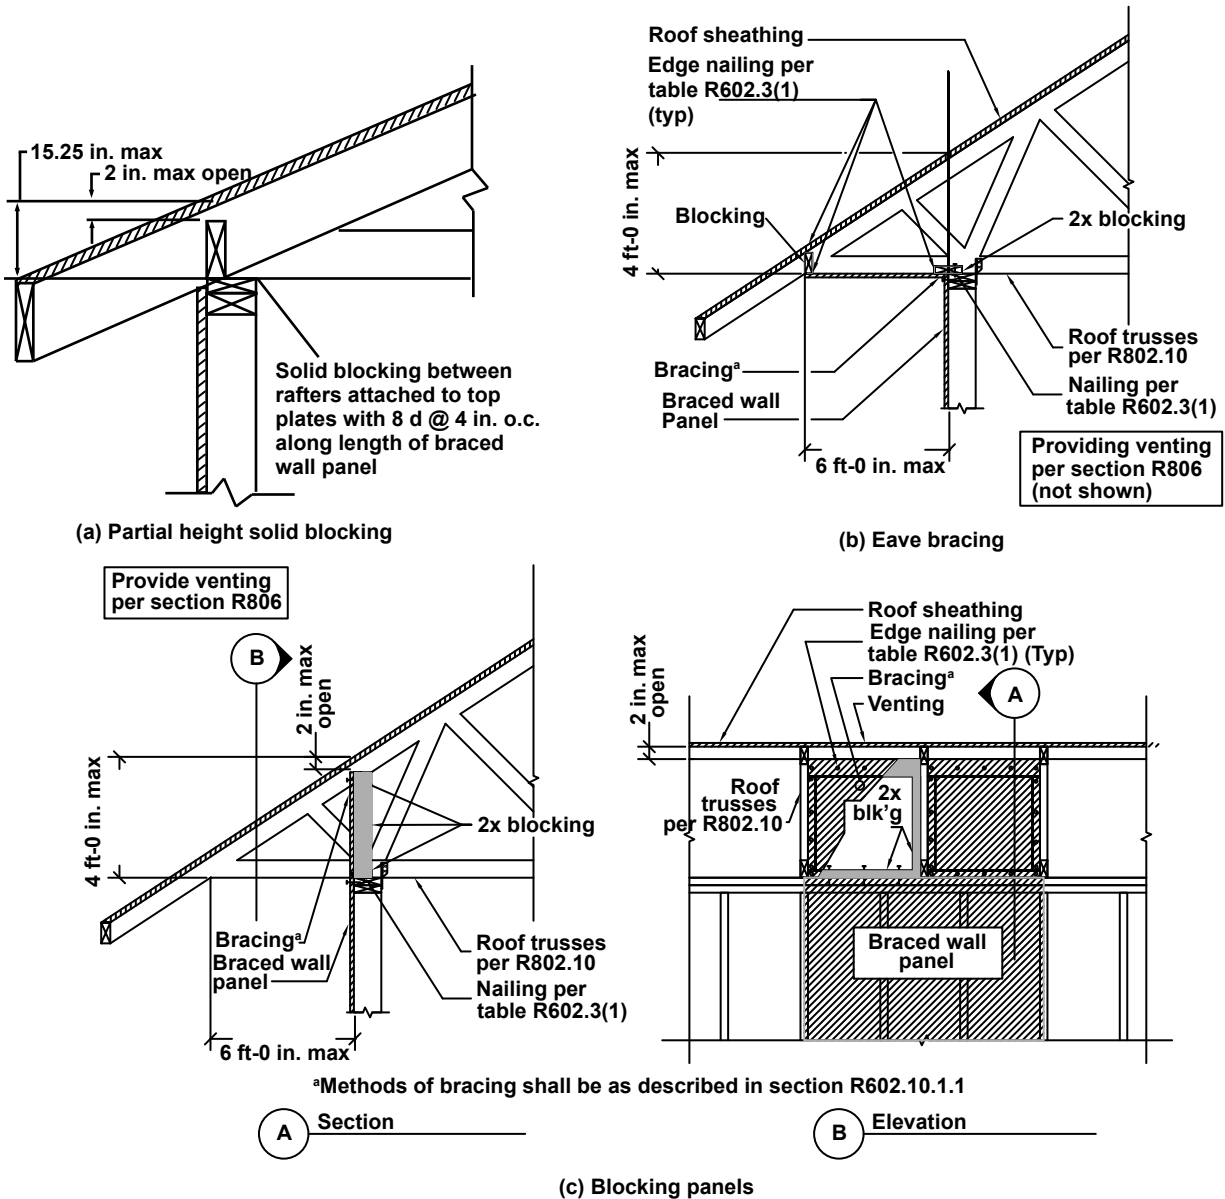
Figure 1. Prescriptive detailing options in IRC: (a) partial height solid blocking, (b) eave bracing, (c) blocking panels.

In the 2012 IRC, eave blocking is the primary method to increase the lateral capacity of the heel joint. The blocking members transfer shear load to the top plate of the wall below through face nailing or toe-nailing and restrict local rotation of the roof framing members caused by the eccentricity of the heel joint. The load from the roof diaphragm is transferred through sheathing connectors into a top chord

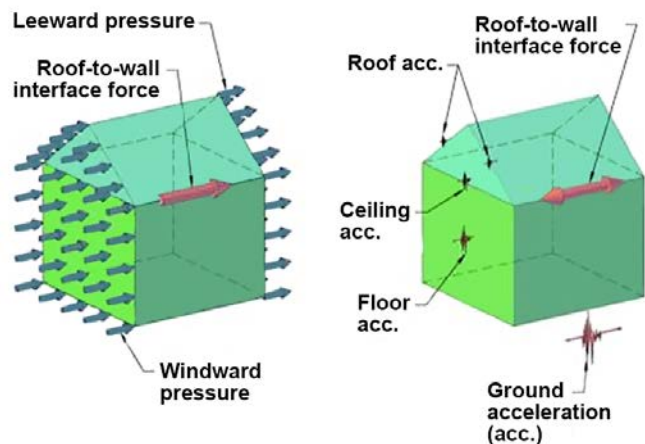
Figure 2. Wind and seismic loading in the parallel-to-wind direction. (Uplift and orthogonal components are not shown for clarity.)

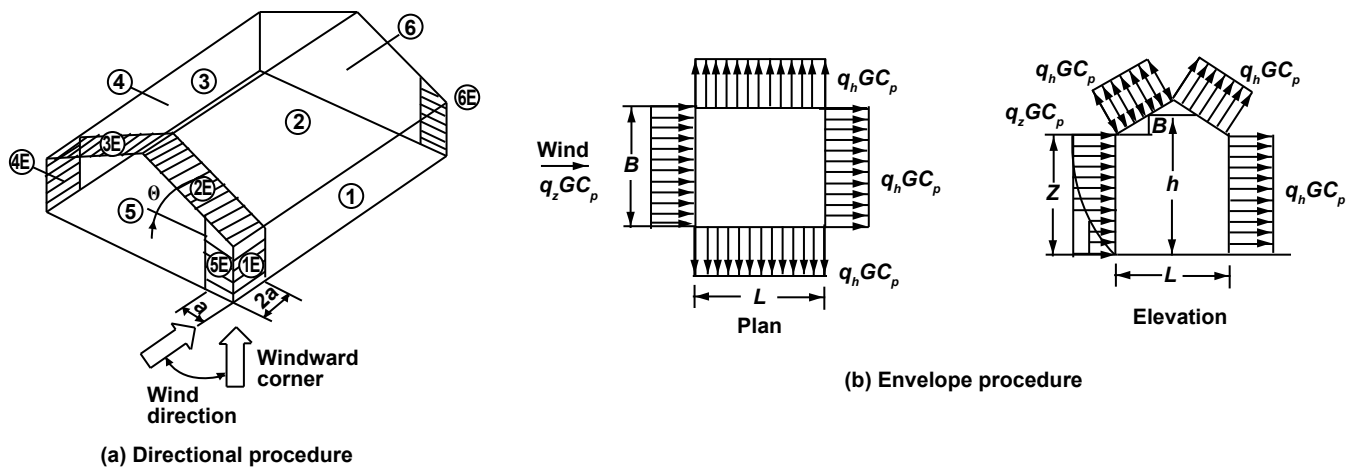
Figure 3. ASCE 7 wind loading profile.

The ASCE 7 lateral wind load profile in the direction parallel to the ridge is shown in Figure 3, with wind pressures acting on both the windward wall surface (positive pressure) and leeward wall surface (negative pressure—suction) of the building. For a typical residential floor aspect ratio, the windward pressure is about twice the leeward pressure. These pressures have the same vector direction and their actions are superimposed to develop the total lateral force acting on the building. The wind pressures on the wall surface are transferred through the vertical framing mem-

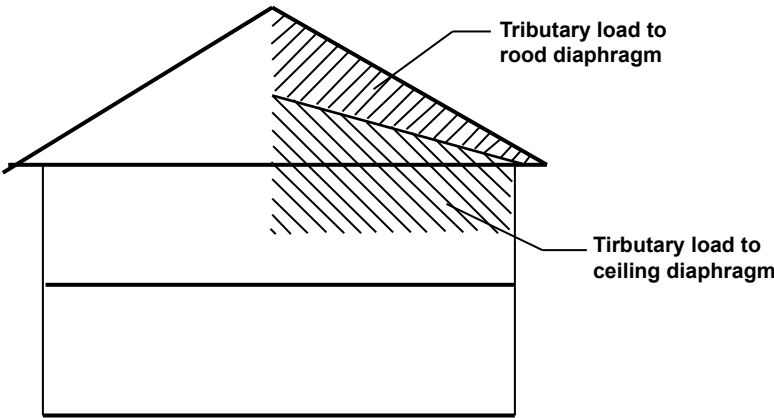
Figure 4. Tributary area of wind loads.

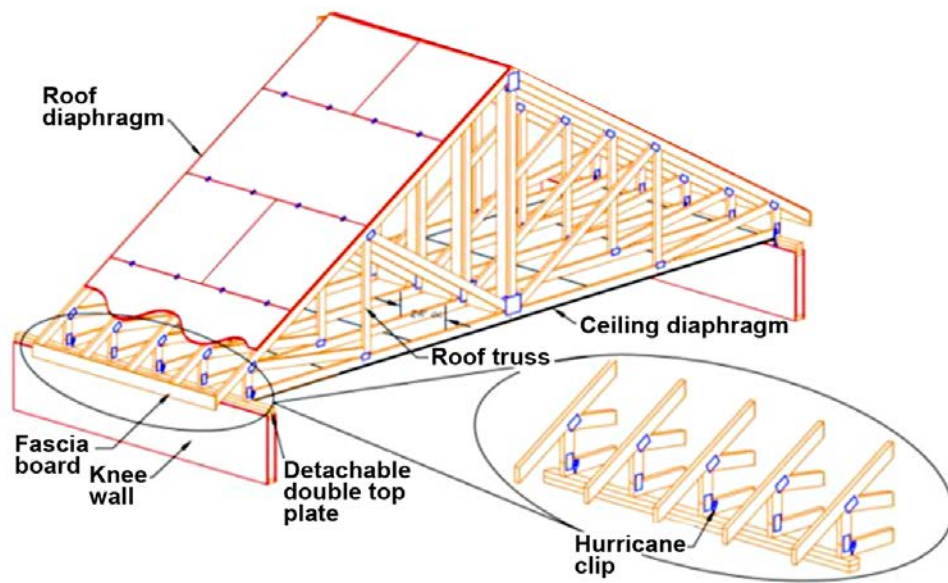
Figure 5. Specimen construction.

Each specimen was constructed with five 24-ft-span wood trusses spaced at 24 in. on center (o.c.), with the overall size of the full roof system at 24 ft wide by 8 ft deep with additional 16-in.-long overhangs on each side (Fig. 5). Trusses were supported at the heel by 4-ft-high light-frame knee walls anchored to the laboratory’s strong floor. Strength and stiffness of the knee walls were sufficiently higher than those of the roof system to prevent any significant

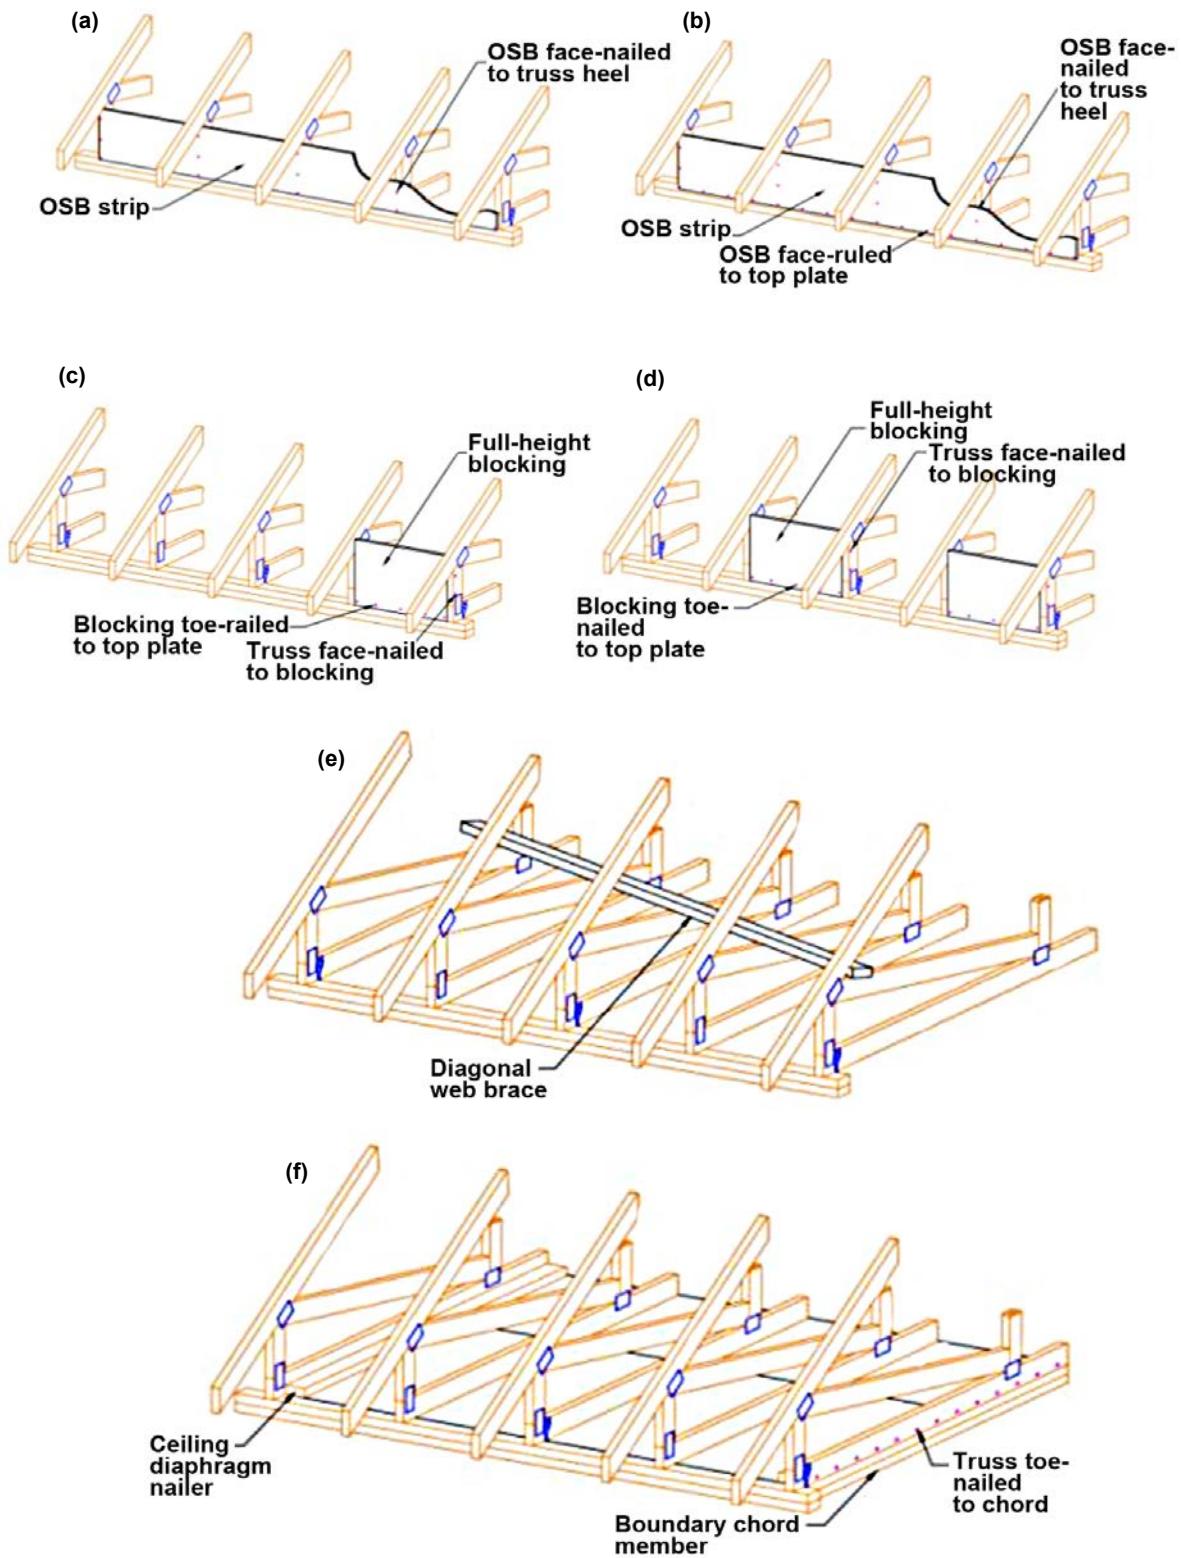
Figure 6. Truss-blocking details: (a) high heel with OSB; (b) high heel with OSB to plate; (c) high heel with 25% blocking; (d) high heel with 50% blocking; (e) high heel with diagonal web bracing; (f) high heel with OSB to plate and reinforced ceiling diaphragm (OSB not shown for clarity).

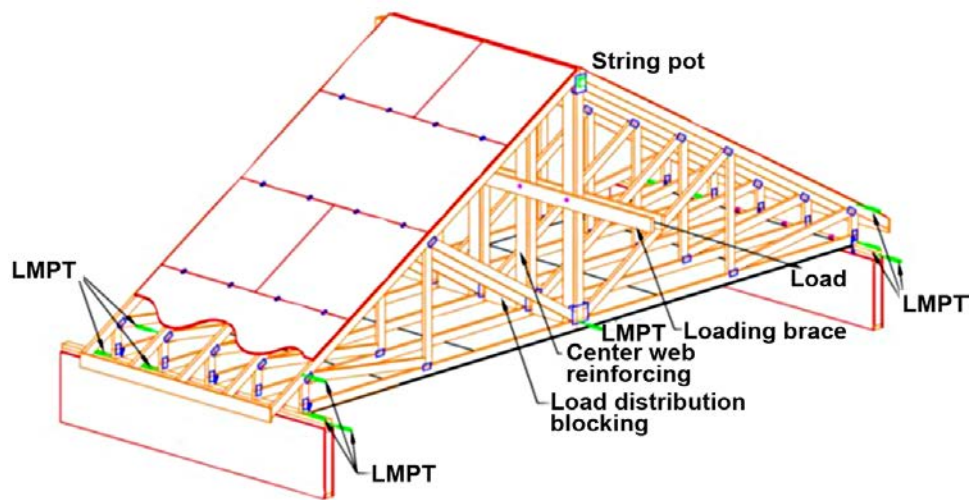
Figure 7. Test setup and instrumentation.

The loading brace members were loaded in tension using a computer-controlled hydraulic cylinder mounted to a steel reaction frame. The reaction frame was attached to the laboratory structural floor. Load was applied monotonically in tension at a constant displacement rate of 0.06 in/min to allow for sufficient visual observations throughout the test and was measured using an electronic load cell installed between the cylinder and the loading bracket. Displacement was continued until failure, defined as a 20% drop in load from the peak.

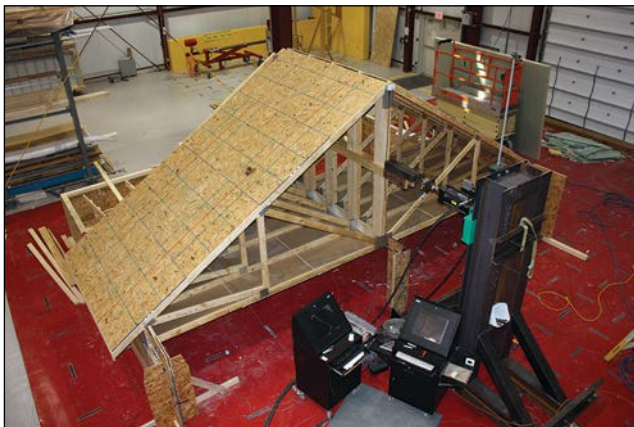
Figure 8. Test setup.

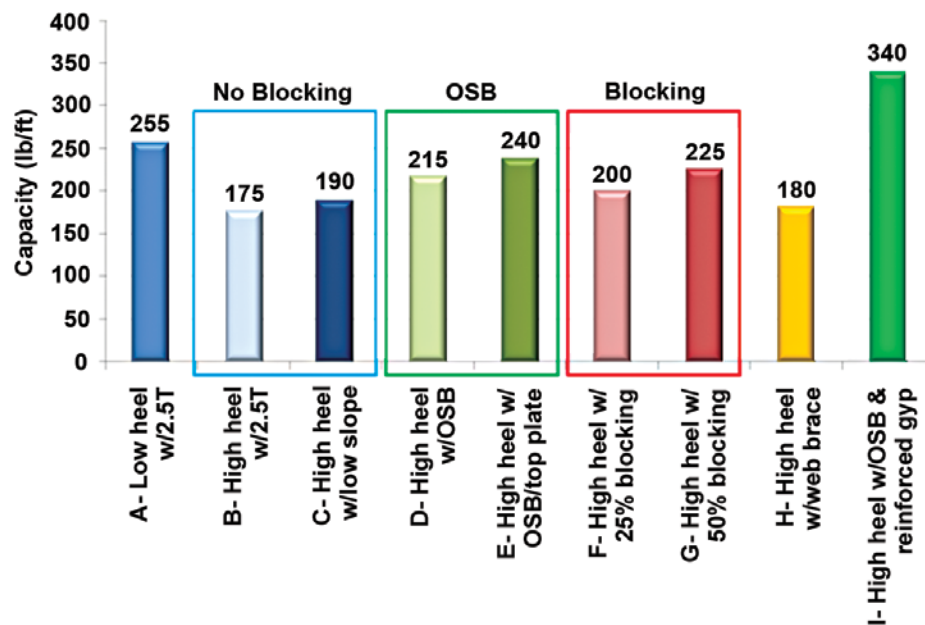
**Figure 9. Comparison of peak capacities per truss connection.**

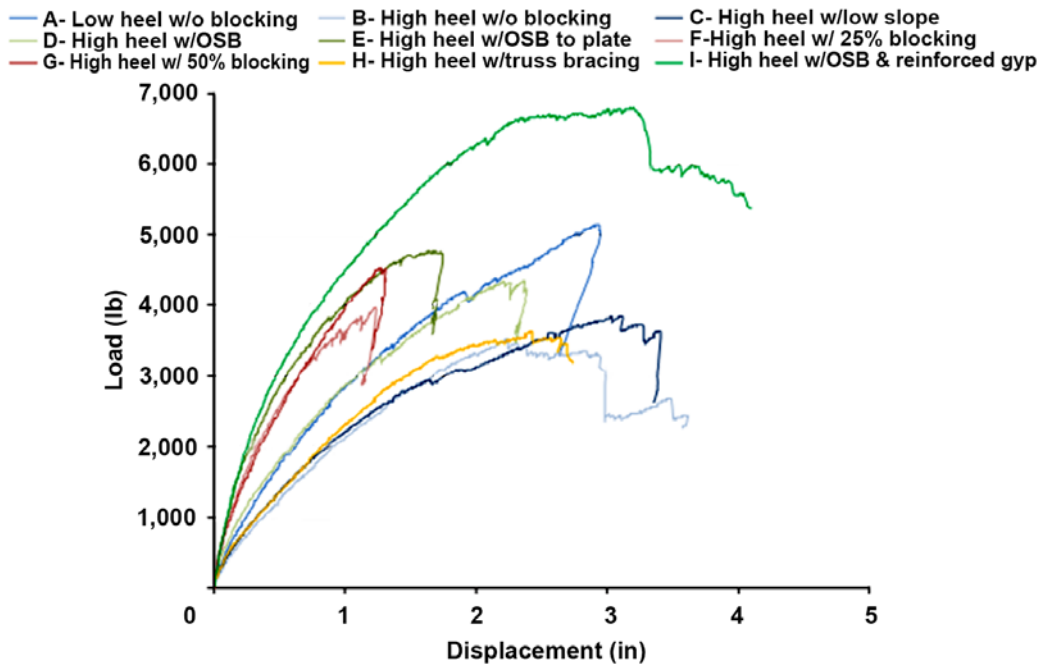
Figure 10. Load–displacement curves (measured at peak of the roof).

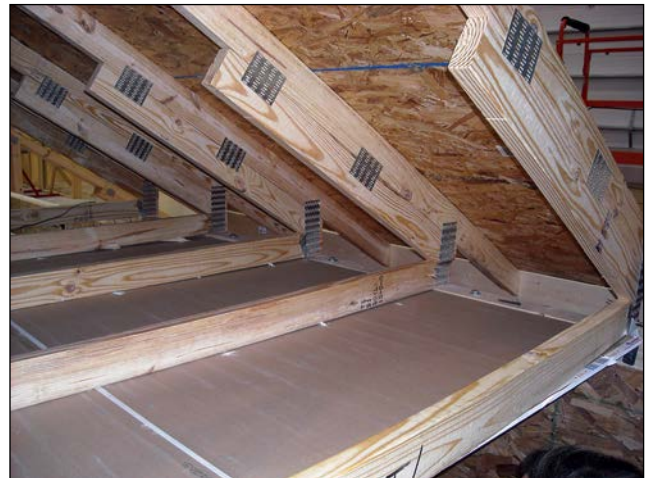
Figure 11. Gypsum fastener tear-through (Specimen A).

8,828 lb/in. Failure of Specimen A included initial fastener tear-through at the outer ends of the ceiling diaphragm near the knee walls followed by complete failure of the fasteners in the center gypsum panel (Figs. 11 and 12). Only minor rotation of the truss heels was observed during testing as well as minor rotation and buckling of the hurricane clips (Fig. 13). Minor displacement of the truss top chord relative to the bottom chord at the heel joint was also observed, along with slight deformation of the metal connector plate at the heel joint (Fig. 14).

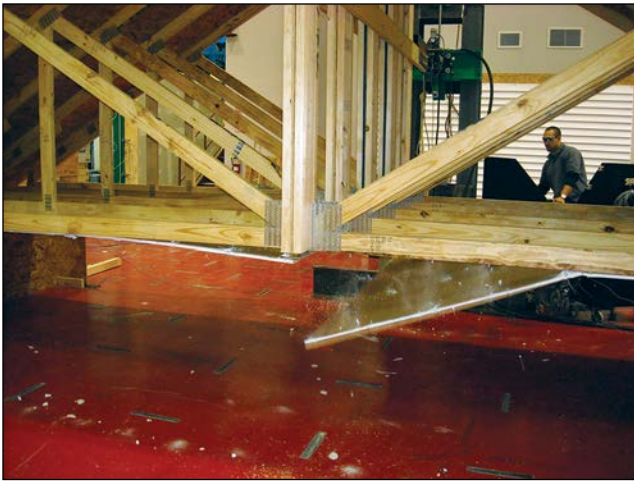
**Figure 12. Complete failure of gypsum fasteners (Specimen A).**

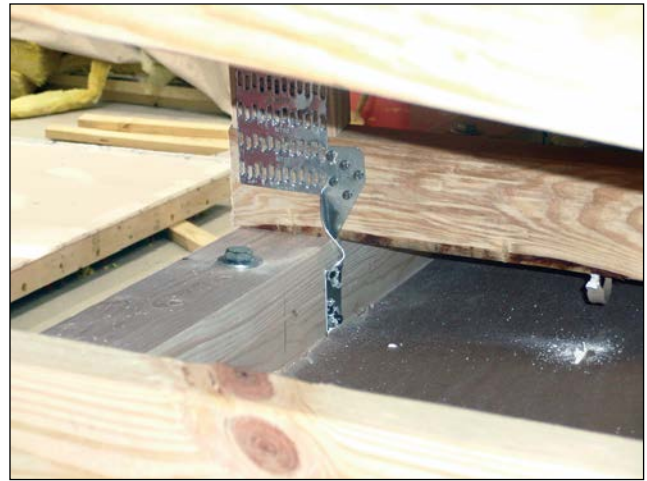
**Figure 15. Buckling of hurricane clip (Specimen C).**

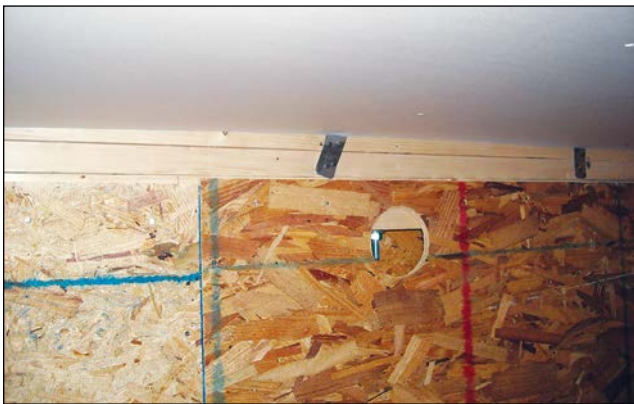
**Figure 13. Rotation of hurricane clip at failure (Specimen A).**

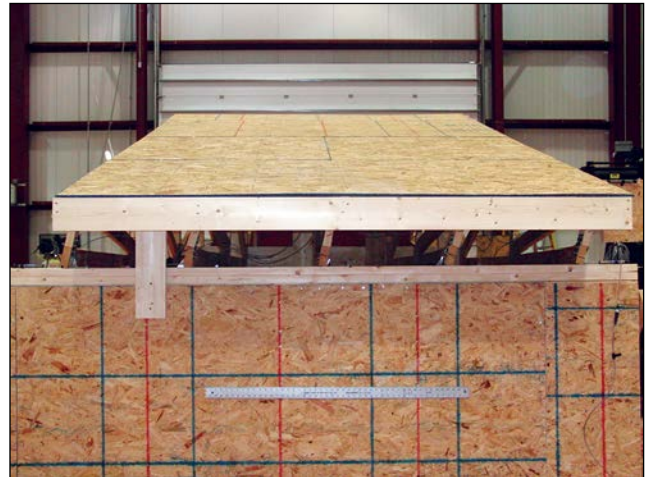
**Figure 16. Specimen C heel rotation at failure.**

indicating that the degree of roof slope has minimal effect on heel connection performance. Figure 16 shows truss rotation observed in Specimen C at failure.

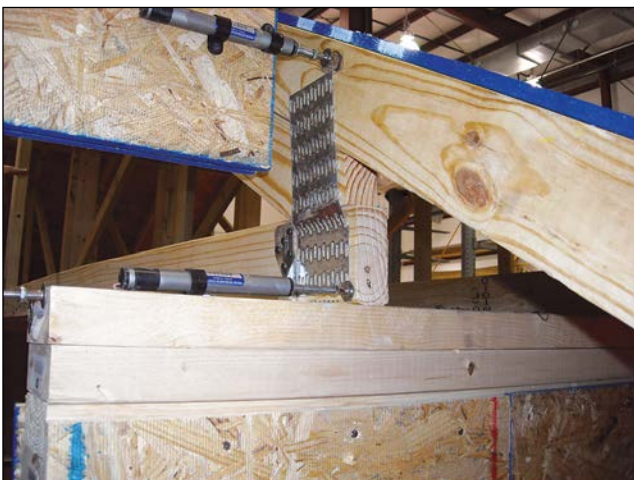
**Figure 14. Truss member displacement and metal connector plate deformation at heel joint (Specimen A).**

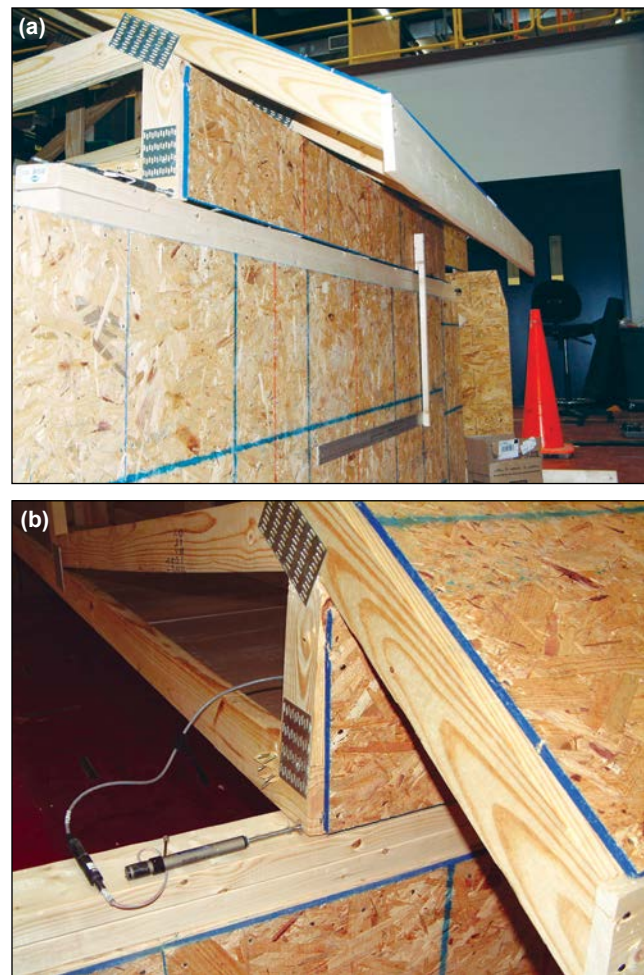
**Figure 17. Comparison of rotation at Truss 5 (Specimen D): (a) before test, (b) after test.**

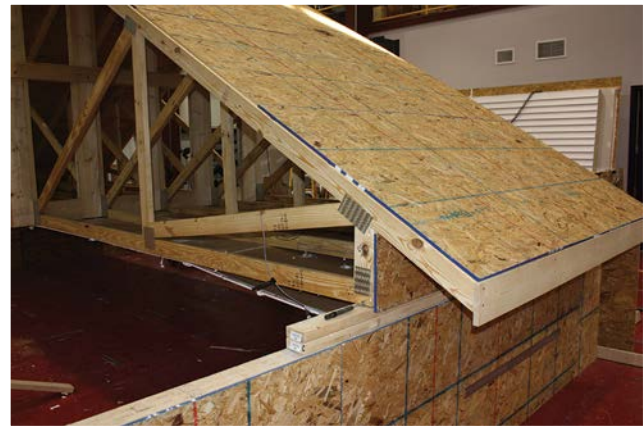
**Figure 18. Truss rotation of Specimen E at failure (Truss 5).**

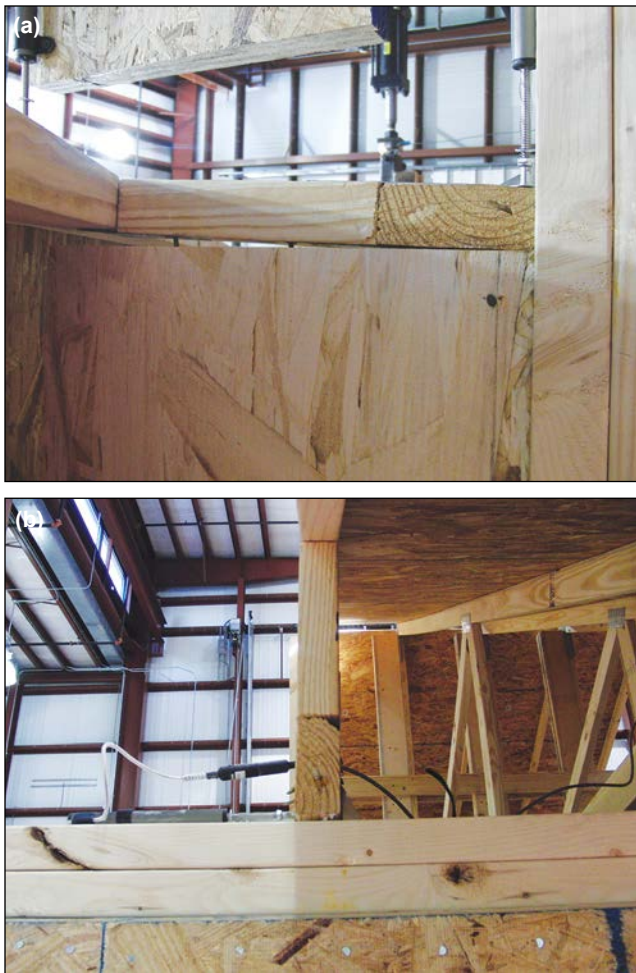
**Figure 19. Comparison of truss heel rotation (Specimen F): (a) Truss 1, (b) Truss 5.**

Specimens F and G were designed to evaluate the performance of code-compliant blocking details. Specimen F included a solid blocking panel installed in a single truss bay on each side (that is, 25% of the specimen wall length). Specimen G was constructed with alternating blocked and unblocked bays, resulting in blocking of two bays per side (that is, 50% of the specimen wall length). The 25% blocking specimen (Specimen F) reached a peak load of 3,988 lb (unit peak capacity of 200 lb/ft) and an initial stiffness of 23,548 lb/in and exhibited gypsum fastener failure as its primary failure mode, as was observed and described for previous specimens. The same moderate rotation was observed at both the front two trusses (where blocking was installed) and the fourth (where no blocking was installed). This visual observation was confirmed through displacement measurements at both locations, indicating that the single blocked bay provides rotational restraint to the entire specimen (that is, the effect of the blocking is not localized). Figure 19 compares the rotation of the first and last trusses.

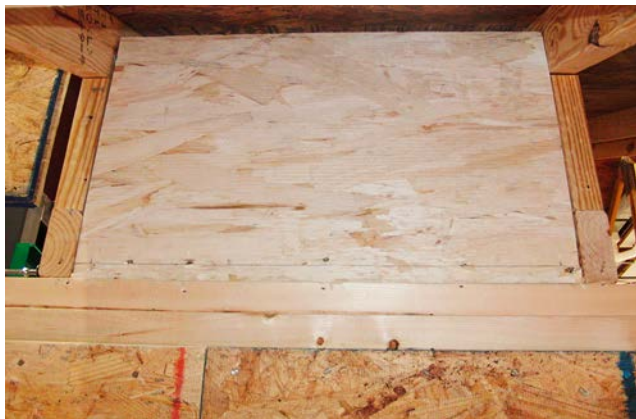
**Figure 20. Rotation of truss heel at blocking location (Specimen G).**

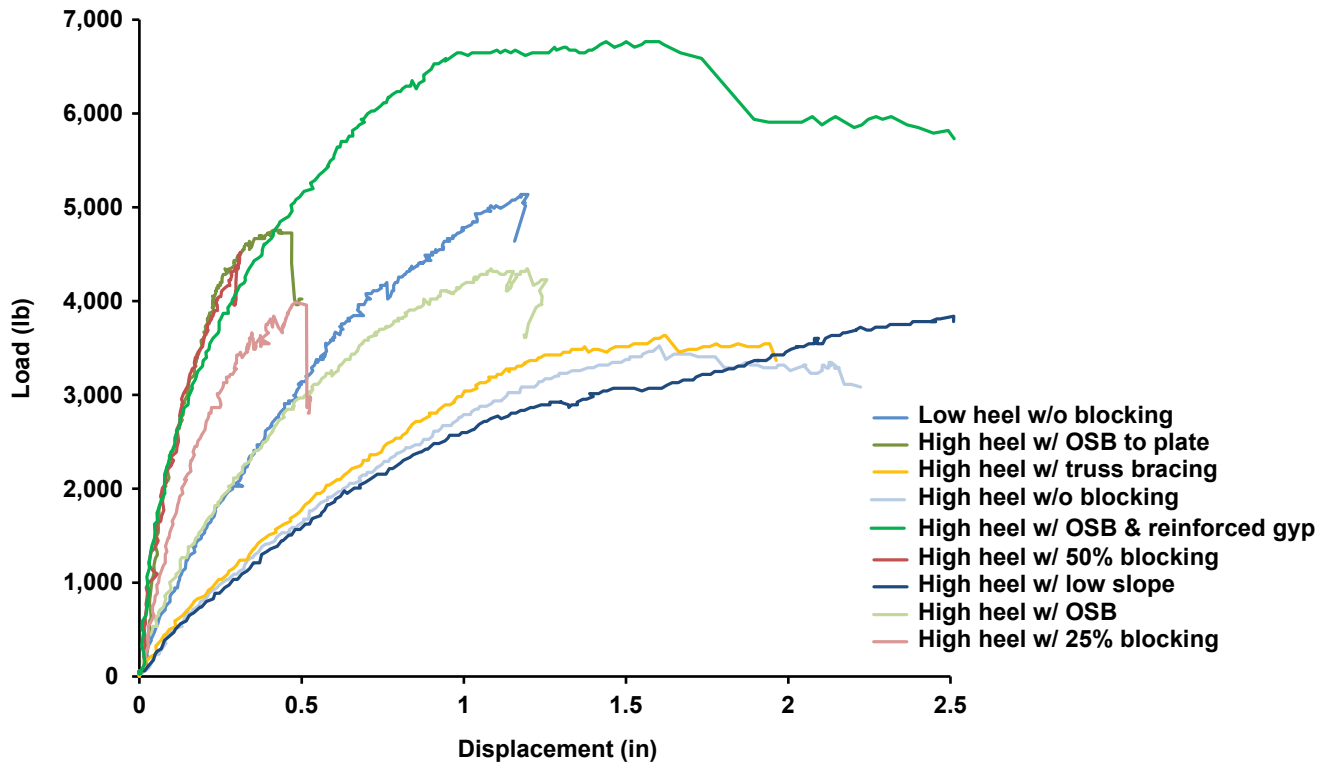
Figure A1. Load–TOH displacement (measured at left end of Truss 1)

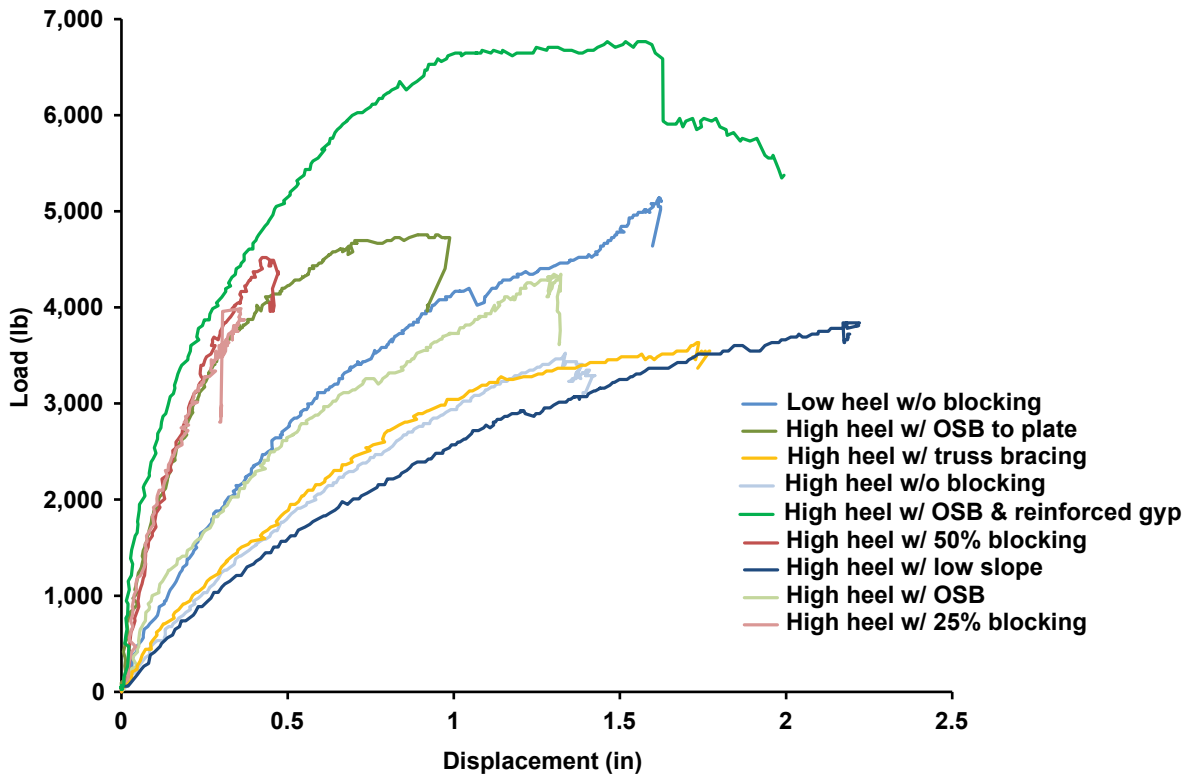
Figure A2. Load–TOH displacement (measured at right end of Truss 1)
