# Streambank Response to Simulated Grazing

Warren P. Clary<sup>1</sup> and John W. Kinney<sup>2</sup>

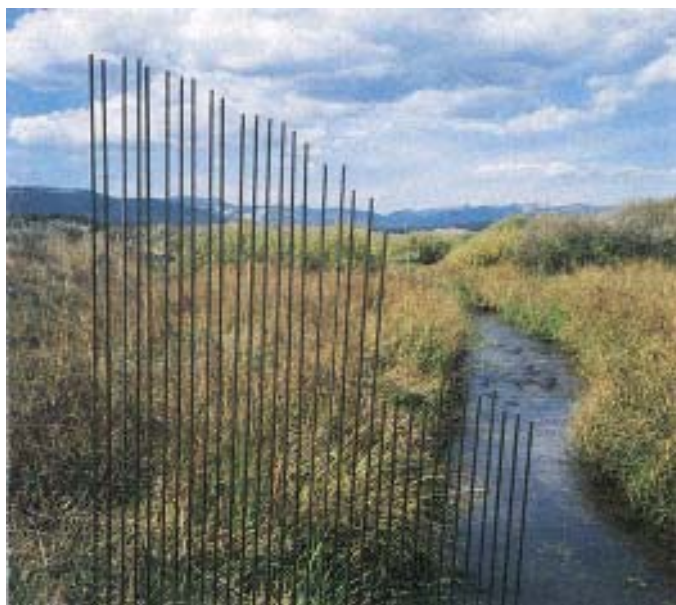
Figure 1. Bankometer positioned on study plot.

Changes in soil surface and bank profile were determined by a bankometer patterned after a rillmeter. A 1.3 cm conduit pipe, 3 m long with 0.6 cm holes drilled on 2.5 cm centers, was anchored to rebar stakes. Stainless steel rods, 0.6 cm in diameter, were positioned through the drilled holes in the conduit pipe and lowered to the soil surface (figure 1). The length remaining above the conduit was recorded for each rod position. Determination of treatment effect on streambank elevation was a function of the change in readings over time. Bankometer readings, bank angle from water's edge to top of bank, wetted

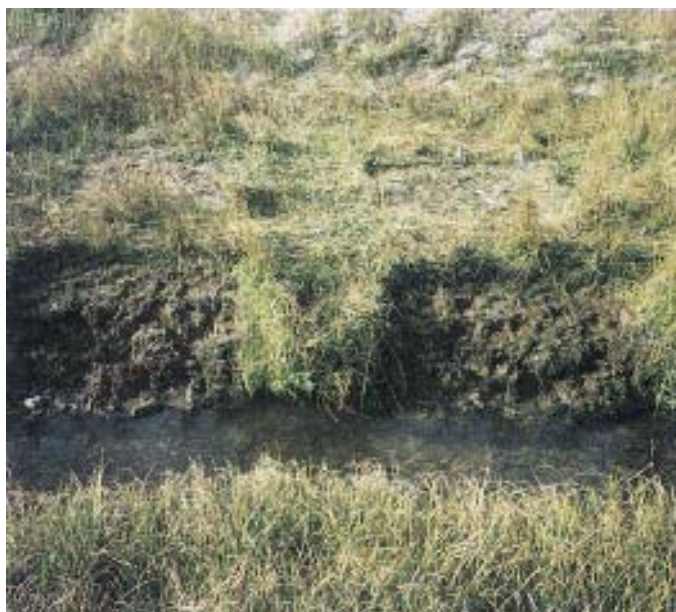
Figure 3. View of subplots following heavy, season-long treatment in 1997.

Streambank elevations experienced a highly significant effect from the treatments ( $P < 0.01$ ). During the study, the plots receiving simulated grazing treatments had a cumulative reduction in average surface elevation as the streambank became progressively more deformed and broken (figure 2). The 2 moderate intensity treatments had about 3 cm of average surface depression, while the heavy season-long treatment had about 11.5 cm of average surface depression as the edge of the bank become severely deformed (figure 3).
