# Placing Riffle Formations to Restore Stream Functions in a Wet Meadow

by Alvin L. Medina and Jonathan W. Long

Natural materials and knowledge of natural stream processes are used to develop a cost-effective means of restoring a montane wet meadow stream.

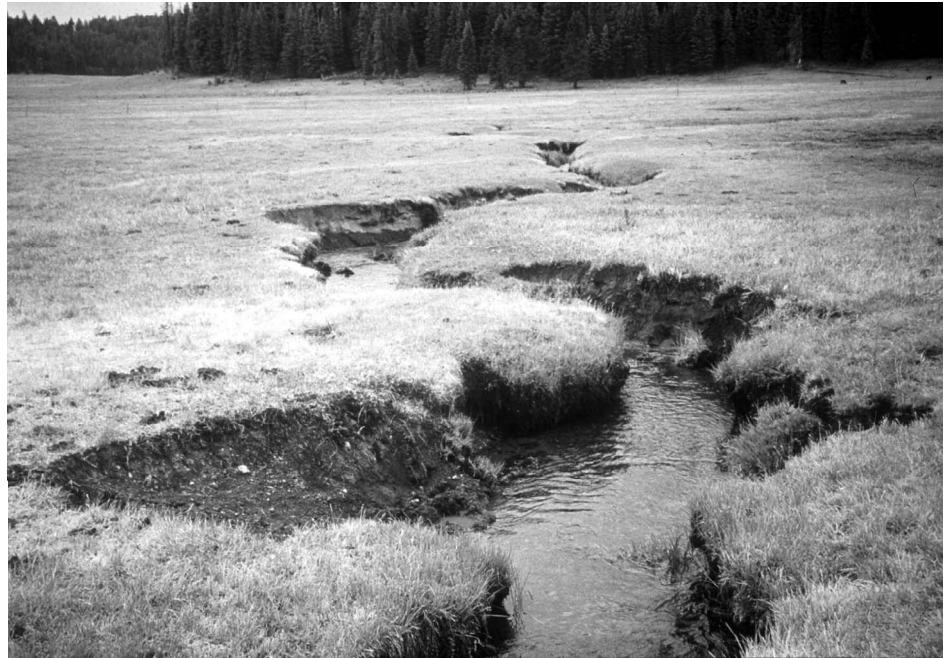
**Figure 1.** July 1997. Pacheta Creek at mid-point of treated reach, prior to restoration treatment. Note low level of water relative to banks, undermining of banks, and animal ramp in the left foreground. Photo by Jonathan Long

Pacheta Creek is a tributary of the Black River in the southeastern corner of the White Mountain Apache Reservation in east-central Arizona (Figure 1). A perennial stream, it has a typical low flow of 1.1 ft<sup>3</sup>/sec (0.03 m<sup>3</sup>/sec) and an estimated bankfull flow of 35.3 ft<sup>3</sup>/sec (1 m<sup>3</sup>/s), both of which are comparable to other mountain streams (DeBano and Heede 1987). Although high-intensity storms occur occasionally during the summer monsoon, the stream's peak flows occur principally from winter snowmelt across its 2.8-mi<sup>2</sup> (7-km<sup>2</sup>) drainage area. At an elevation of 8,938 ft (2,725 m), the stream flows from a narrow canyon into a broad (820-3,280 ft {250-1,000 m}) wet meadow, known as Pacheta Cienega. This meadow reach harbors a robust population of non-native brook trout (*Salvelinus fontinalis*) (Rinne 2000), and is located at the transition from steeply sloping silicic rocks to flat-lying basalt flows (Merrill 1974). This geologic transition coincides with a shift

We attributed channel downcutting and widening to direct and indirect effects of use by elk and cattle (Figure 1). Animal trampling had formed "ramps" along some streambank sections used as crossings, left hoof imprints in the stream bed, and created slump deposits in the channel—all of which produce turbulence and concentrate stream flows (Trimble and Mendel 1995). These direct effects induced erosion of gravel substrates that armored the bed. The erosion scoured pools, widened the channel, lowered the water below the overhanging banks, and exposed plant roots. These geomorphic changes caused the meadow to become drier, which, in turn, favored the expansion of shallow-rooted graminoids, such as Kentucky bluegrass.

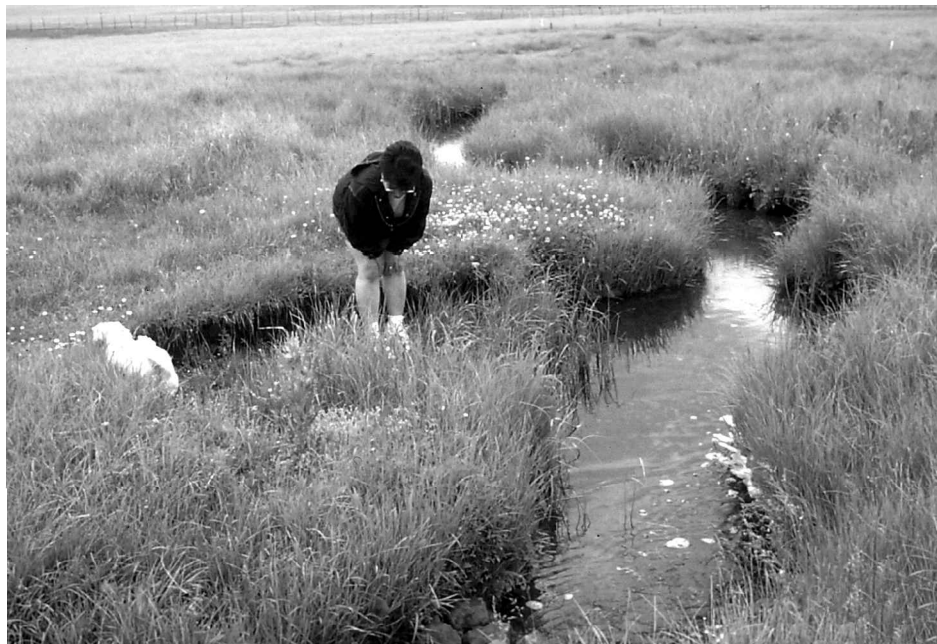
**Figure 5.** July 2001. Pacheta Creek at mid-point of treated reach, after restoration treatment. Note height of water relative to banks and growth of sedge transplants across formerly bare ground. Photo by Alvin Medina

In terms of vegetation, the higher water levels along the channel have allowed the sedge transplants to thrive and revegetate former animal crossings and eroded banks (Figure 5). The addition of sedge transplants to the riffle formations has increased channel roughness and helped to bind the formations to the bank. The heightened riffles disperse flows onto the banks and into the meadow during spring floods. In addition to dissipating stream energy, the riffle formations have re-armored much of the bed, rendering it less susceptible to erosion. The treatment has
