# Moisture Performance of Energy-Efficient and Conventional Wood-Frame Wall Assemblies in a Mixed-Humid Climate

**Abstract:** Long-term moisture performance is a critical consideration for design and construction of building envelopes in energy-efficient buildings, yet field measurements of moisture characteristics for highly insulated wood-frame walls in mixed-humid climates are lacking. Temperature, relative humidity, and moisture content of wood framing and oriented strand board (OSB) structural panel sheathing were measured over a period from mid-November 2011 through March 2013 in both north- and south-facing orientations in test structures near Washington, DC, USA. Wall configurations varied in exterior cladding, water-resistive barrier, level of cavity insulation, presence of exterior continuous insulation, and interior vapor retarder. The combination of high interior humidity and high vapor permeance of painted gypsum board led to significant moisture accumulation in OSB sheathing during winter in walls without a vapor retarder. In contrast, wintertime moisture accumulation was not significant with an interior kraft vapor retarder. Extruded polystyrene exterior insulation

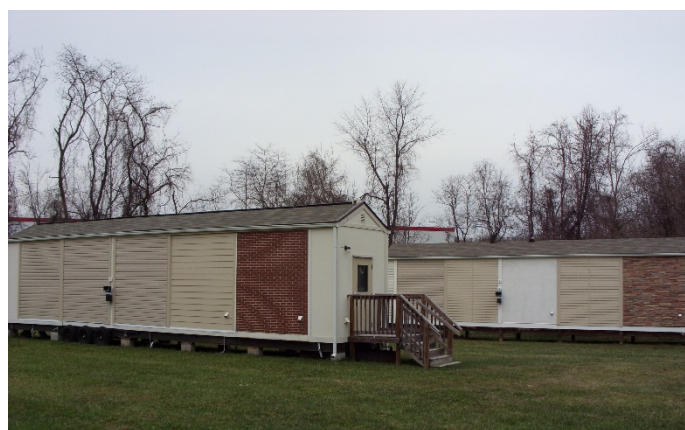
Two outdoor test structures (depicted in Figure 1) have been in use since 2008 on the campus of Home Innovation Research Labs (formerly NAHB Research Center), located in Upper Marlboro, Maryland, approximately 30 km east of Washington, DC (IECC Climate Zone 4A). Each structure has a nominal footprint of 2.4 m  $\times$  14.6 m (8 ft  $\times$  48 ft), and each long side features five pairs of 2.4 m (8 ft) wide by 2.7 m (9 ft) high bays for installation of test wall sections. The structures are oriented with the long axis aligned east to west. Wall assemblies are tested in pairs with each wall configuration in north- and south-facing orientation.

**Figure 1.** Test structures showing south-facing wall assemblies.

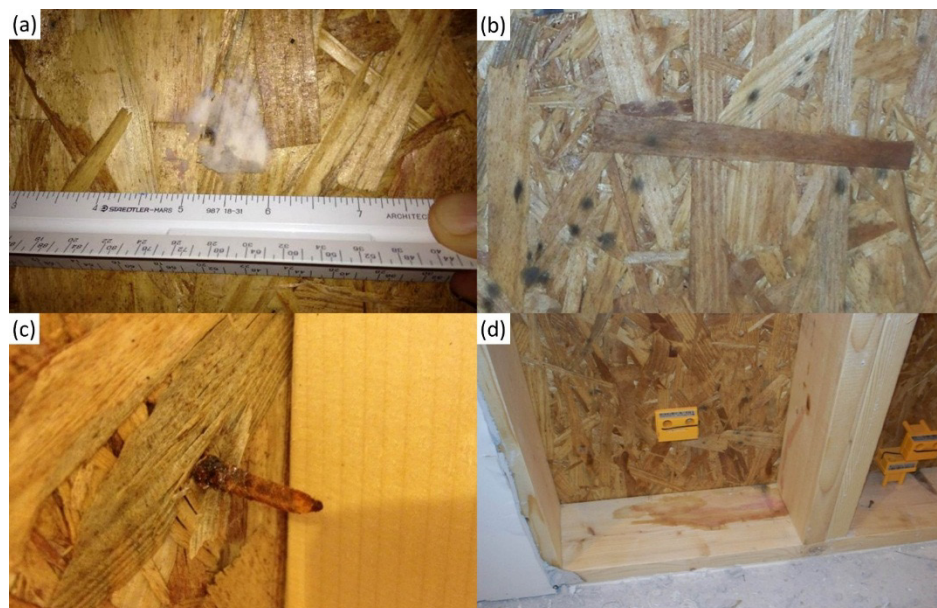
Failure of some of the moisture sensors during the winter of 2011–2012 in Wall 8b prompted inspection of the interior cavity of that wall section. The gypsum board and insulation were removed in the summer of 2012. Inspection of the OSB and the framing members revealed water stains, mold growth, and corrosion of siding nails (Figure 8). These observations are consistent with high levels of relative humidity and OSB moisture content. The mold growth and corrosion developed between the time when the materials were installed new (November 2011) and the time when conditions dried out, likely mid-April 2012 by comparison to similar wall assemblies (Figures 6 and 7). Premature failure of the sensors' batteries may have been a result of persistent high RH levels. Because the sensors do not register moisture levels above the fiber saturation point, the actual moisture content in this wall configuration is unknown. The water staining suggests that OSB moisture content exceeded the fiber saturation point.

**Figure 8.** Observations indicating high moisture levels in the cavity of Wall 8b: (a,b) Mold growth; (c) Corrosion on siding nail; (d) Staining on bottom plate.
