# Chapter 6. It's Not All Bad News—Riparian Areas in the Anthropocene

*Kenneth J. Kingsley*

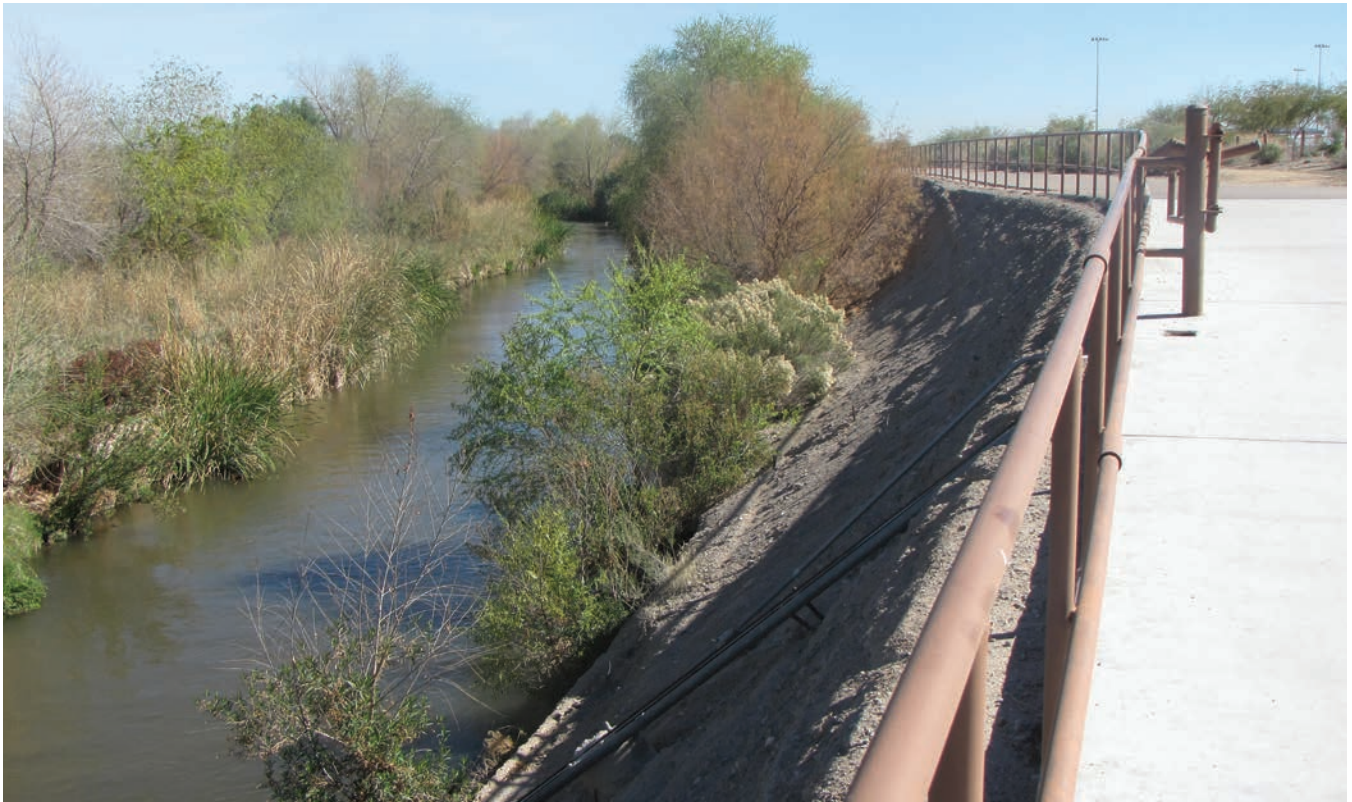
**Figure 20**—Riparian habitat: effluent-dominated reach of Santa Cruz River in Tucson, historically dry, currently wet. Note narrow width of riparian vegetation and soil cement bank. Photo by author.

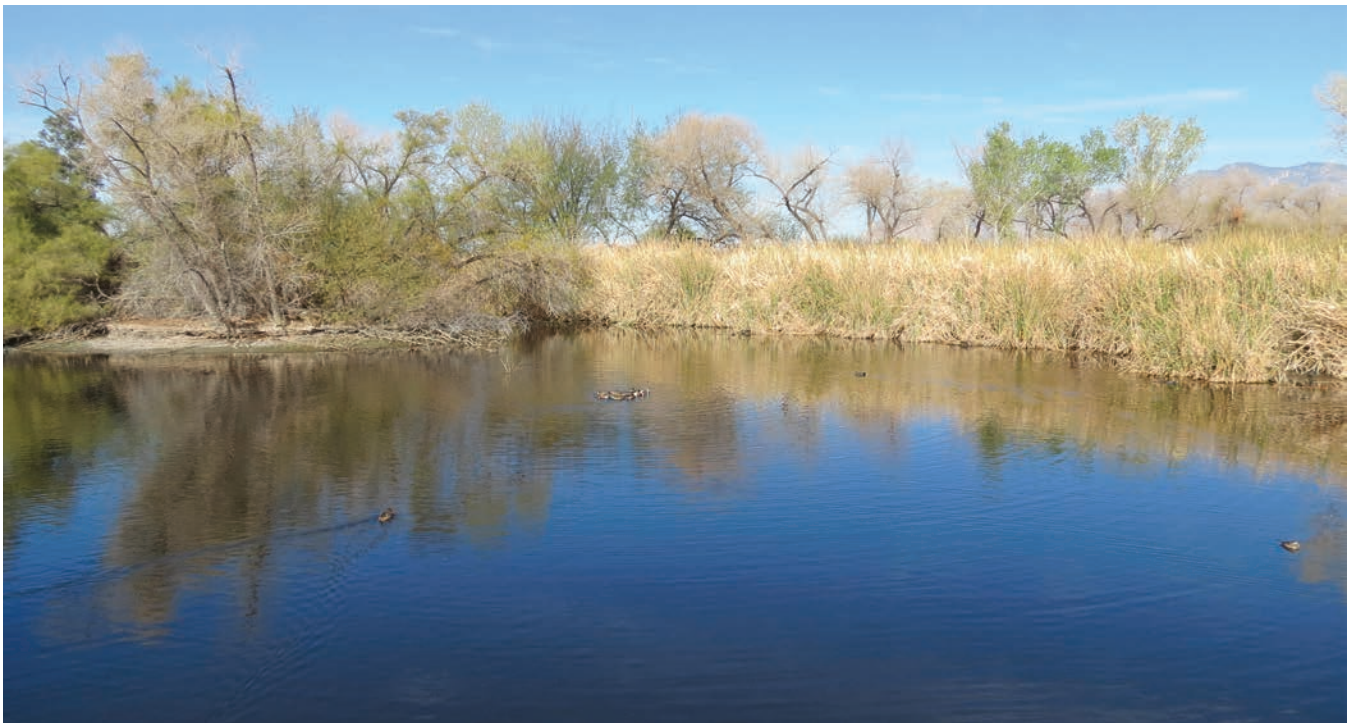
**Figure 22**—One of the ponds at Sweetwater Wetlands, February 2014. Originally used to process filter backflush water as part of an older sewage treatment system, this and adjacent ponds are currently filled with reclaimed water to provide wildlife habitat and a recreational amenity for the community. Photo by author.

Sweetwater Wetlands was created, planted with native wetland plants including Fremont cottonwood and cattails (*Typha latifolia*) and put into operation. It included ponds with islands for nesting birds (fig. 22), dense cattail stands for various stages of water

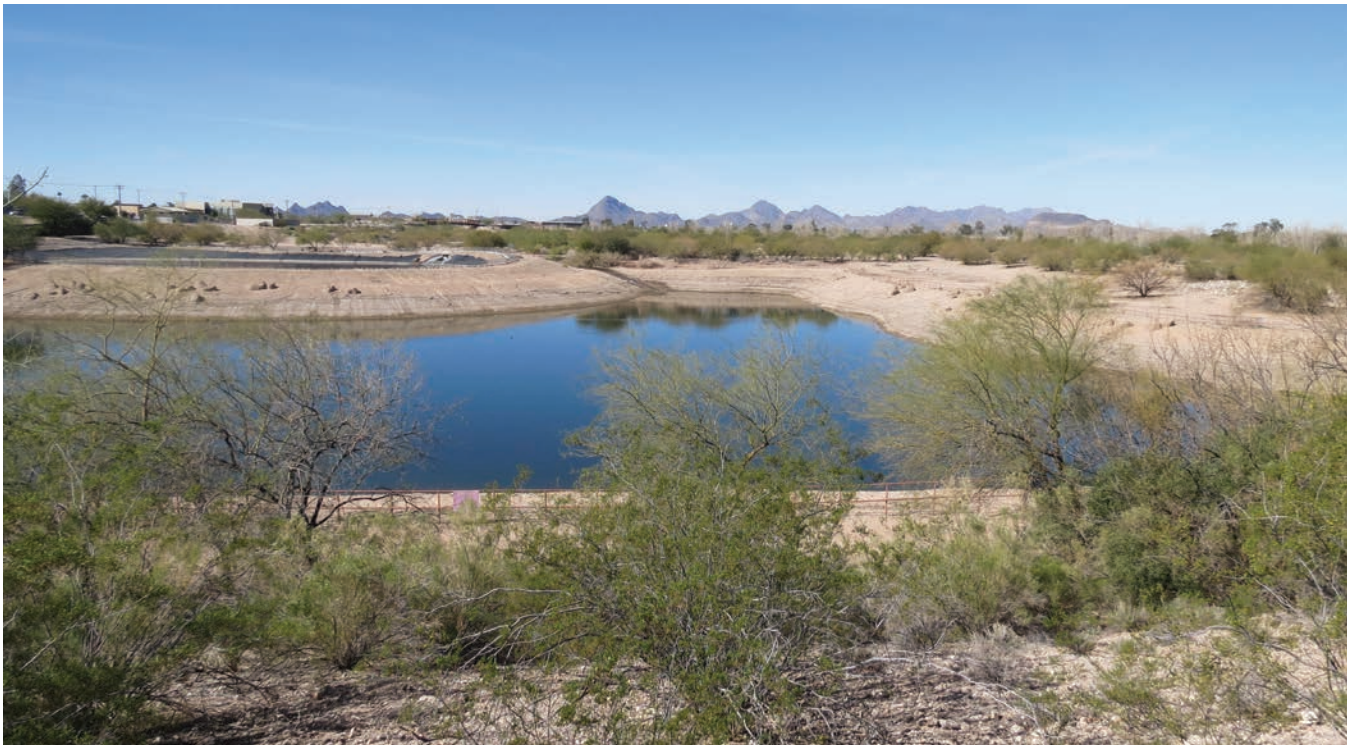
**Figure 23**—Riparian habitat: Kino Environmental Restoration Project, deep pond and vegetation, February 2014. The pond was created primarily a receptacle for stormwater runoff from the upstream urban area, and is managed, in part, to provide wildlife habitat and as a recreational amenity. Its design and management allow for rapid filling following storm events and minimization of mosquito habitat. Photo by author.

The project today is managed by the Kino Sports Complex/Stadium District in cooperation with Pima County departments, such as the Health Department, Regional Flood Control District, Department of Transportation, and the Regional Wastewater Reclamation Department, in addition to a number of State agencies to ensure KERP meets the State and Federal guidelines set forth for an environmental habitat. The final footprint of the KERP covers 141 acres and contains 28 acres of riparian and open water including: a 5.6-acre, 50-foot deep pond; 21 acres of grassland, mesquite bosque, marsh and upland vegetation; three short stream courses; and 92 acres that include flood control structures, a basin earthen berm, and a 2.2-mile recreational path that surrounds the basin (figs. 23 and 24).

reclaimed water) is purchased from Tucson Water to maintain pond levels and protect habitats. A 16-inch reclaimed water pipeline feeds water into the pond. In addition, the open water areas and marsh can be fed by three additional pipelines at KERP.

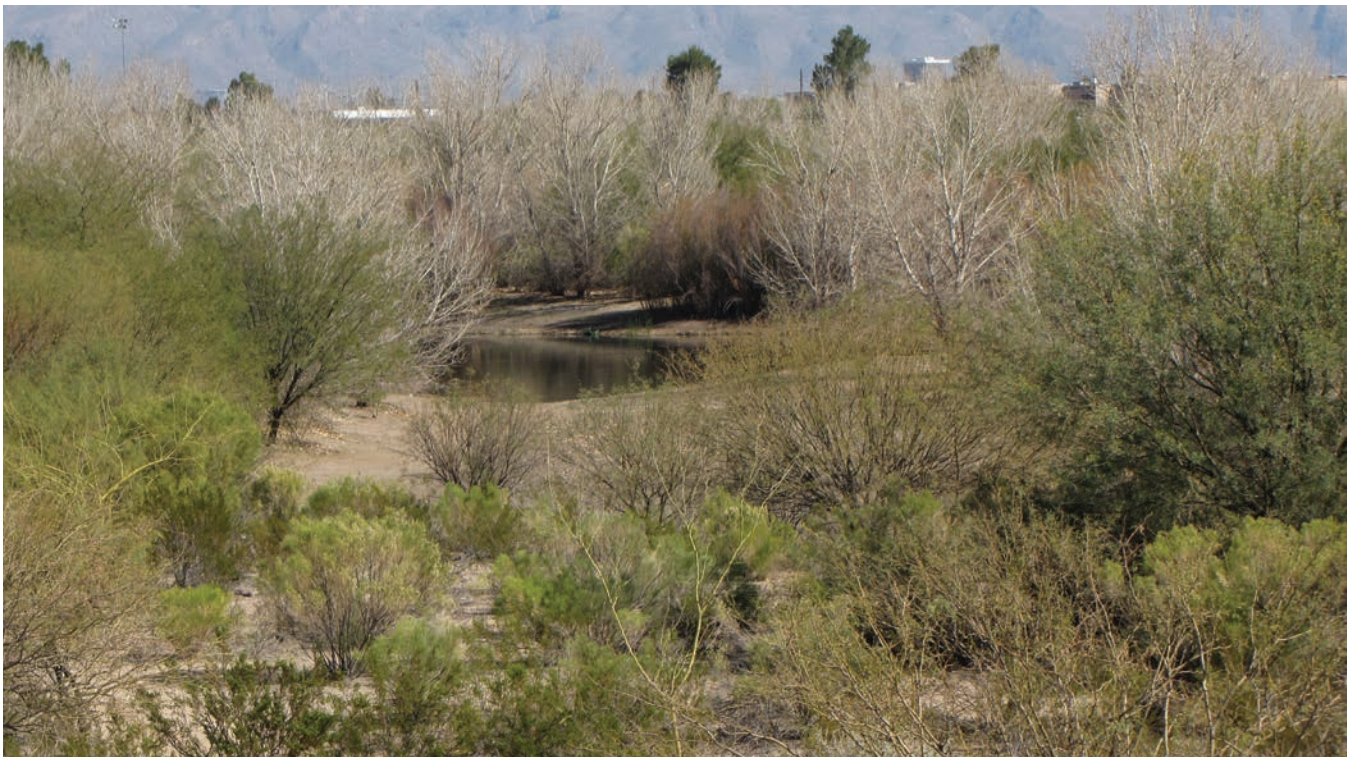
**Figure 24**—Riparian habitat: Kino Environmental Restoration Area, shallow pond and vegetation, February 2014. This pond is off the stormwater channel, so is not subject to rapid inundation, but is filled by water intentionally diverted from the large pond for the purposes of aquifer recharge, water storage, and wildlife habitat. Photo by Amy Gaiennie.

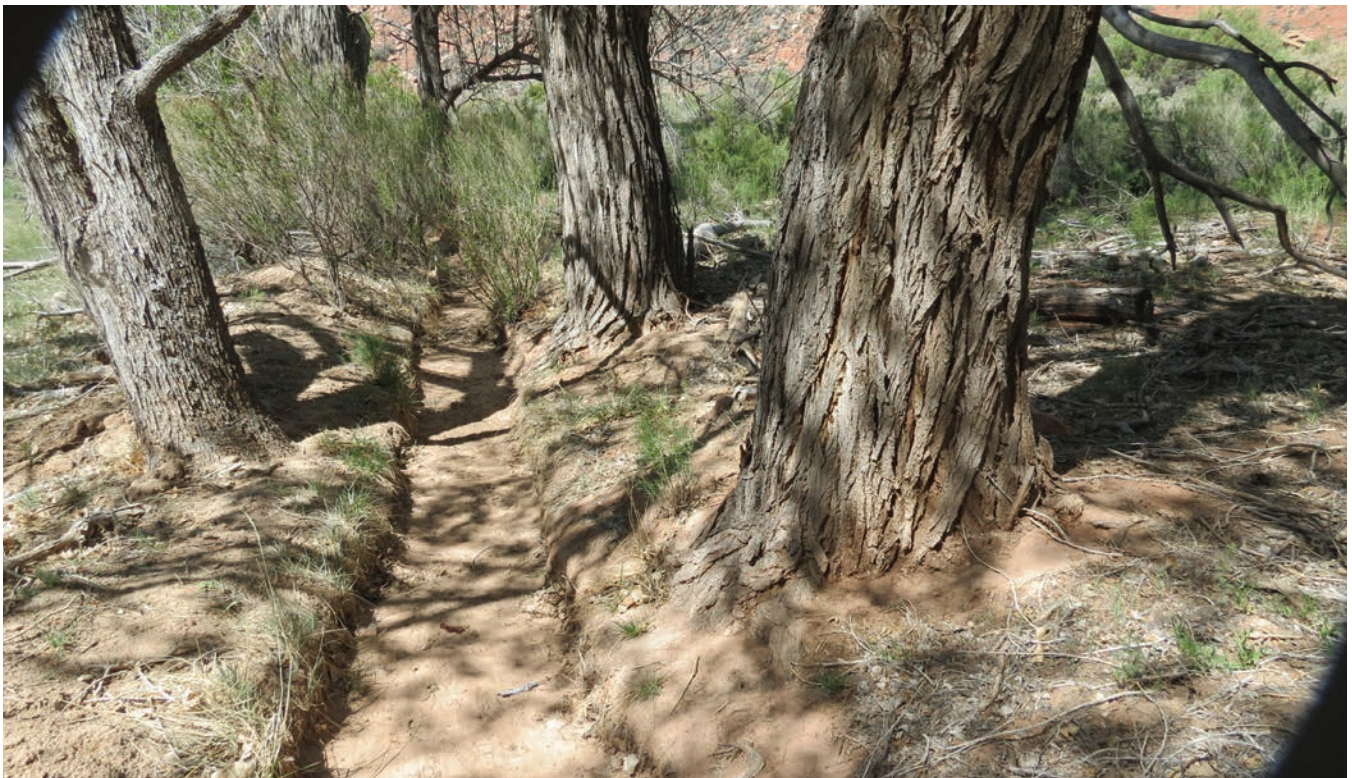
**Figure 26**—Century-old irrigation canal, still in use, with cottonwoods. Originally put in to irrigate an agricultural field, the canal is now part of Zion National Park. Cottonwoods apparently invaded after the canal was created and are now well established. Photo by author.

That irrigation canals support a new riparian resource has long been considered (fig. 26). Breninger (1898 p. 128), referring to the cactus ferruginous pygmy-owl, stated: “And since trees planted by man have become large enough to afford nesting sites for woodpeckers, this Owl has gradually worked its way from the natural growth of timber bordering the rivers to that bordering the banks of irrigating canals until now it can be found in places ten miles from the rivers.”
