# Immediate changes in stream channel geomorphology, aquatic habitat, and fish assemblages following dam removal in a small upland catchment

The Pelham dam (also known as the Bartlett Rod Shop Company dam; NID #MA01761) on Amethyst Brook was removed in Fall 2012. The masonry structure was in poor condition, stood ~6 m high and 50 m wide (Fig. 1), and in conjunction with large mainstem dams on the Connecticut River (e.g., Holyoke dam) significantly blocked upstream fish passage (Fig. 2). Originally constructed c. 1820, the dam supplied water power to the adjacent mill until the mid-twentieth century and then created a local swimming hole for several decades thereafter. The private dam owner was assisted in the dam removal process by a coalition of local, state, federal, and nongovernmental organizations with mutual interests in restoring fish passage (including diadromous species), improving sediment and organic matter transport for improved ecological conditions downstream, and eliminating risk and liabilities associated with the aging structure.

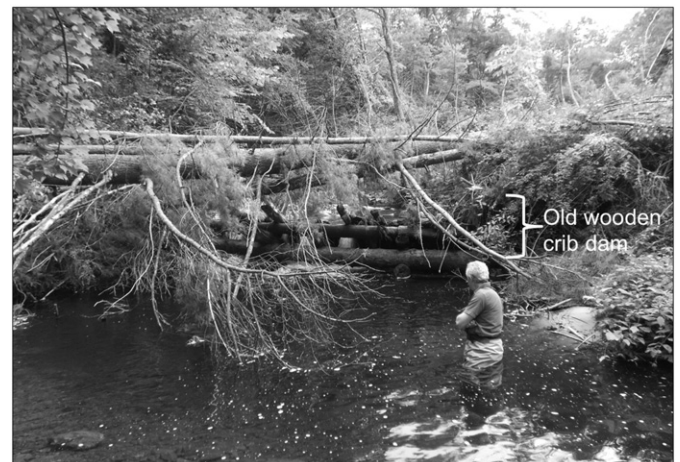
**Fig. 12.** Exhumed wooden crib dam. Photo taken soon following the 28 June 2013 flood.

historical records suggesting a very early historical age (older than the A.D. 1820 Pelham dam). Although unanticipated, exhumation of buried structures is not an uncommon phenomenon following dam removal (Harris and Evans, 2014; Wilcox et al., 2014; Zunka et al., 2015).

but bed surveys revealed a bedrock ledge ~45 m upstream of the crib dam that would have arrested further upstream propagation. The limited spatial extent of headcutting seems to predominate in physiographic regions like New England where streams flow on resistant bedrock or where coarse Pleistocene deposits get exhumed and limit progressive headward propagation (Pearson et al., 2011; Gartner et al., 2015). For Amethyst Brook, the spatial extent of headcutting was on the order of ~4–5 bankfull widths above the former impoundment head (due to the crib dam) but would have only progressed to ~9–10 bankfull widths before encountering its first bedrock ledge.
