# Rehabilitating Valley Floors to a Stage 0 Condition: A Synthesis of Opening Outcomes

**Keywords:** process-based restoration, valley-scale restoration, monitoring, multiple metrics, ecohydraulic design

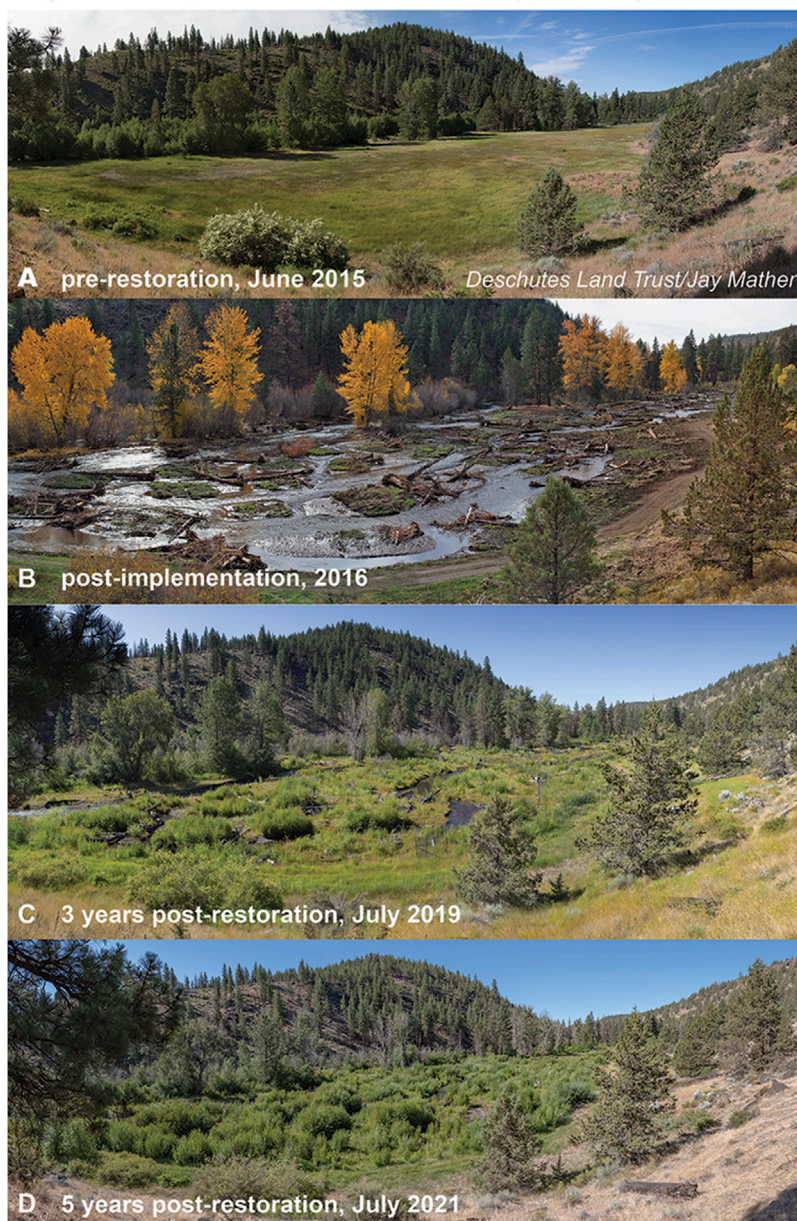
Whychus Creek, Deschutes Land Trust's Whychus Canyon Preserve

**FIGURE 1** | At Whychus Creek, at the Whychus Canyon Preserve, restoration to a stage 0 condition was implemented and documented with photos of: **(A)** pre-restoration condition; **(B)** immediately post implementation condition; **(C)** 3 years post restoration, and; **(D)** 5 years post restoration.

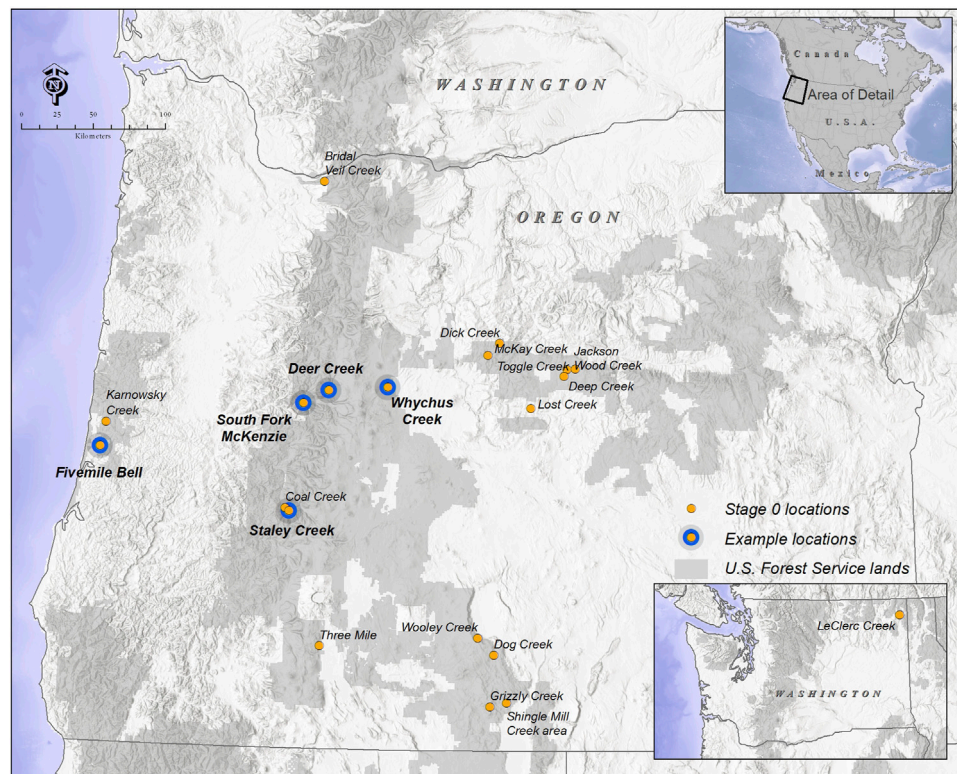
**FIGURE 2 |** Restoration projects targeting a Stage 0 condition were identified in the Pacific Northwest, United States, and primarily in Oregon. Projects were identified based on project goals to restore/reconnect rivers to their floodplain at a valley scale allowing for the development of longitudinal, lateral, and vertical hydrologic connectivity.

Stream restoration practitioners identified over 20 sites where process-based, valley-scale intervention was intended to restore dynamic river systems (Figure 2). Some of these projects were completed before the advent of the term “Stage 0”. Recent projects are that larger in spatial extent tended to have more focused

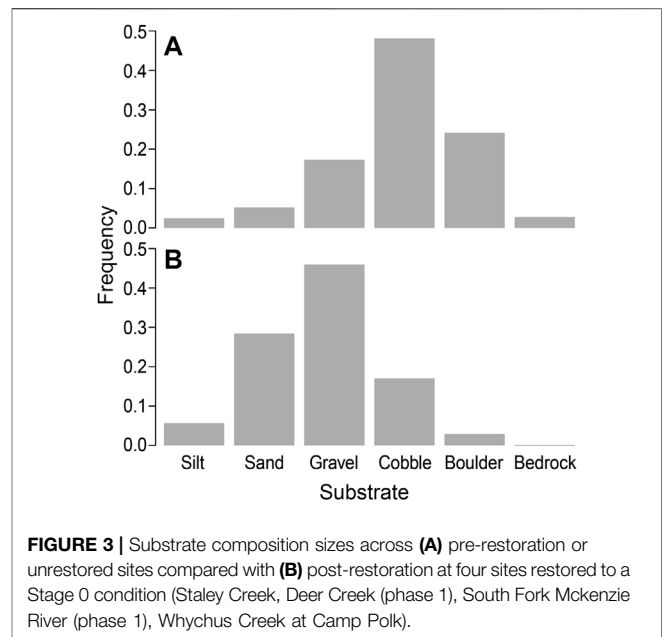
**FIGURE 3 |** Substrate composition sizes across (A) pre-restoration or unrestored sites compared with (B) post-restoration at four sites restored to a Stage 0 condition (Staley Creek, Deer Creek (phase 1), South Fork Mckenzie River (phase 1), Whychus Creek at Camp Polk).

toward finer particle sizes was observed across four sites monitored for stream substrate. Across all sites, larger particles present before restoration were replaced with smaller size classes that are more conducive to salmon (Riebe et al., 2014) and lamprey spawning (Hogg et al., 2014). The shift in substrate size likely reflects both the mechanical reorganization of material during restoration, as well as fluvial deposition and sorting of finer particles over time as the restored reach became a slower-water, depositional environment (for relevant sedimentation and fluvial processes see Hudson, 2017). Additional monitoring to document changes in sediment and wood distribution, and resulting effects on available aquatic habitat complexity will elucidate how placed and subsequently rearranged materials alter stream habitats for native biota including fish. Notably, long-term monitoring of wood transport distance in hydraulically rough, multi-channel, Stage 0 systems will help inform both the potential for long-term benefits from placed wood and the effects of restoration to Stage 0 on the wood regime.

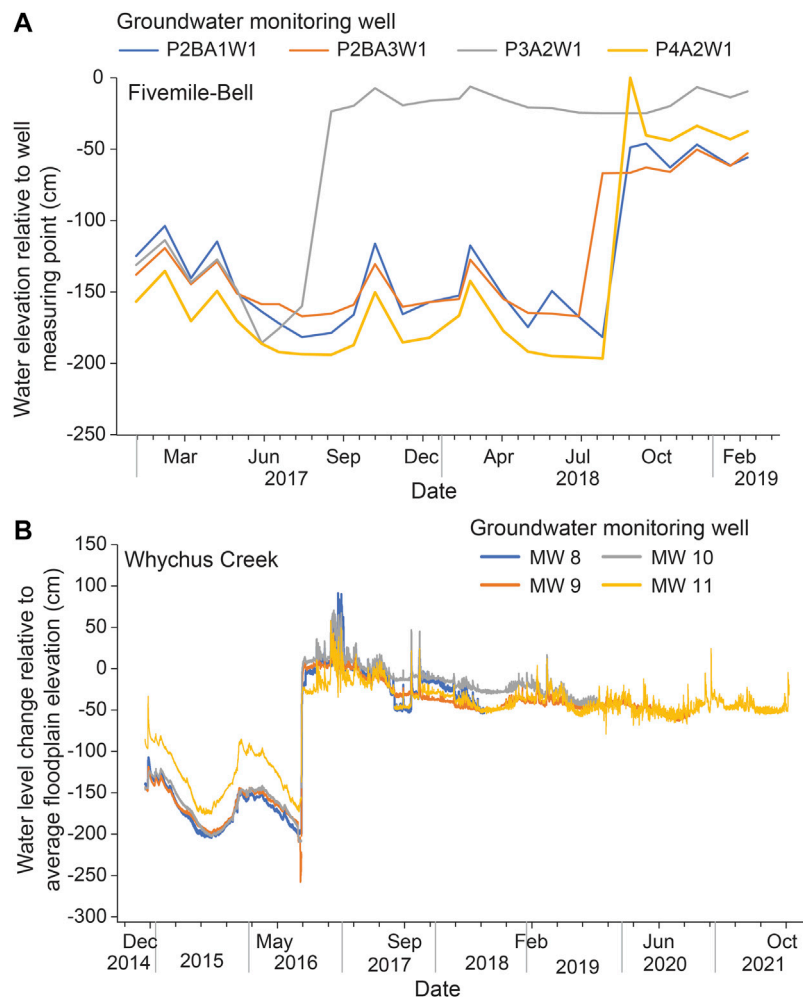
**FIGURE 4 |** Surface and water table depth at **(A)** Fivemile-Bell Creek; and **(B)** Whychus Canyon.

At WCPreserve Phase 1, maximum groundwater depths pre-restoration occurred in August, ranging from  $-2.5$  m to  $-1.7$  m. Minimum groundwater depths occurred between late December and mid-February, at  $-1.2$  m to  $-0.3$  m. Maximum groundwater depths post-restoration occurred between late July and mid-September, ranging from  $-0.6$  m to  $-0.1$  m. In contrast to pre-restoration conditions, these post-implementation groundwater levels are within the range needed to support hydrophytic

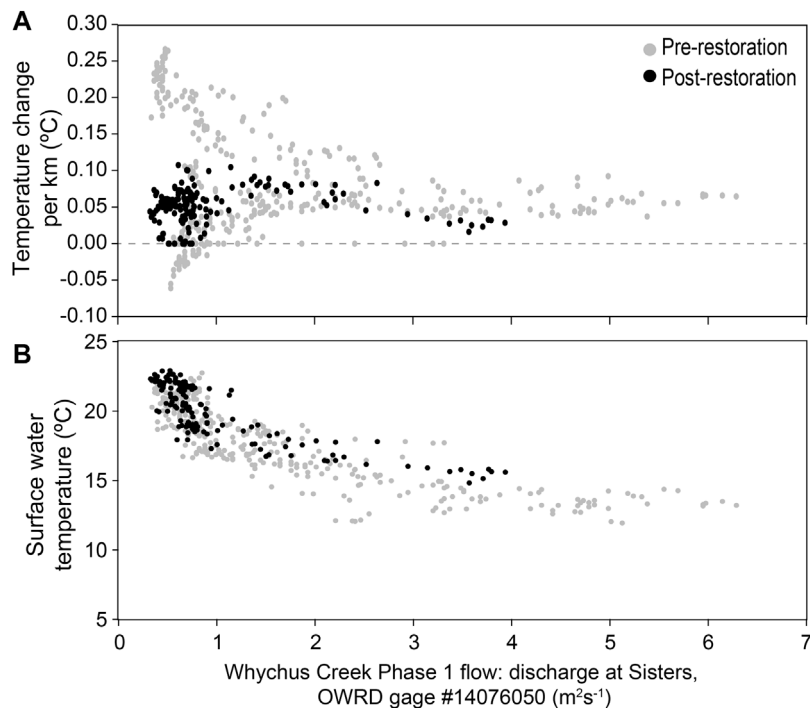
**FIGURE 5** | Water temperature pre- and post-restoration to a Stage 0 condition at Whychus Creek at Whychus Canyon: **(A)** rate of change per kilometer, and; **(B)** surface temperature (°C).

At the WCPreserve Phase 1 site, higher variability in thermal change per kilometer was apparent at low-flows pre-restoration ( $-0.07^{\circ}$ – $0.26^{\circ}\text{C km}^{-1}$ ), while the rate of change at all flows post-restoration remained relatively steady ( $0$ – $0.13^{\circ}\text{C km}^{-1}$ ). Rate of change at higher flows appeared lower post-restoration than pre-restoration (Figure 5A). July surface temperature remained within the same range of variation present in the pre-restoration data (Figure 5B).

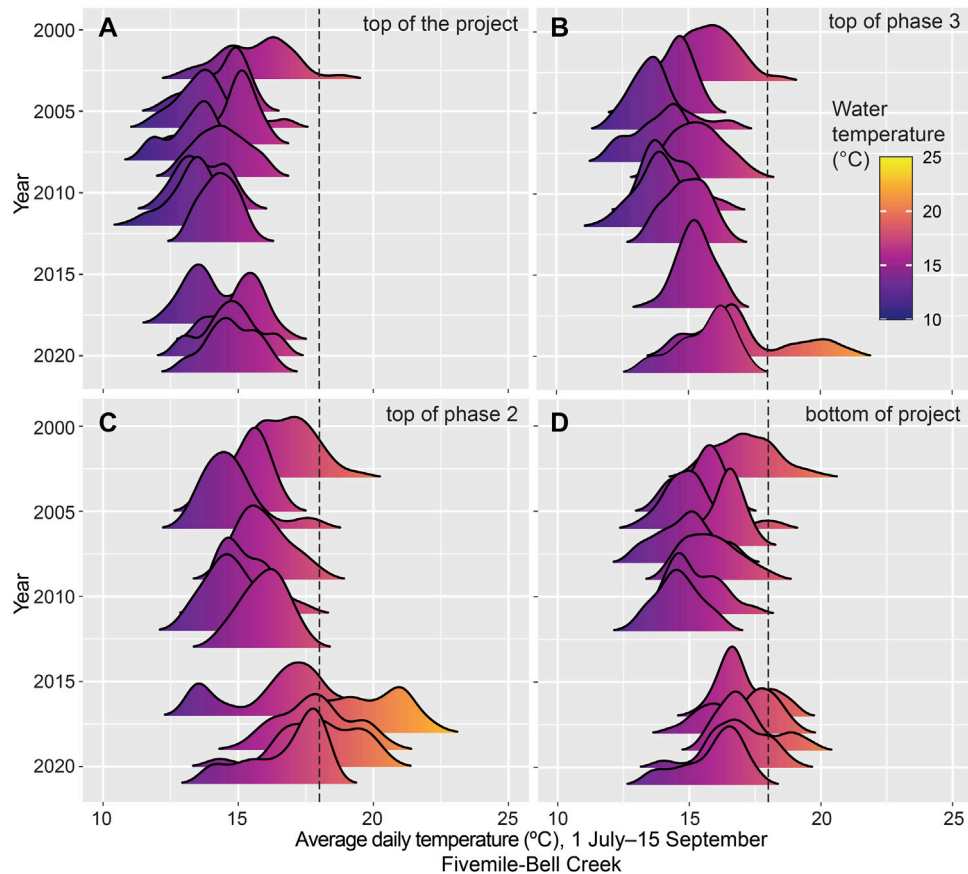
**FIGURE 6 |** Stream temperature over time at Fivemile Bell site that drains into Tahkenitch Lake on the south coast of Oregon, United States.

At Fivemile-Bell, the lowest temperature observed was  $5.79^{\circ}\text{C}$  in November 2007. Minimum temperatures across all sites typically occurred between October and December ( $5.79$ – $10.58^{\circ}\text{C}$ ). From 2003 through 2013, maximum temperatures occurred from July through September ( $16.33$ – $18.52^{\circ}\text{C}$ ), with an outlier extreme of  $20.1^{\circ}\text{C}$  in July 2003. Post-restoration maximum temperatures ranged from  $20.75$  to  $29.92^{\circ}\text{C}$ . However, daily average temperatures did not exceed  $23^{\circ}\text{C}$  during the same time period (Figure 6C). Despite the

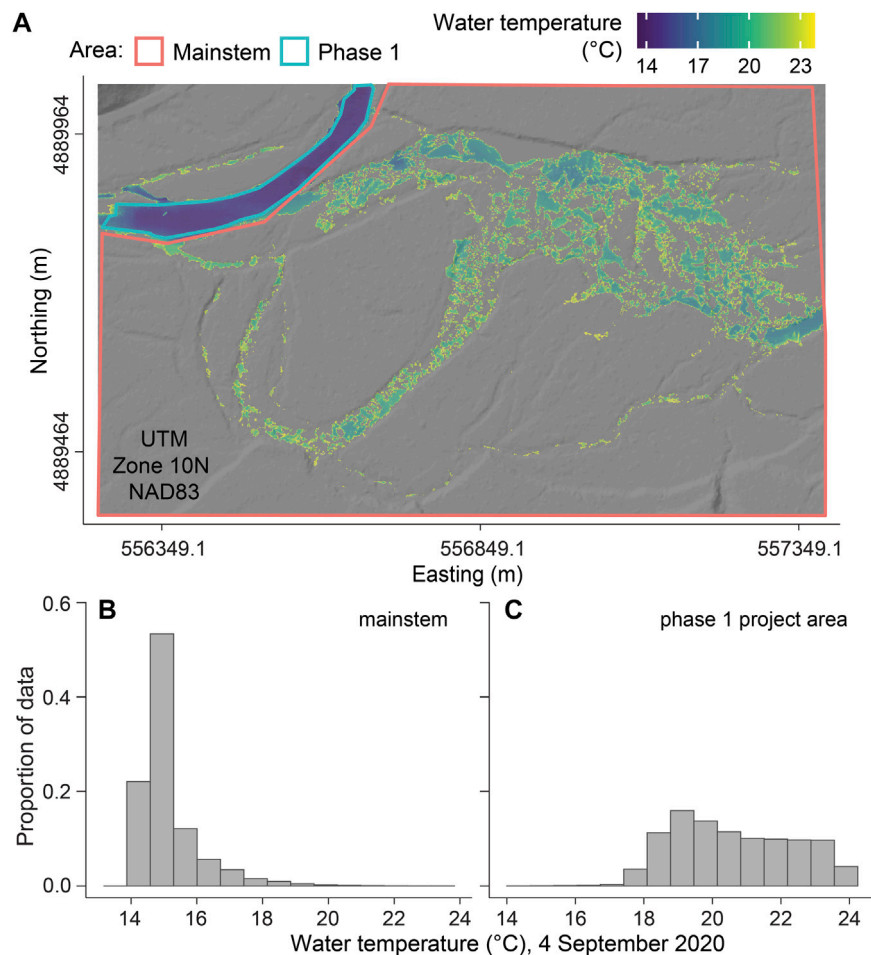
**FIGURE 7** | Water temperature derived from UAS imagery of: **(A)** the mainstem McKenzie River, and in the phase 1 restoration reach of the South Fork McKenzie River; **(B)** temperature distribution of mainstem on 4 September 2020; and **(C)** temperature distribution of Phase 1 of Stage 0 restoration reach on 4 September 2020.

The thermal imagery (**Figures 7A–C**) shows temperatures from 4 September 2020 surveyed between 1:46 to 3:18 p.m. PDT, with average water temperatures at the USGS gage of 13.88°C. Based on the rate of heating with distance, the expected pre-restoration average water temperature would have been 15.82°C. In contrast, no point location on the thermal imagery was colder than 14.0°C (**Figure 7C**; **Supplementary Table S3-4**), and the median temperature of the surface of the water was 20.4°C. The imagery (**Figure 7A**) also shows higher spatial variation in temperatures in the restored SFMR than in the mainstem McKenzie River. The surface temperature of the mainstem had a standard deviation of 0.9°C and a range of 4.2°C (**Supplementary Table S3-4**), with visibly warmer water evident along channel edges and a patch west of the Phase 1 outlet. Phase 1 appears more heterogeneous, having surface temperature standard deviation of 1.6°C and a range of 6.1°C (**Supplementary Table S3-4**), with warmer water present near accumulated woody material and the stream edge. These

differences are clearly shown in the width and shape of the frequency distributions of the surface water temperatures (**Figure 7B** vs **Figure 7C**).

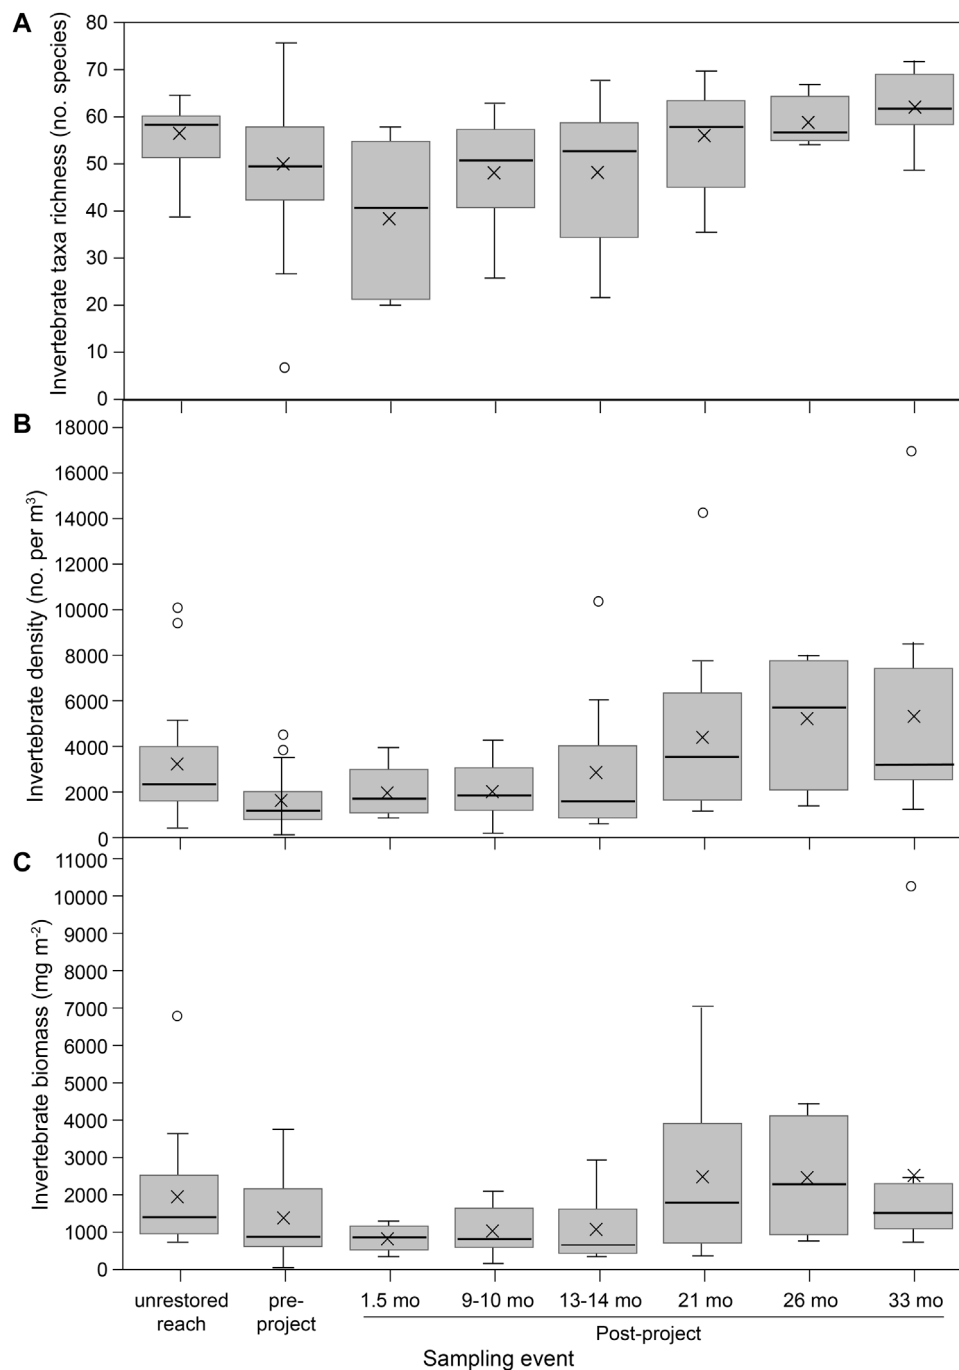
**FIGURE 8 |** South Fork McKenzie River benthic macroinvertebrates from reference (unrestored) habitats, pre-restoration, and in the months post-restoration for: **(A)** invertebrate taxa richness; **(B)** invertebrate density; and **(C)** invertebrate biomass. Boxplot center line is the median, and X is the data mean.

Generally, similar values of aquatic macroinvertebrate richness, abundance, and biomass were found among pre-restoration, post-restoration, and unrestored sites in the SFMR (**Figures 8A–C**). Invertebrate richness and biomass were not significantly different pre-restoration, whereas density was significantly lower (**Supplementary Table S4-2**). However, all metrics increased over time following restoration (**Supplementary Table S4-2**). Samples collected approximately the first year after restoration (1.5–14 months) have richness, density, and biomass values within the range of pre-restoration. Samples collected approximately 2–3 years after restoration (21–33 months) have higher values compared to pre-restoration, but within the range of unrestored samples. Comparisons of overall taxa richness, density, and

biomass did not account for changes in assemblage compositions. That said, qualitative differences in community assemblages were observed. The snail *Juga* (*Juga hemphilli maupinensis*), for instance, comprised an average of 22 and 24% of the biomass in unrestored and pre-restoration samples, but only 5% of the biomass post-restoration.

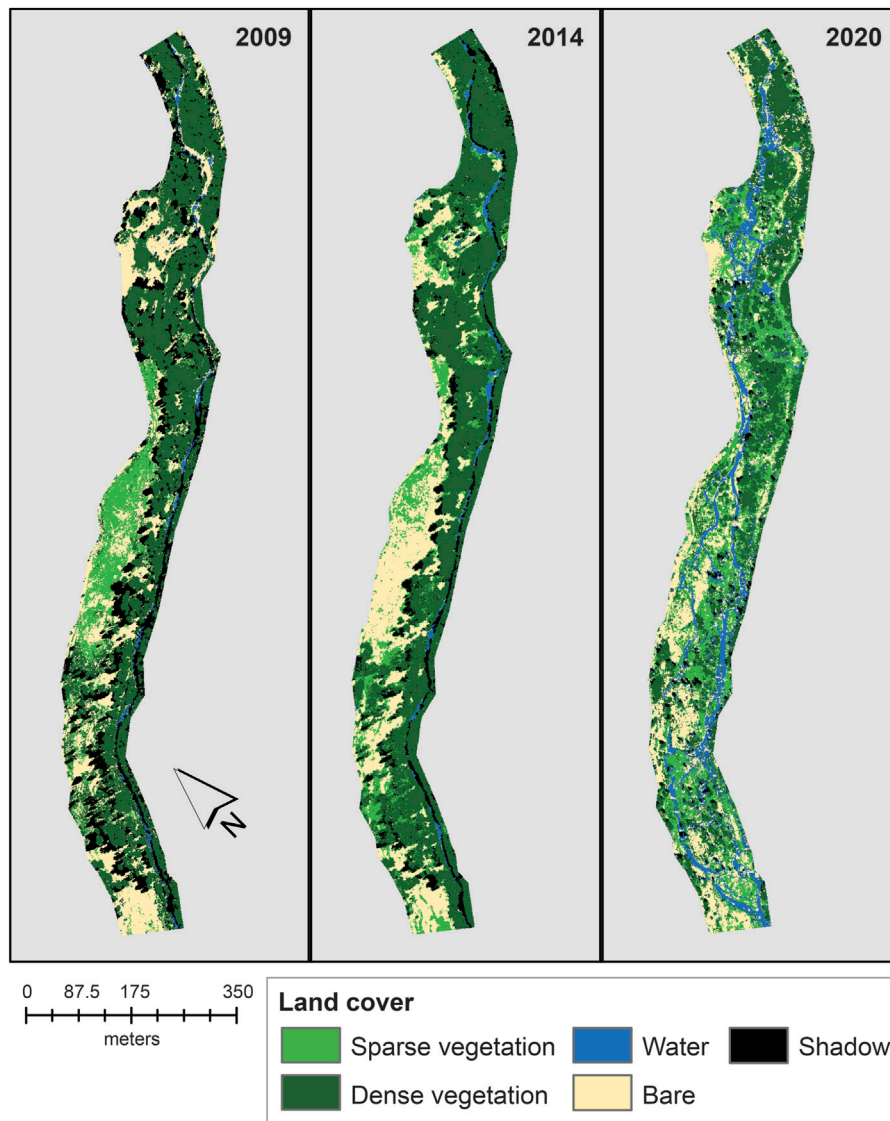
**FIGURE 10 |** Isocluster unsupervised classification of surface vegetation at Whychus Canyon Preserve Phase 1 site using National Agricultural Imagery Program NDVI datasets. Restoration occurred at this site in 2016.

The presence of shadows from imagery collected at different times of day presents difficulties for attaining the most accurate classifications possible. The shadows caused an underestimation of percent coverage for all classification categories. Without ground truthing vegetation surveys, it is not possible to determine the exact extent of underestimation for each classification category, but the extent of underestimation would be less than or equal to the percent coverage associated with shadows. This highlights the importance of using imagery collected at or near solar noon to reduce the effect of shadows in classifying images. However, the high overall accuracy suggests

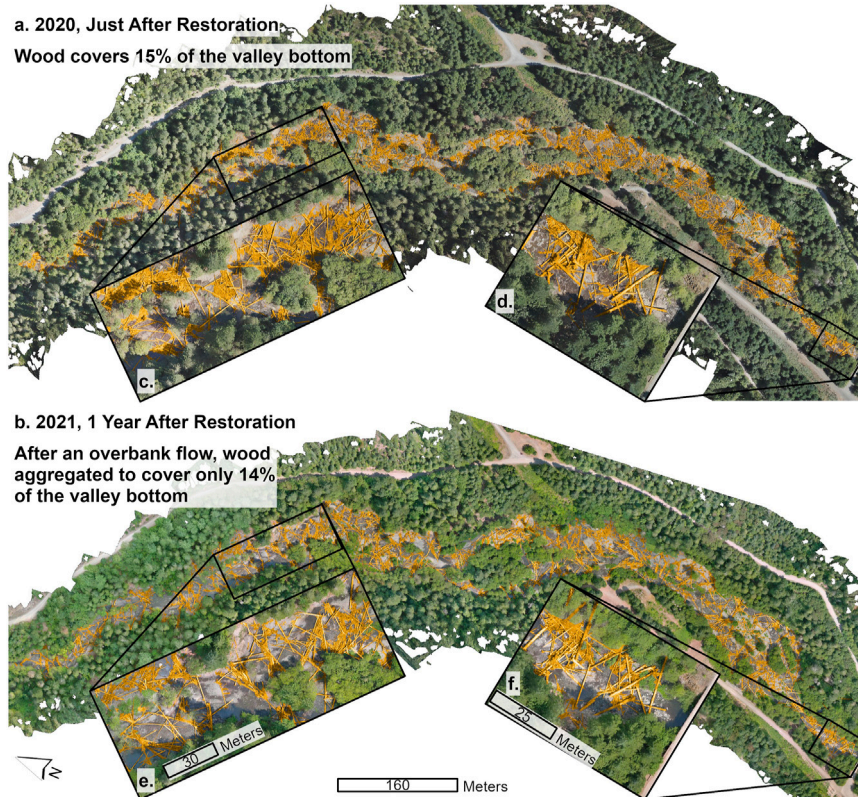
**FIGURE 11 |** Wood (colored in yellow) on the valley floor of the Deer Creek, Oregon site: **(A)** shortly after restoration was completed; **(B)** 1 year post-restoration; **(c,d)** insets showing placement of wood lattices; and **(e,f)** insets of parallel locations showing accumulation of wood material after overbank flow events of the winter months.

This post-restoration high-flow event, and the wood aggregation it caused, resulted in a loss of wood coverage from 15 to 14% of the valley bottom area. However, this reduction in coverage was likely due to aggregation, not the export of wood from the project site. We infer this based on observations that the jam at the downstream end of the reach is taller than the flood-flow depth and did not move substantially during the flood or noticeably lose wood (compare Figure 11D with Figure 11F). This jam likely caught any wood that made it near the downstream end of the reach, preventing downstream mobilization.

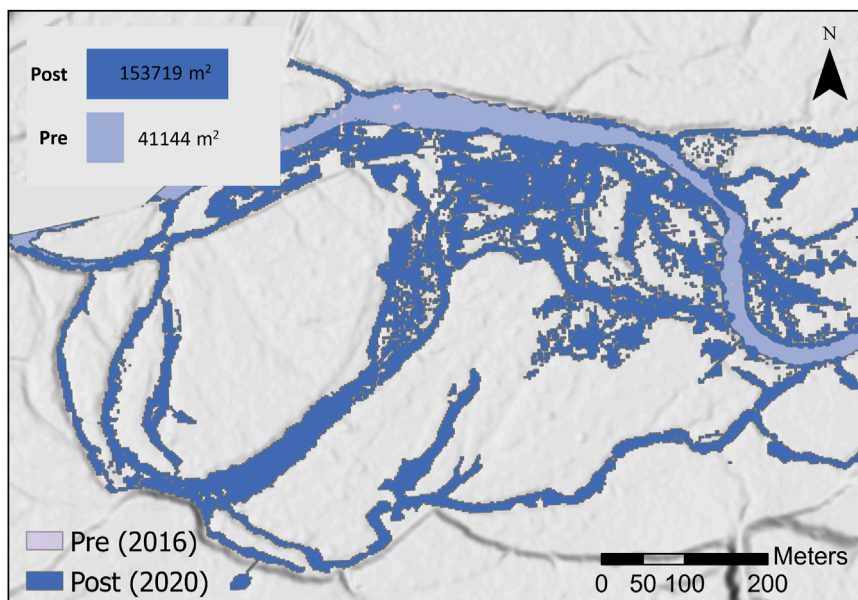
**FIGURE 12 |** Inundated area comparison pre- and post-restoration to a Stage 0 condition at the South Fork McKenzie River, OR. Visual overlay of the pre-treatment wetted area, based on early-summer 2016 imagery, compared to post-treatment wetted area, based on late-summer base-flow imagery. The background image is the LIDAR-derived DEM from 2020. Prior to restoration, the channel occupied only 41,114 m<sup>2</sup> of area, as depicted on the northern edge of the image. In contrast, the post-restoration channel occupies not only a greater area, approximately 153,719 m<sup>2</sup>, but encompasses a landscape of over 400,000 m<sup>2</sup> in area.

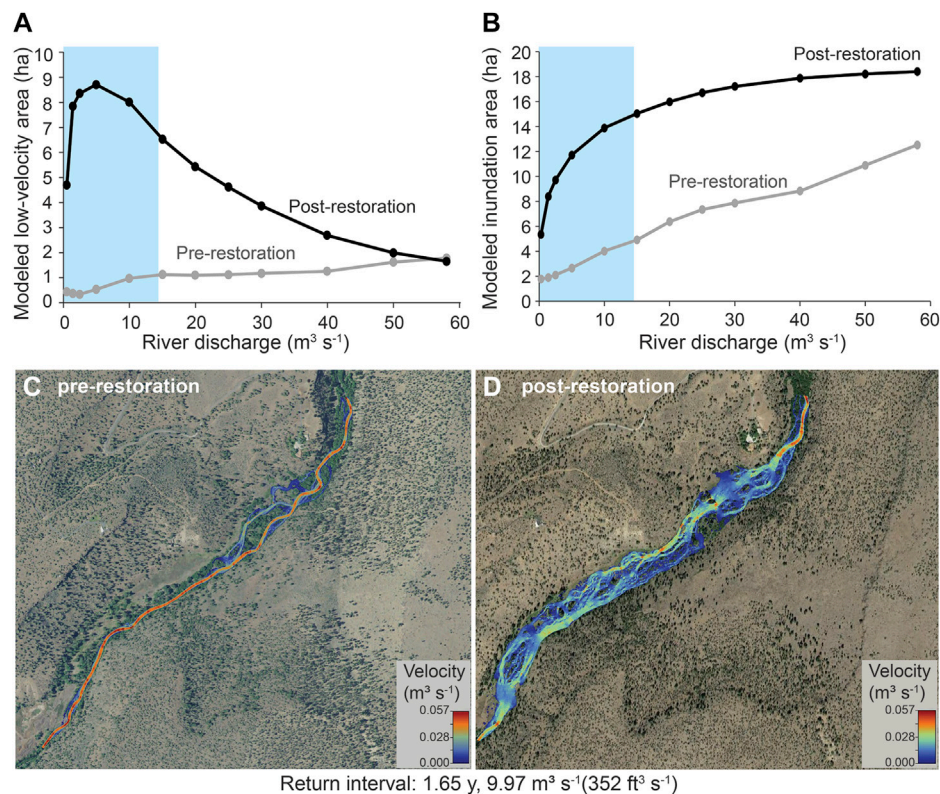
**FIGURE 13 |** Velocity modeling at the Whychus Creek at Whychus Canyon restoration site show: **(A)** suitable juvenile salmonid rearing habitat for the pre- and post-restoration conditions (blueshaded area delineates flow conditions for rearing); **(B)** modeled inundation area across river discharge levels for pre and post-restoration valley configurations; **(C)** mapped pre-restoration velocity for one commonly occurring winter flow of 10 cms, and; **(D)** mapped post-restoration velocity for one commonly occurring winter flow of 10 cms.

Model results of velocity patterns from the restoration of WCPreserve Phase 1 to a Stage 0 condition showed substantially increased low-velocity habitat suitable for rearing juvenile salmonids over a broad range of discharge (Figure 13A). Suitable rearing habitat is plotted over the range from summer base-flow to the 100-years event (Figure 13A). Pre-restoration juvenile rearing habitat was low overall and decreased to minimum values when common winter and spring storm flows occurred (Figure 13C), evidence of potential for juveniles to be flushed downstream by these events. In the post-restoration environment, the suitable rearing habitat

increased substantially and reached maximum values up to 27 times greater during juvenile rearing flows (**Figures 13A,D**). The two curves converge at the highest flows (e.g., Q100) because the narrow floodplain is confined between steep canyon walls and is filled to capacity (**Figure 13A**).
